# Manual for Dismantling, Documenting and Rebuilding Historic Tiled Stoves

**—Sustainable Heritage Report No. 3**

Novia Publications and Productions,  
series S: Student Works, 2/2012

A joint project between Gotland University, Estonian Academy of Arts  
and Novia University of Applied Sciences.

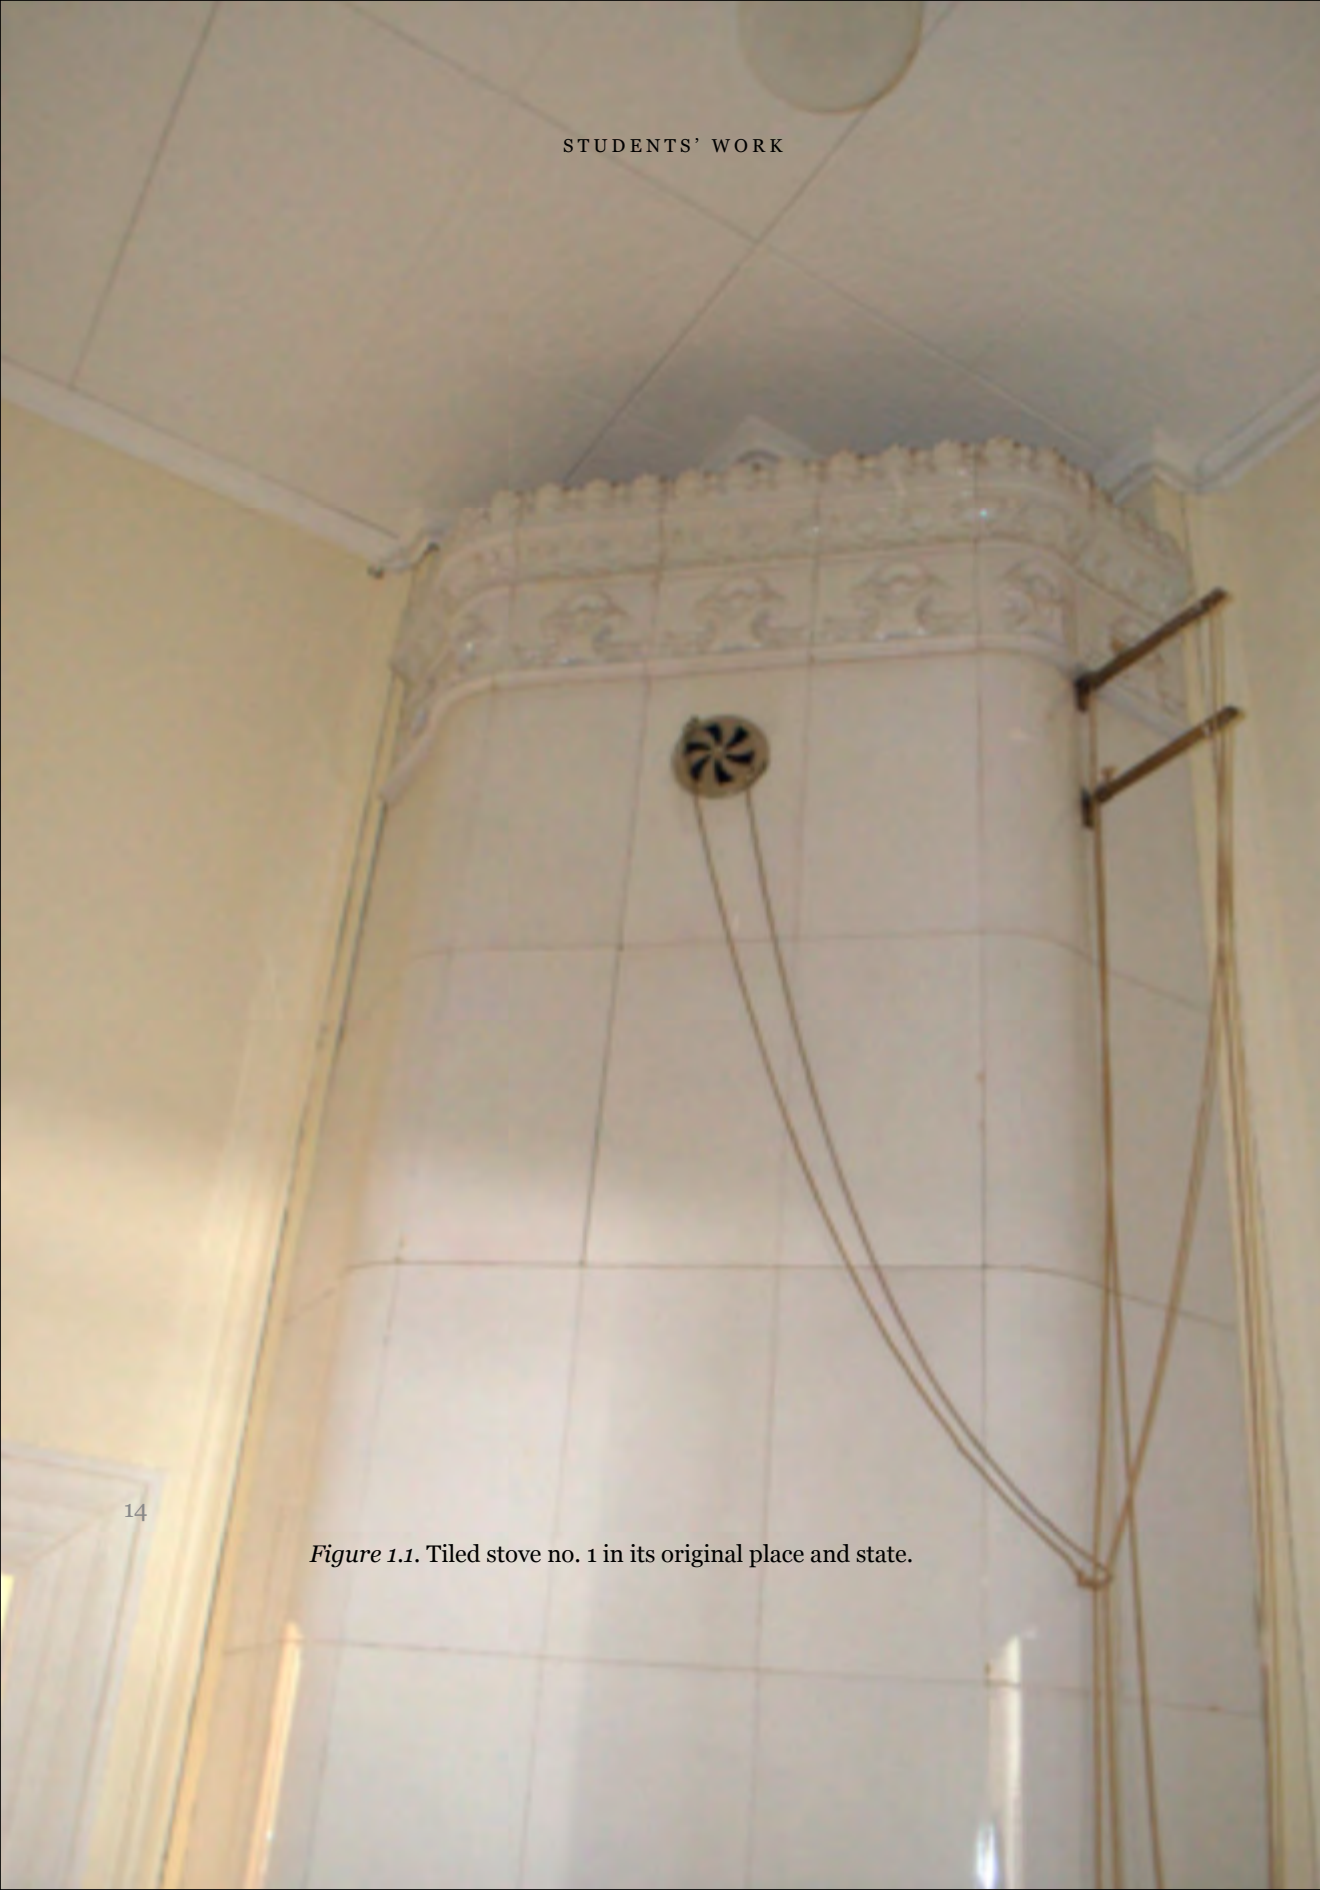
Figure 1.1. Tiled stove no. 1 in its original place and state.

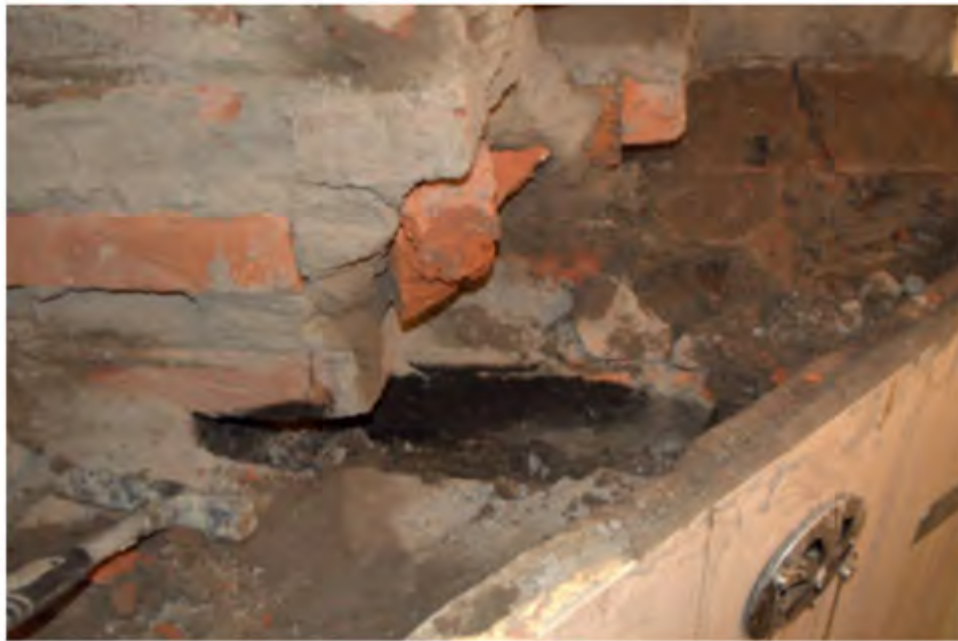
Figures 1.3 a, b. Section D–D with air vent.

This drawing and photo show the first air vent we encountered in the dismantling process. It was situated behind row 3 of tiles.

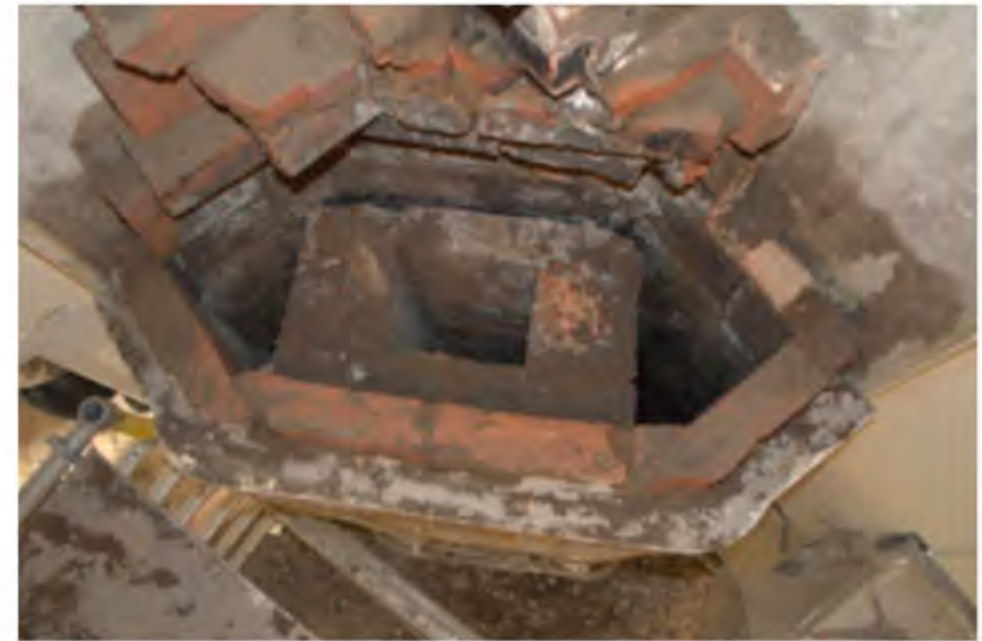
Figures 1.4 a, b. Section C–C; image and technical drawing.

The photo shows a typical section of this stove. In the middle you can see the flue (up) from the furnace, and the secondary flues (down) around it. Tile rows 4–8 were all of this type.

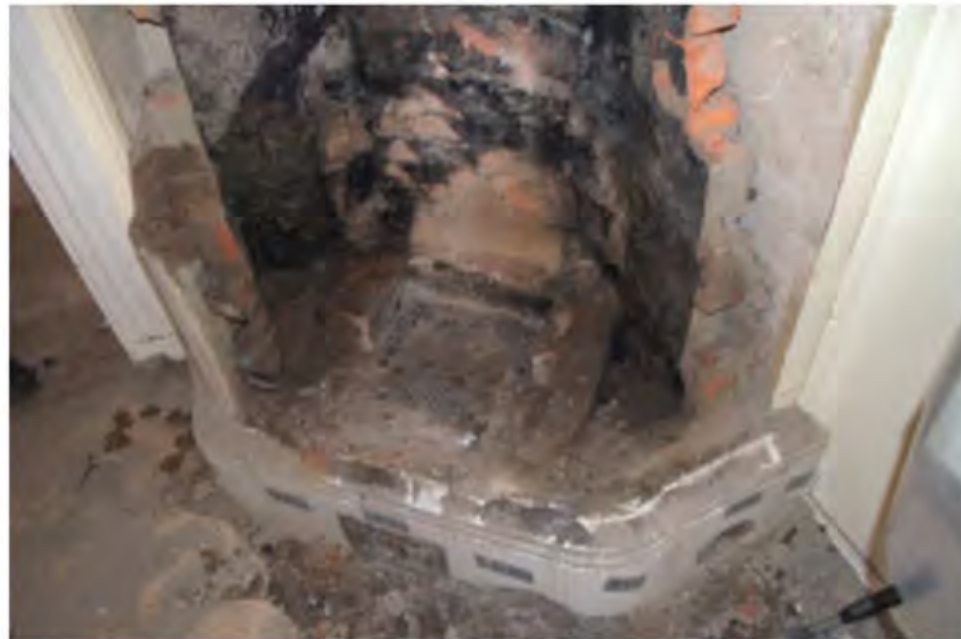
Figures 1.5 a, b. Section B-B and photo of the same.

Here we see tile row 9 where the furnace and its doors were. The bricks closest to the furnace were all fireproof bricks.

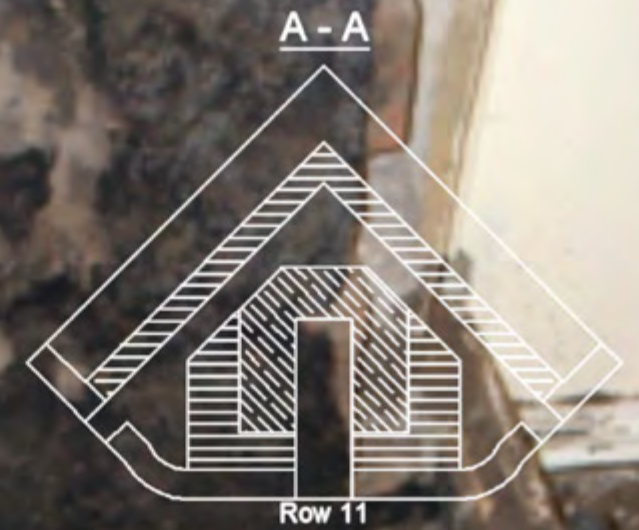
Figures 1.6 a, b. Section A-A and image.

This picture shows the bottom row 11, where there was an ash dump and two openings for cleaning the flues. After we dismantled the last row of tiles we took apart the rest of the chimney and the back wall, which we had left there for stability.

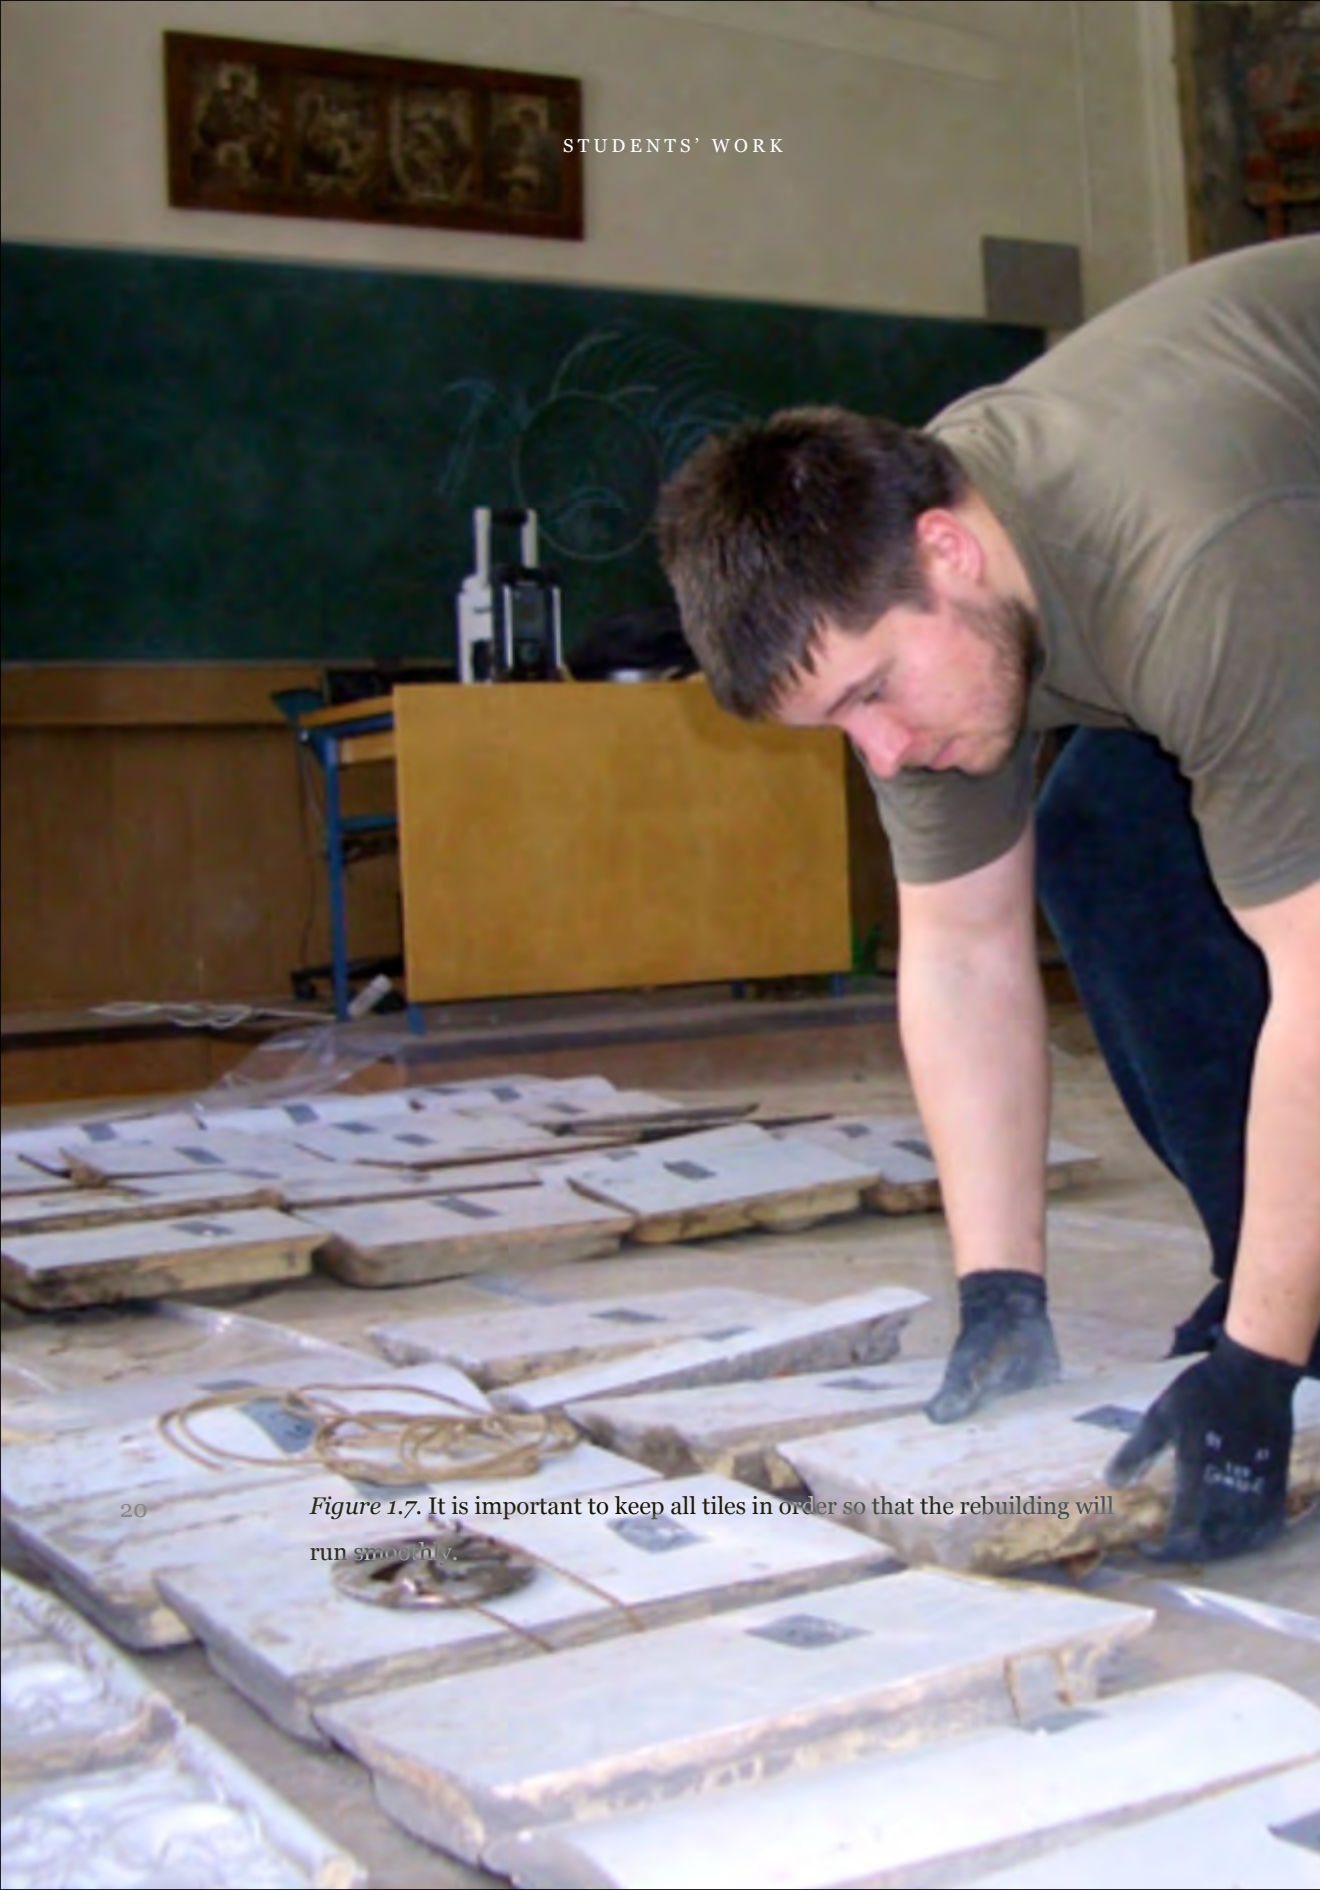
Figure 1.7. It is important to keep all tiles in order so that the rebuilding will run smoothly.

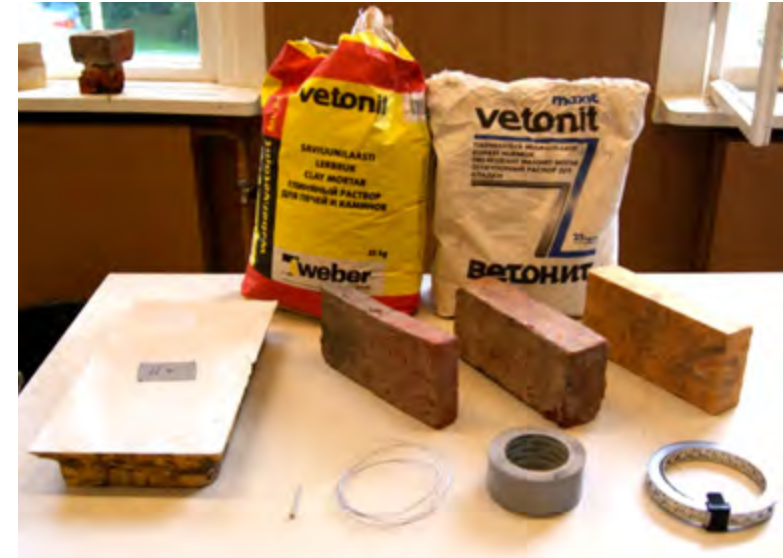
Figure 1.8. Materials we used.

- Tiles (reused)
- Bricks: Thin red clay bricks (reused material) to fill the tiles (*left*); red clay bricks (reused material from the old stove) for building secondary flues (*middle*); fire-proof bricks (new) for building the furnace and the lower parts of the main flue (*right*)
- Ready-mix mortars and recipes: clay mortar, 25kg to 4–4,5 liters of water; fire-proof mortar, 25kg mixed with 4–4,5 liters of water
- Nails, wire and metal strip for connecting the rows of tiles
- Duct tape is used to secure the tiles during the assembly of the stove

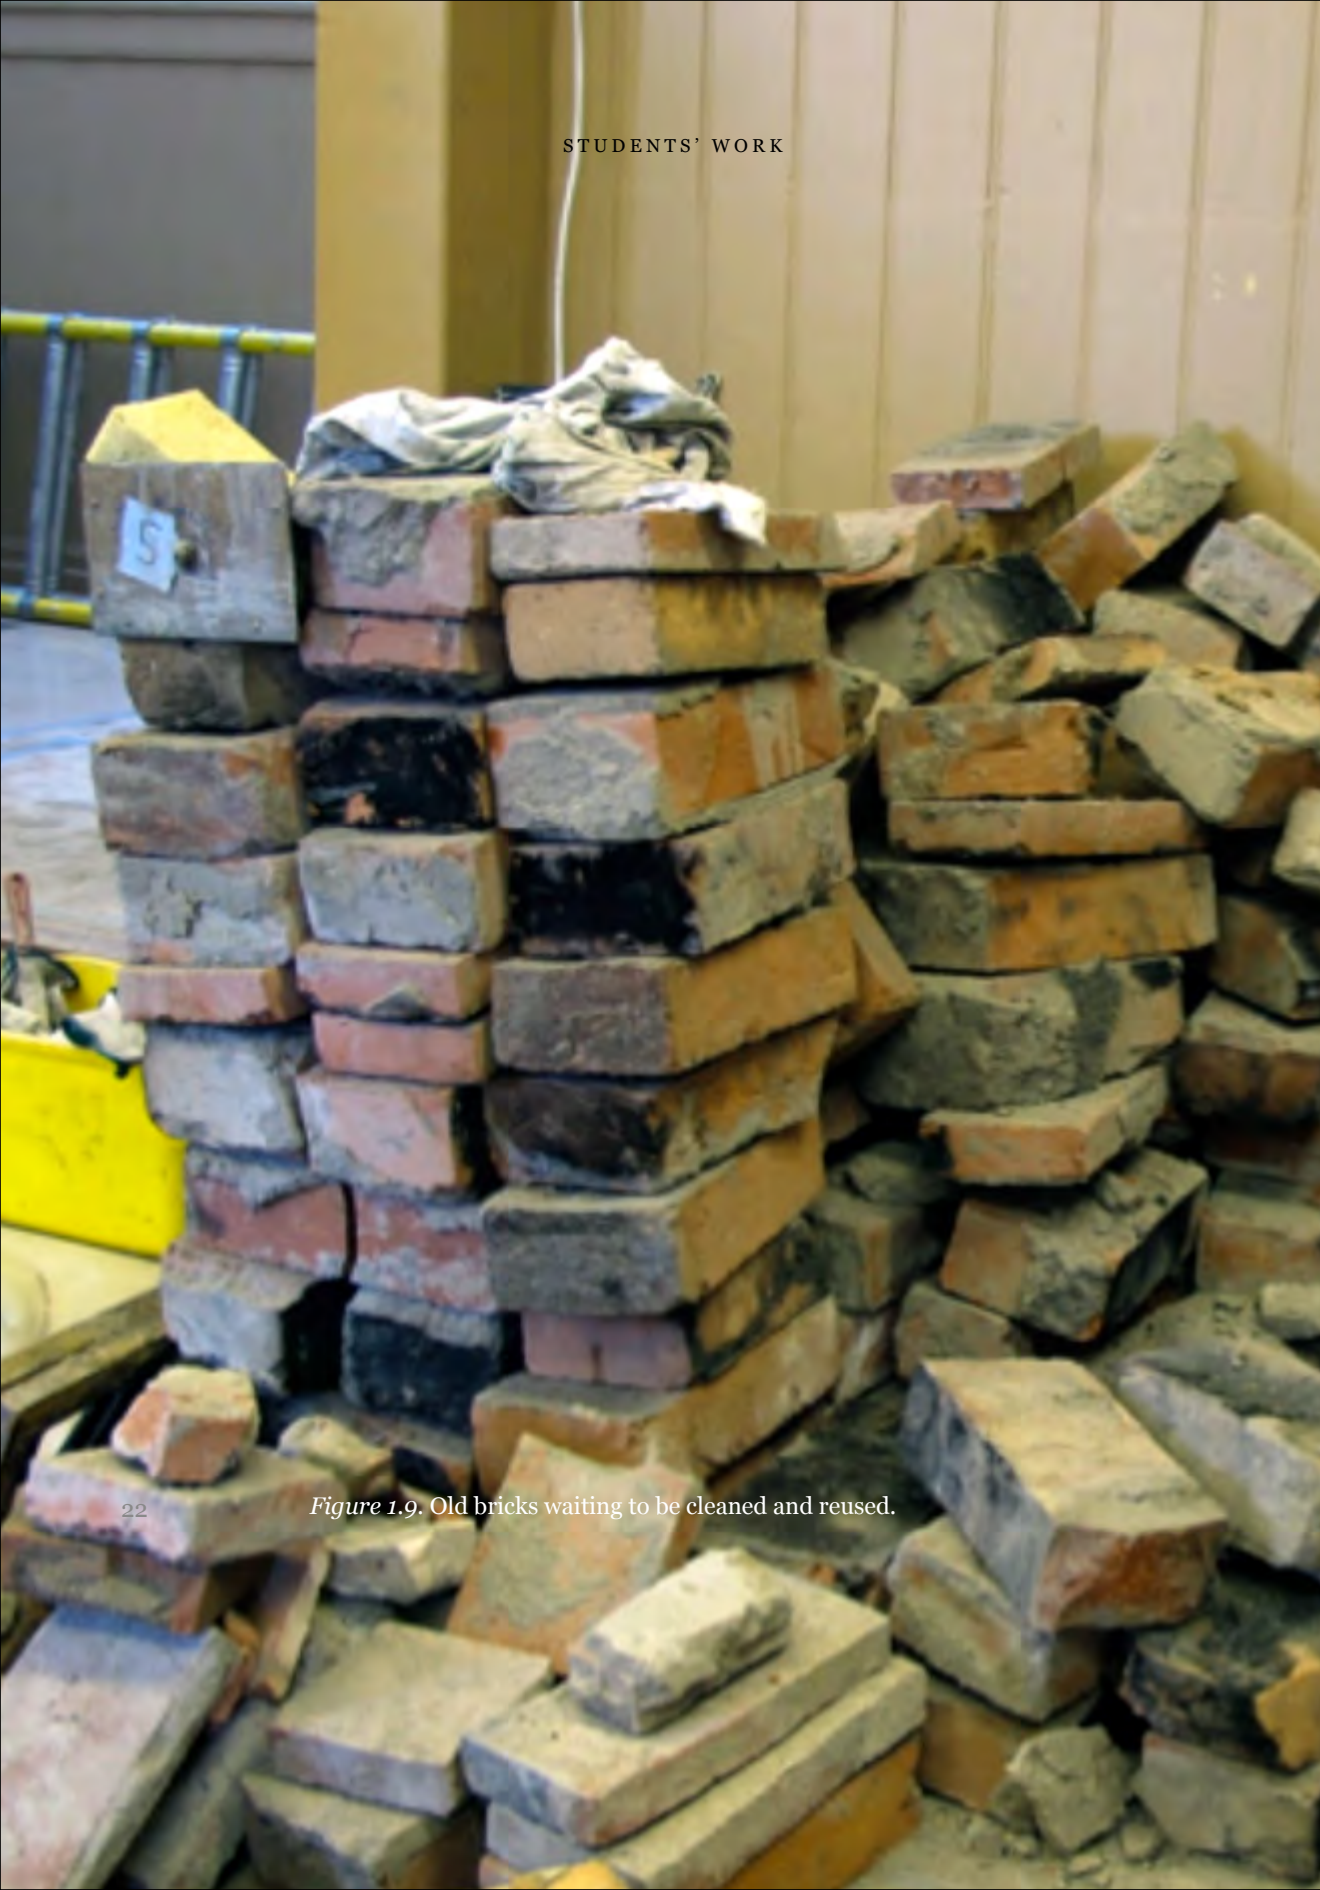
Figure 1.9. Old bricks waiting to be cleaned and reused.

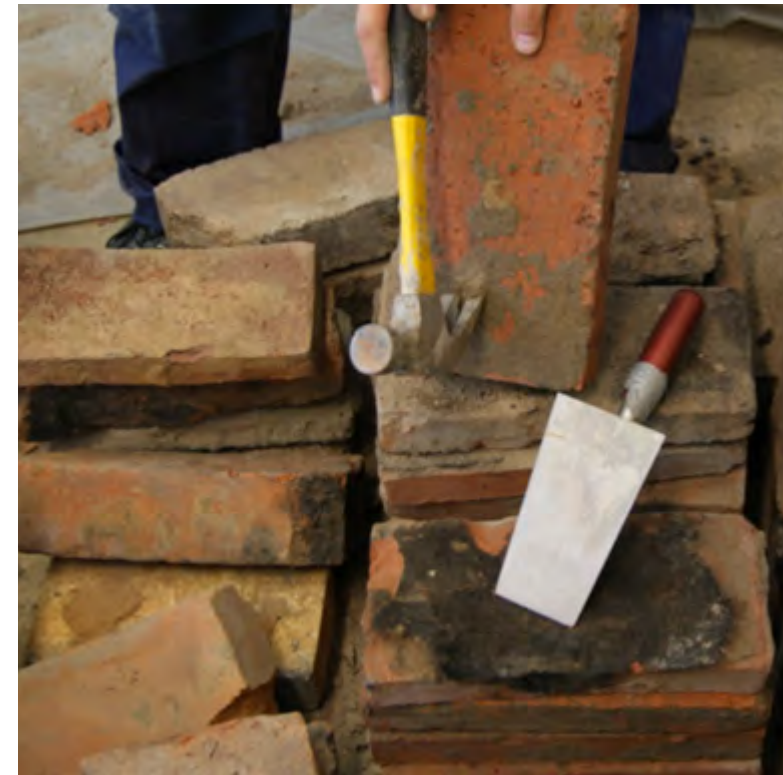
Figure 1.10. Cleaning the bricks is done by using a hammer and a trowel. Clay mortar comes off quite easily but the job is dusty and dirty.

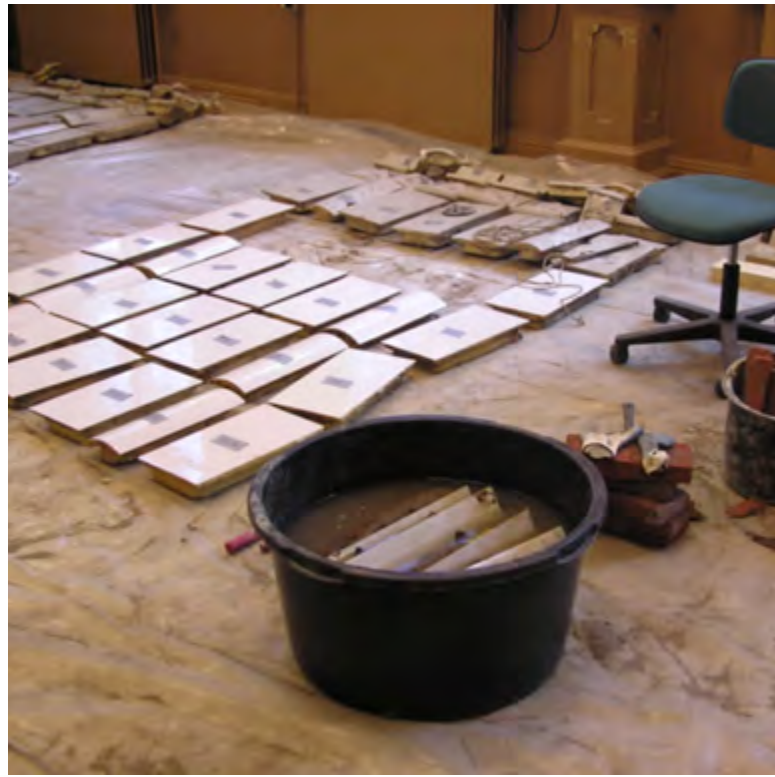
*Figure 1.11.* The tiles were soaked in water to soften the mortar. Three rows of the tiles on the floor have been cleaned and the lower rows of tiles are already assembled on the stove.

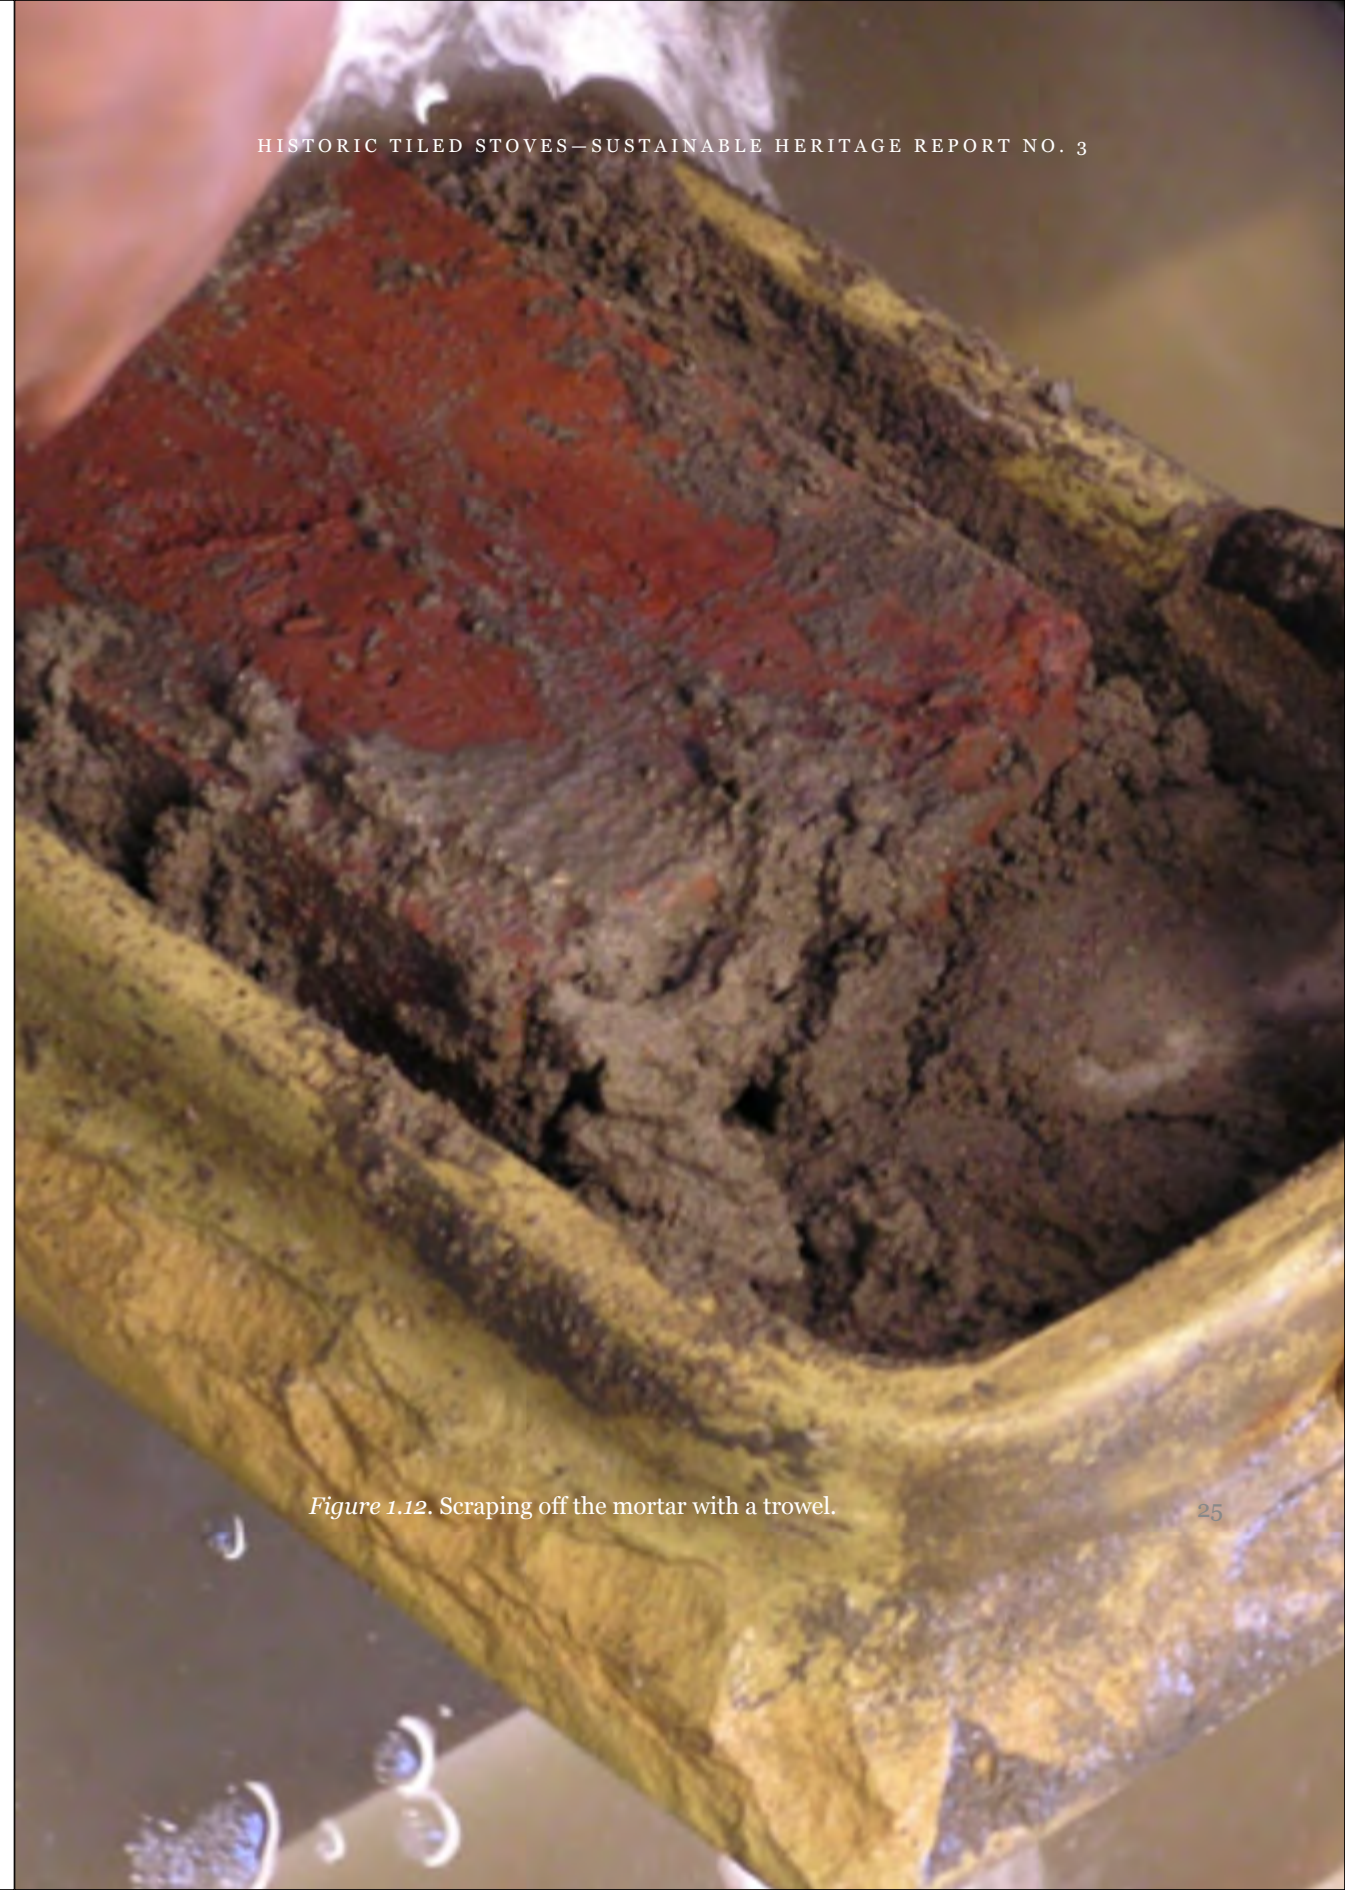
*Figure 1.12.* Scraping off the mortar with a trowel.

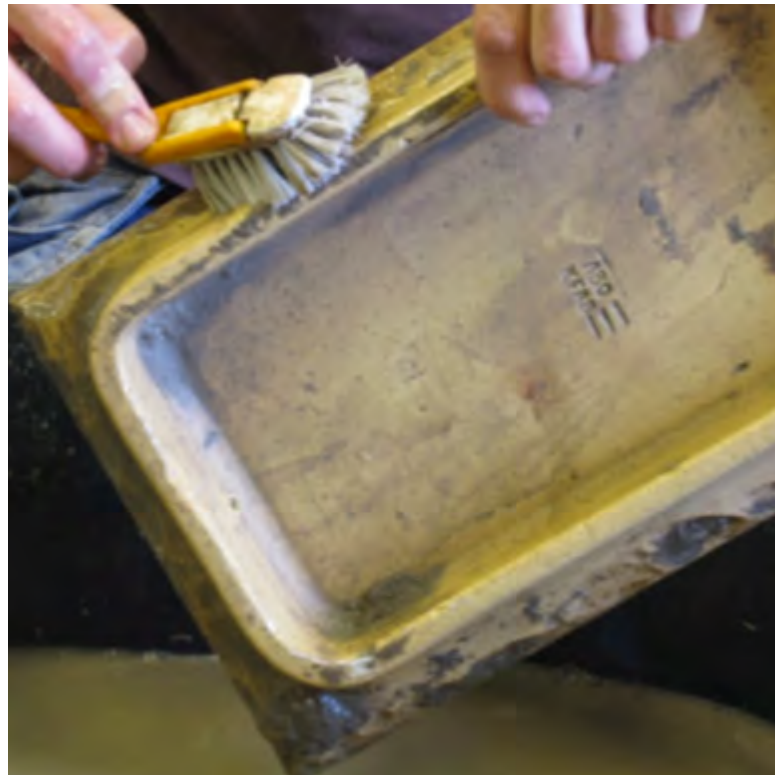
*Figure 1.13.* Brushing off remaining particles of mortar. The manufacturer's stamp, ÅBO KFAB, stands for Åbo Kakelfabrik Ab, the Swedish for Turun Kaakelitehdas Oy.

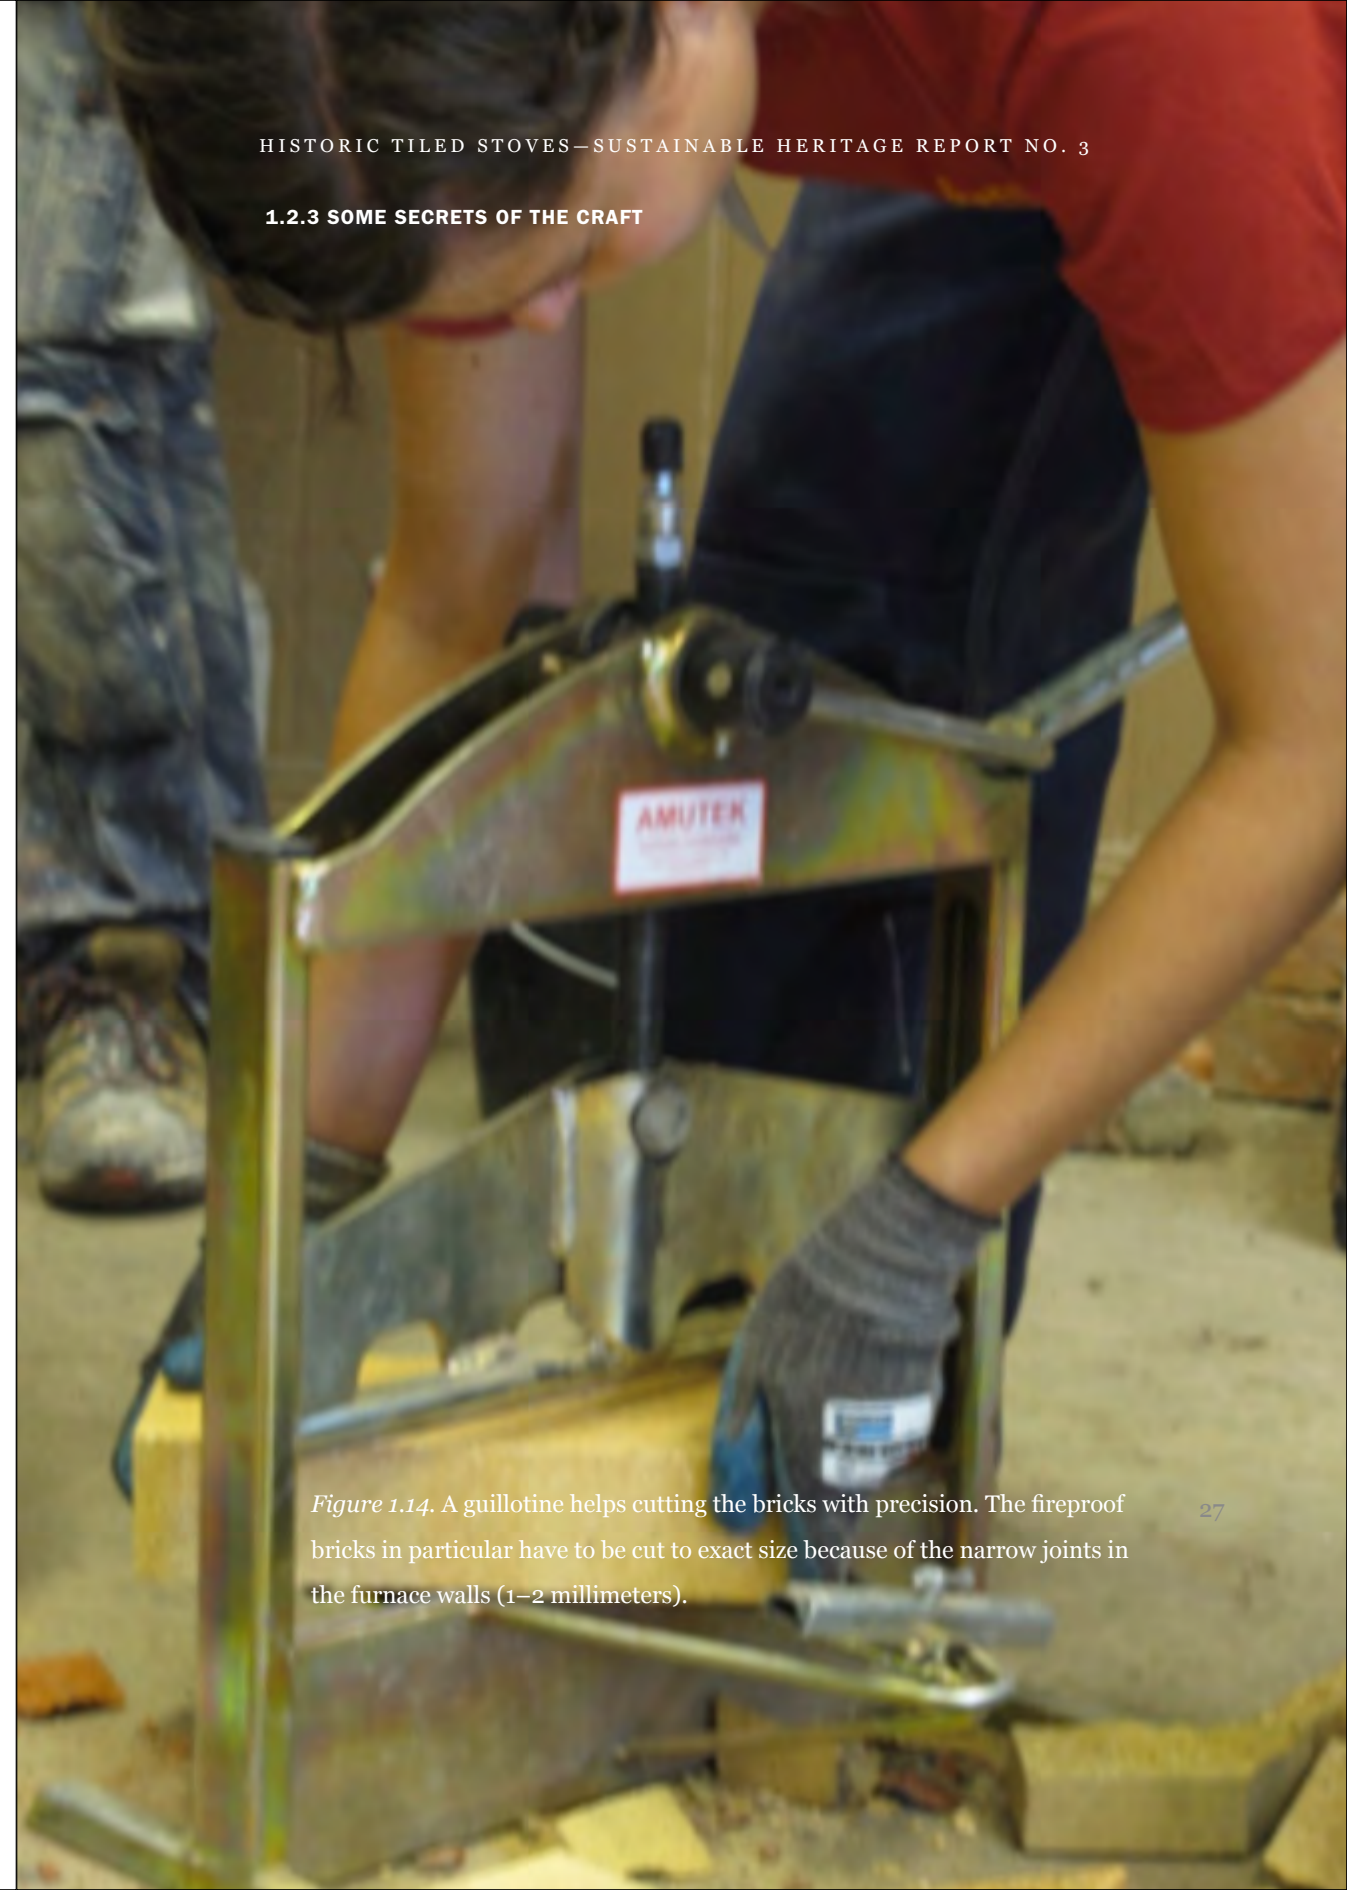
*Figure 1.14.* A guillotine helps cutting the bricks with precision. The fireproof bricks in particular have to be cut to exact size because of the narrow joints in the furnace walls (1–2 millimeters).

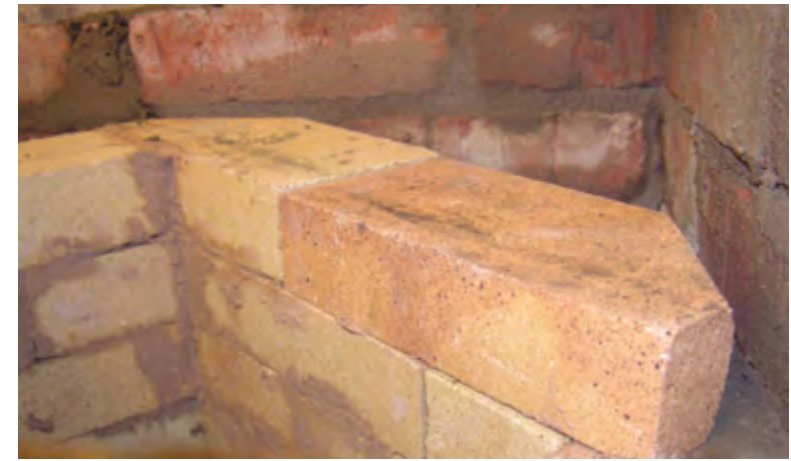
Figure 1.16. Fireproof bricks and mortar are used for the furnace. The bricks have to cover each cross-joint of the previous course.

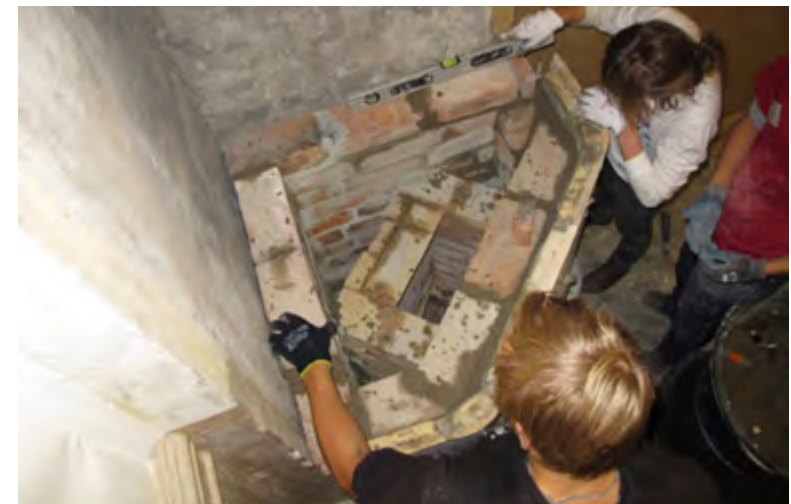
Figure 1.17. A spirit level should be used to level the bricks and help make the structure straight and secure.

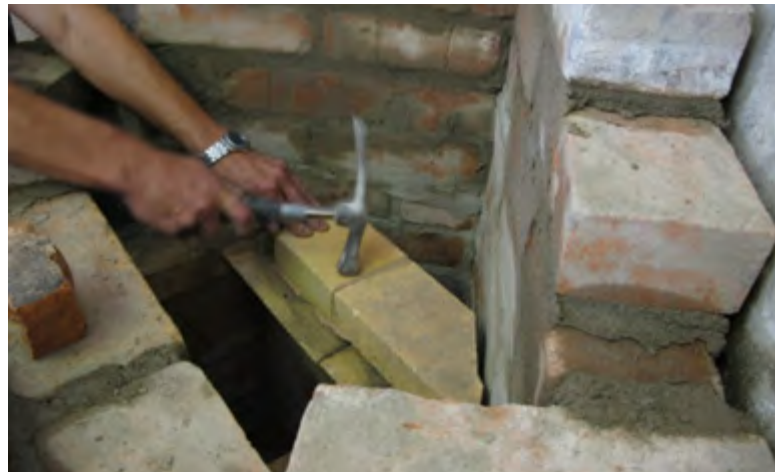
Figure 1.18. A hammer is used to adjust the bricks and tighten the joints.

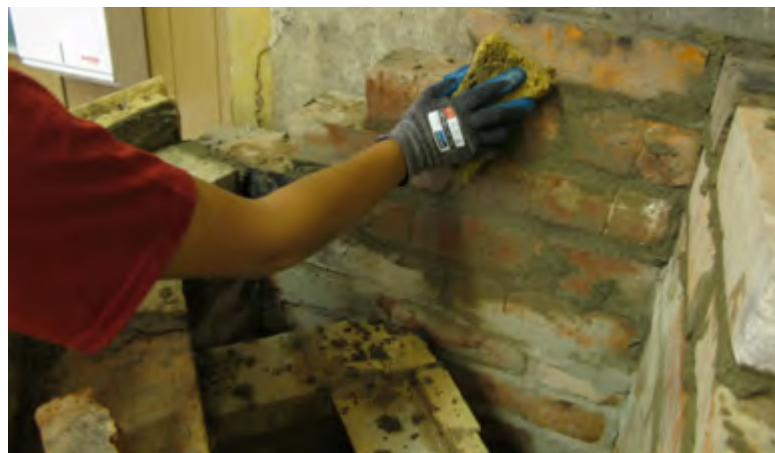
Figure 1.19. Washing off the clay mortar from the bricks in order to smoothen the walls of the flues.

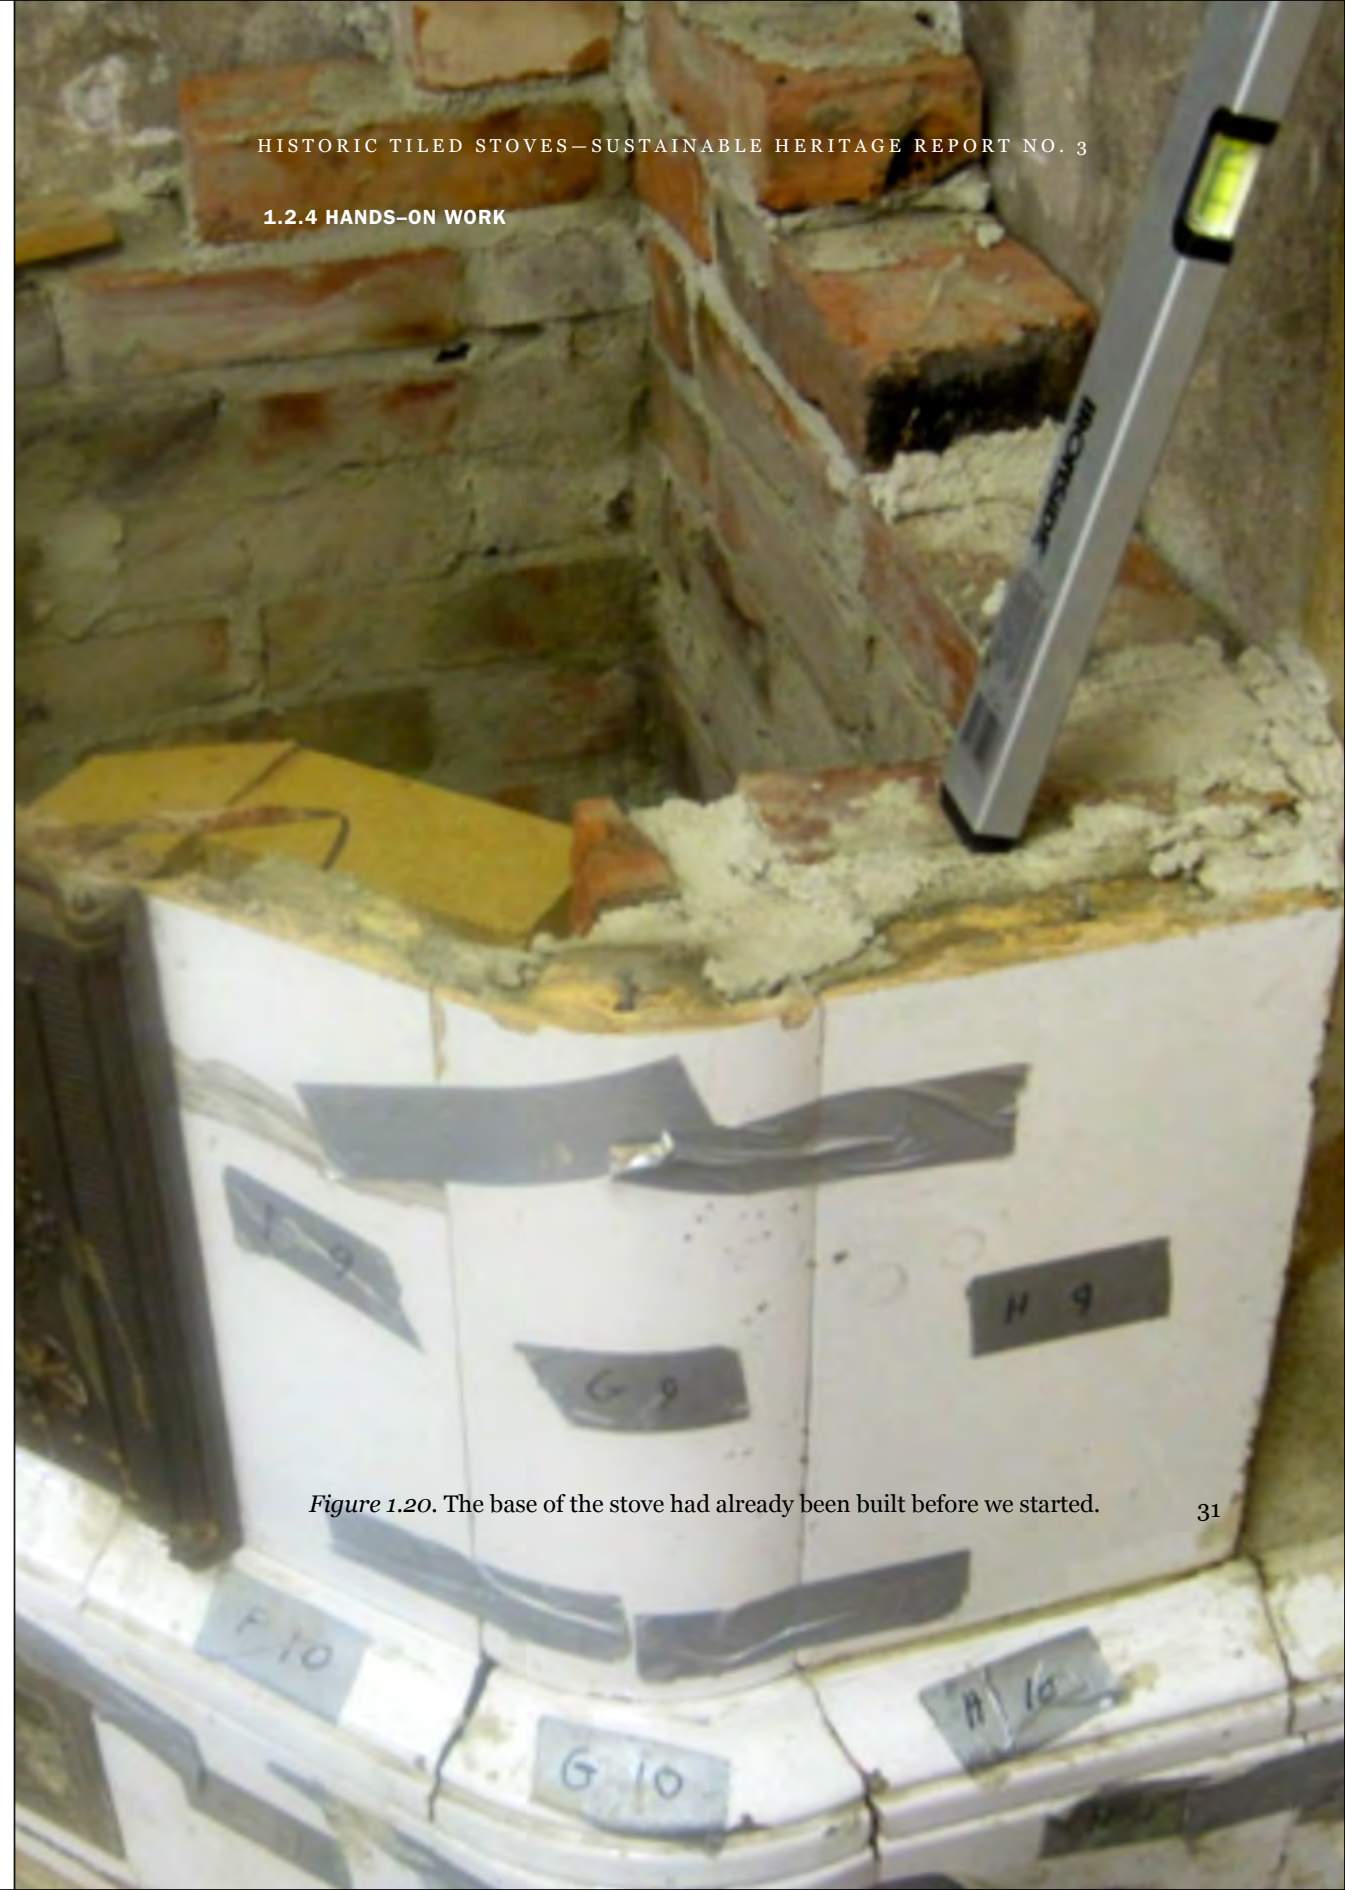
Figure 1.20. The base of the stove had already been built before we started.

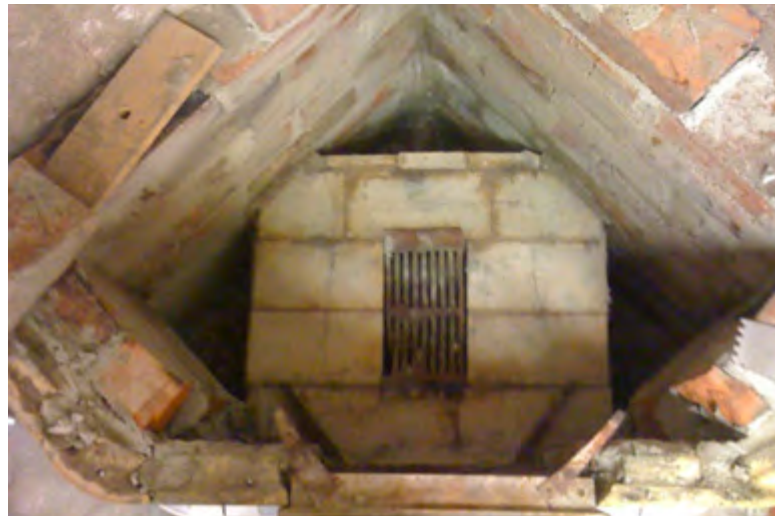
*Figure 1.21.* The interior of the stove showing the floor of the furnace.

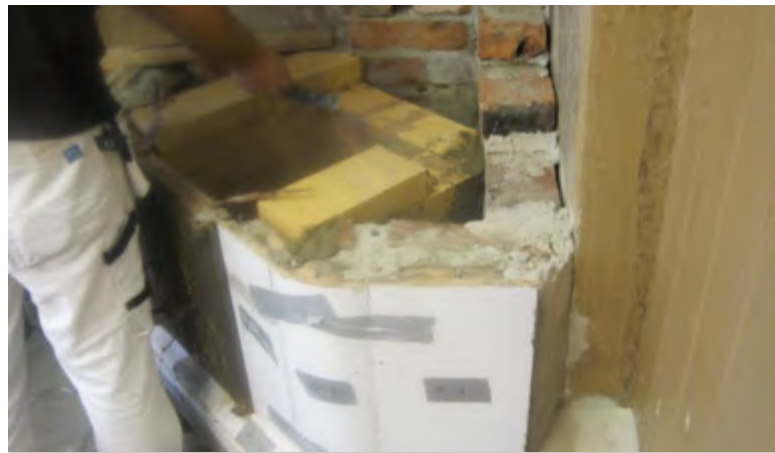
*Figure 1.22.* Laying the lower part of the furnace. Fireproof bricks and mortar were used. The masonry of the furnace should be bonded together with thin joints (1–2 mm) and separated from the rest of the masonry that has wider joints of clay mortar (13–15 mm).
