# Manual for Dismantling, Documenting and Rebuilding Historic Tiled Stoves

**—Sustainable Heritage Report No. 3**

Novia Publications and Productions,  
series S: Student Works, 2/2012

A joint project between Gotland University, Estonian Academy of Arts  
and Novia University of Applied Sciences.

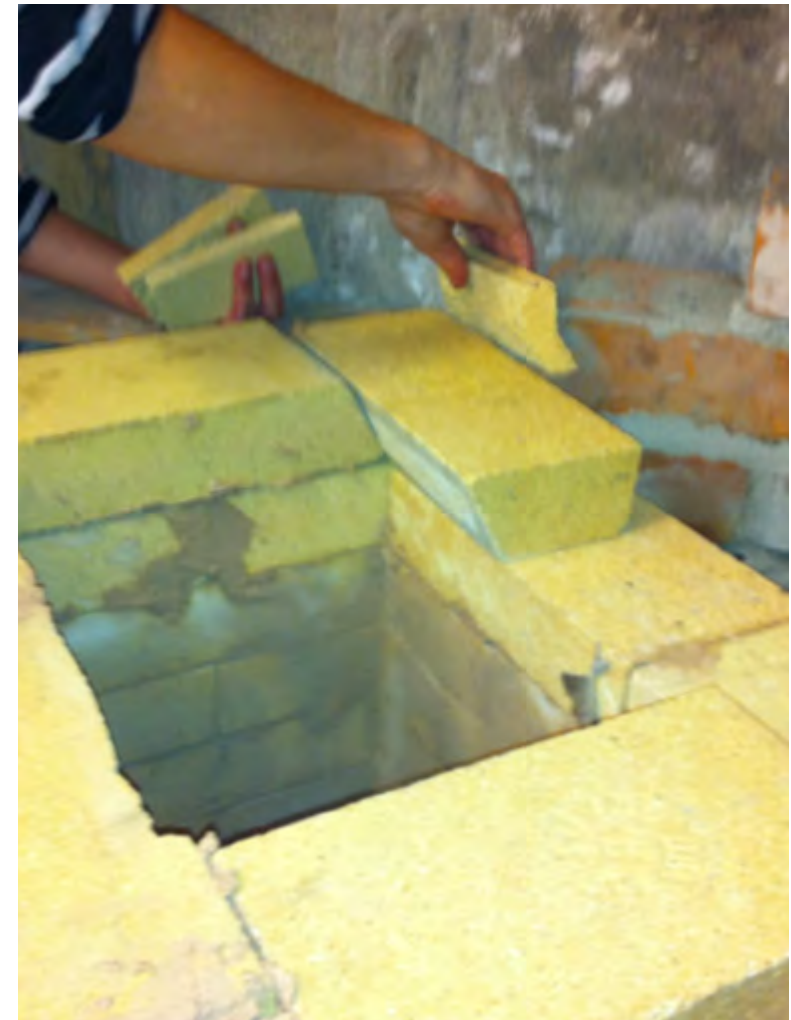
*Figure 1.23.* The rear masonry was laid to the height of half of the next tiles to be used as a support for the tiles.

The next step was to build the smoke flue upwards from the furnace. It was made narrower than the furnace. The bricks were sawn sidelong to narrow the canal from 420 x 355mm to 350 x 160mm. This is always done to create draught through the stove. Further up the flue is made wider again.

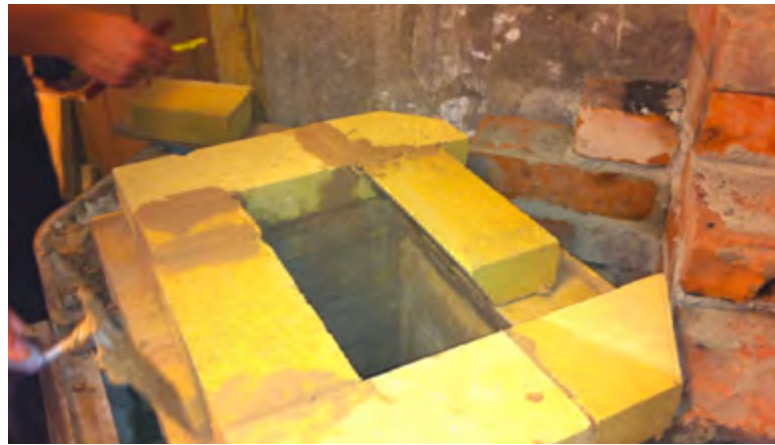
*Figure 1.24.* Installing the second row of sawn bricks.

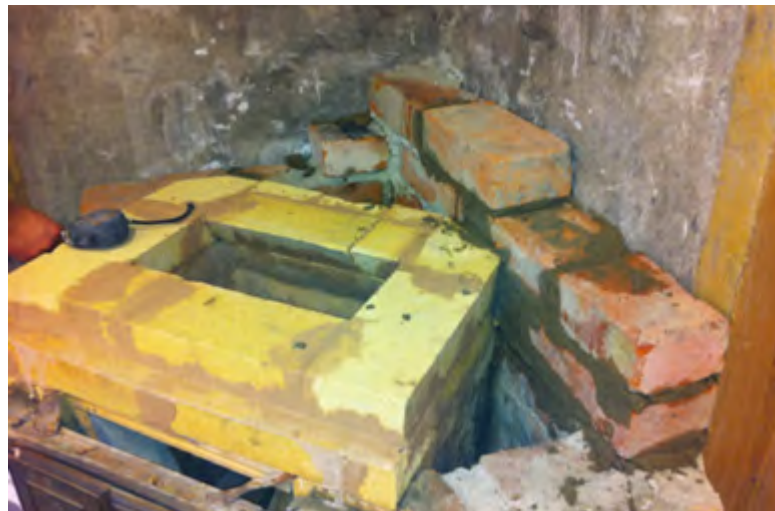
*Figure 1.25.* Continuing the laying of bricks at the rear. The gap between the fire wall and the rear masonry works as an insulator which keeps the warmth from transferring into the walls. It also allows the bricks to expand without breaking the stove.

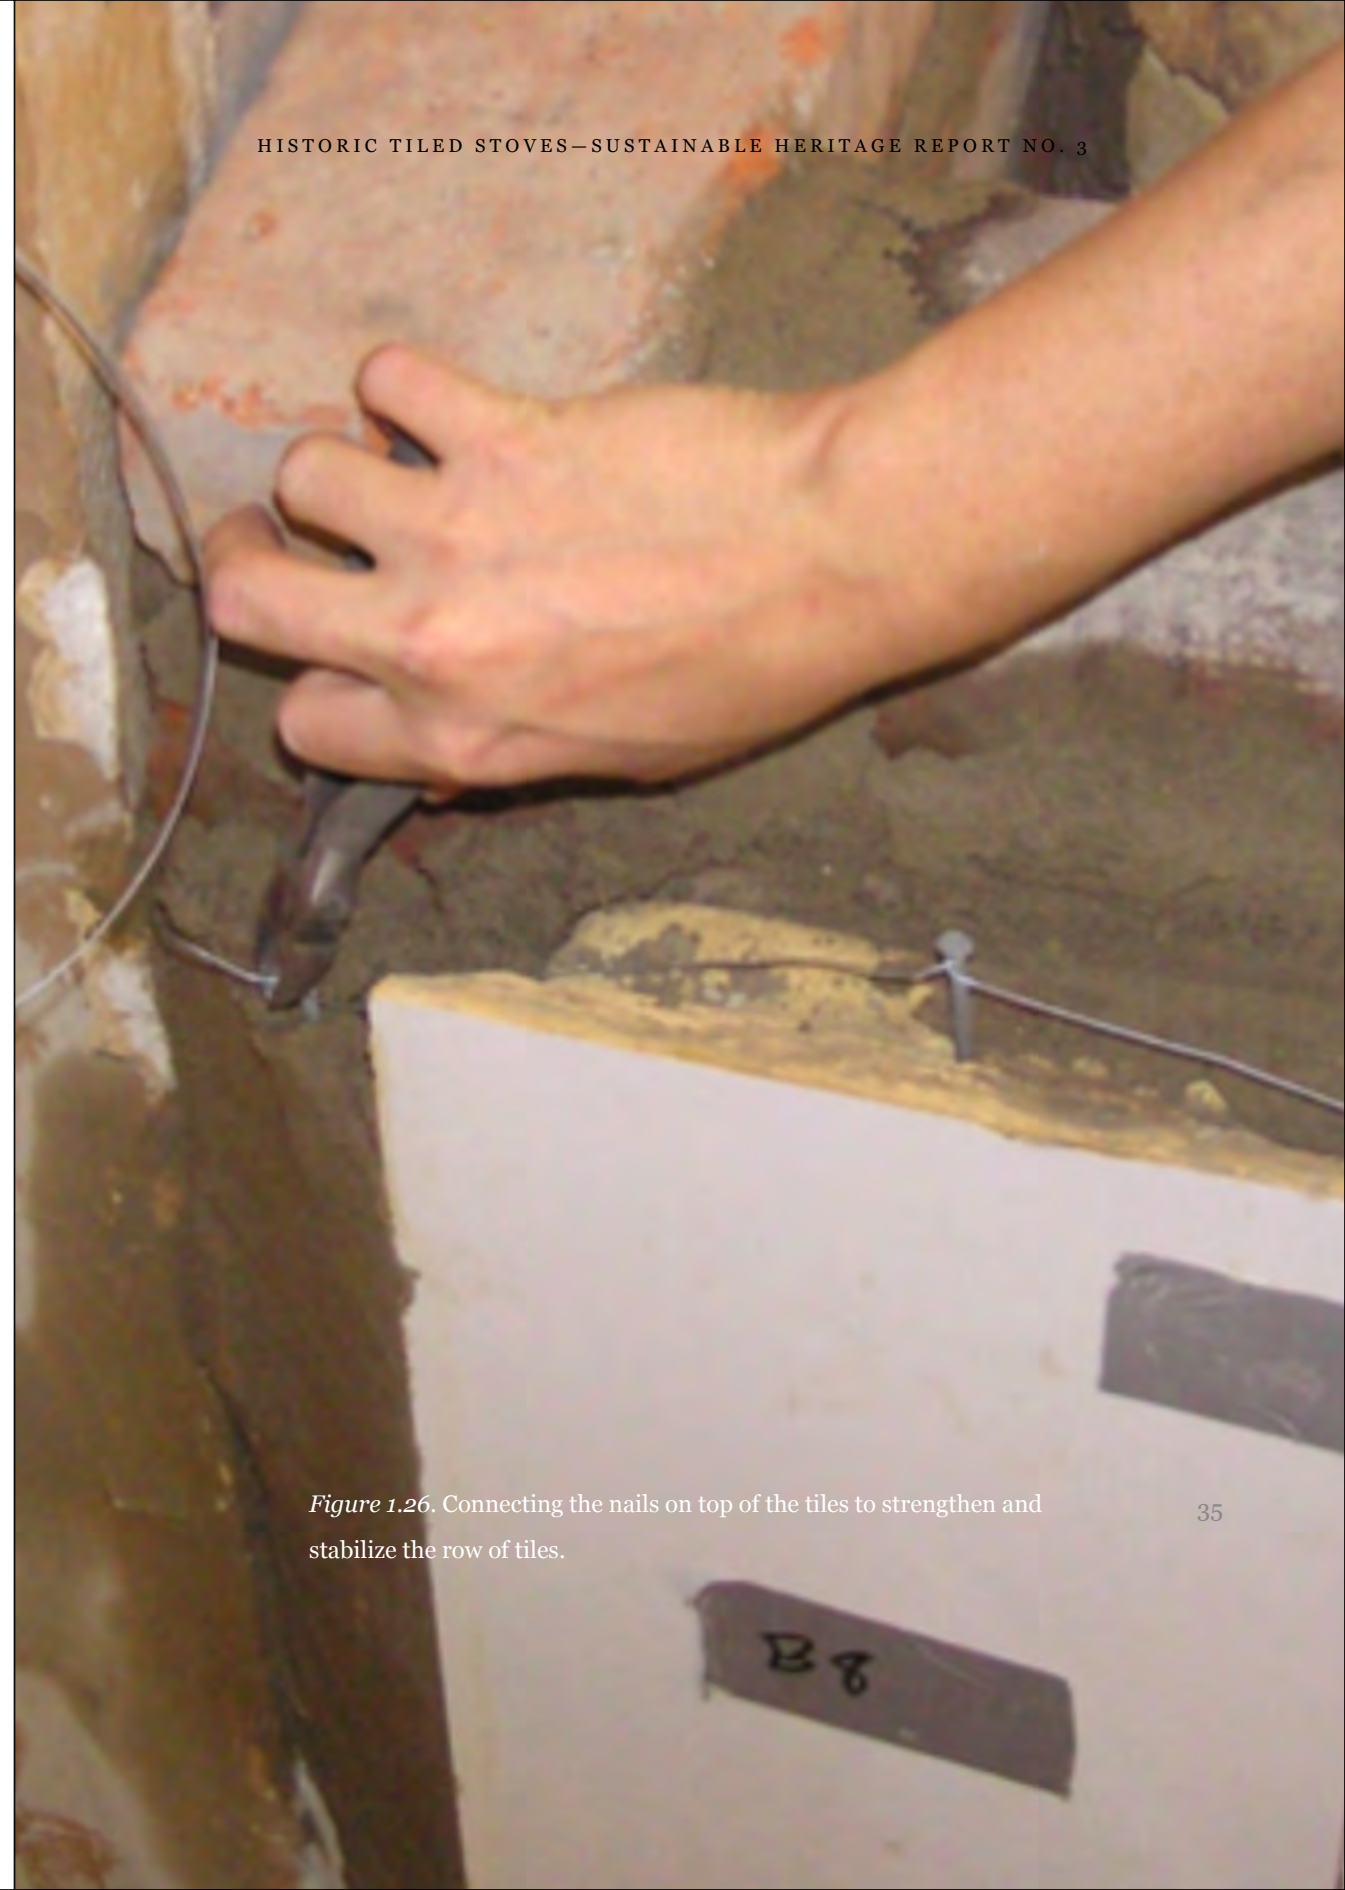
*Figure 1.26.* Connecting the nails on top of the tiles to strengthen and stabilize the row of tiles.

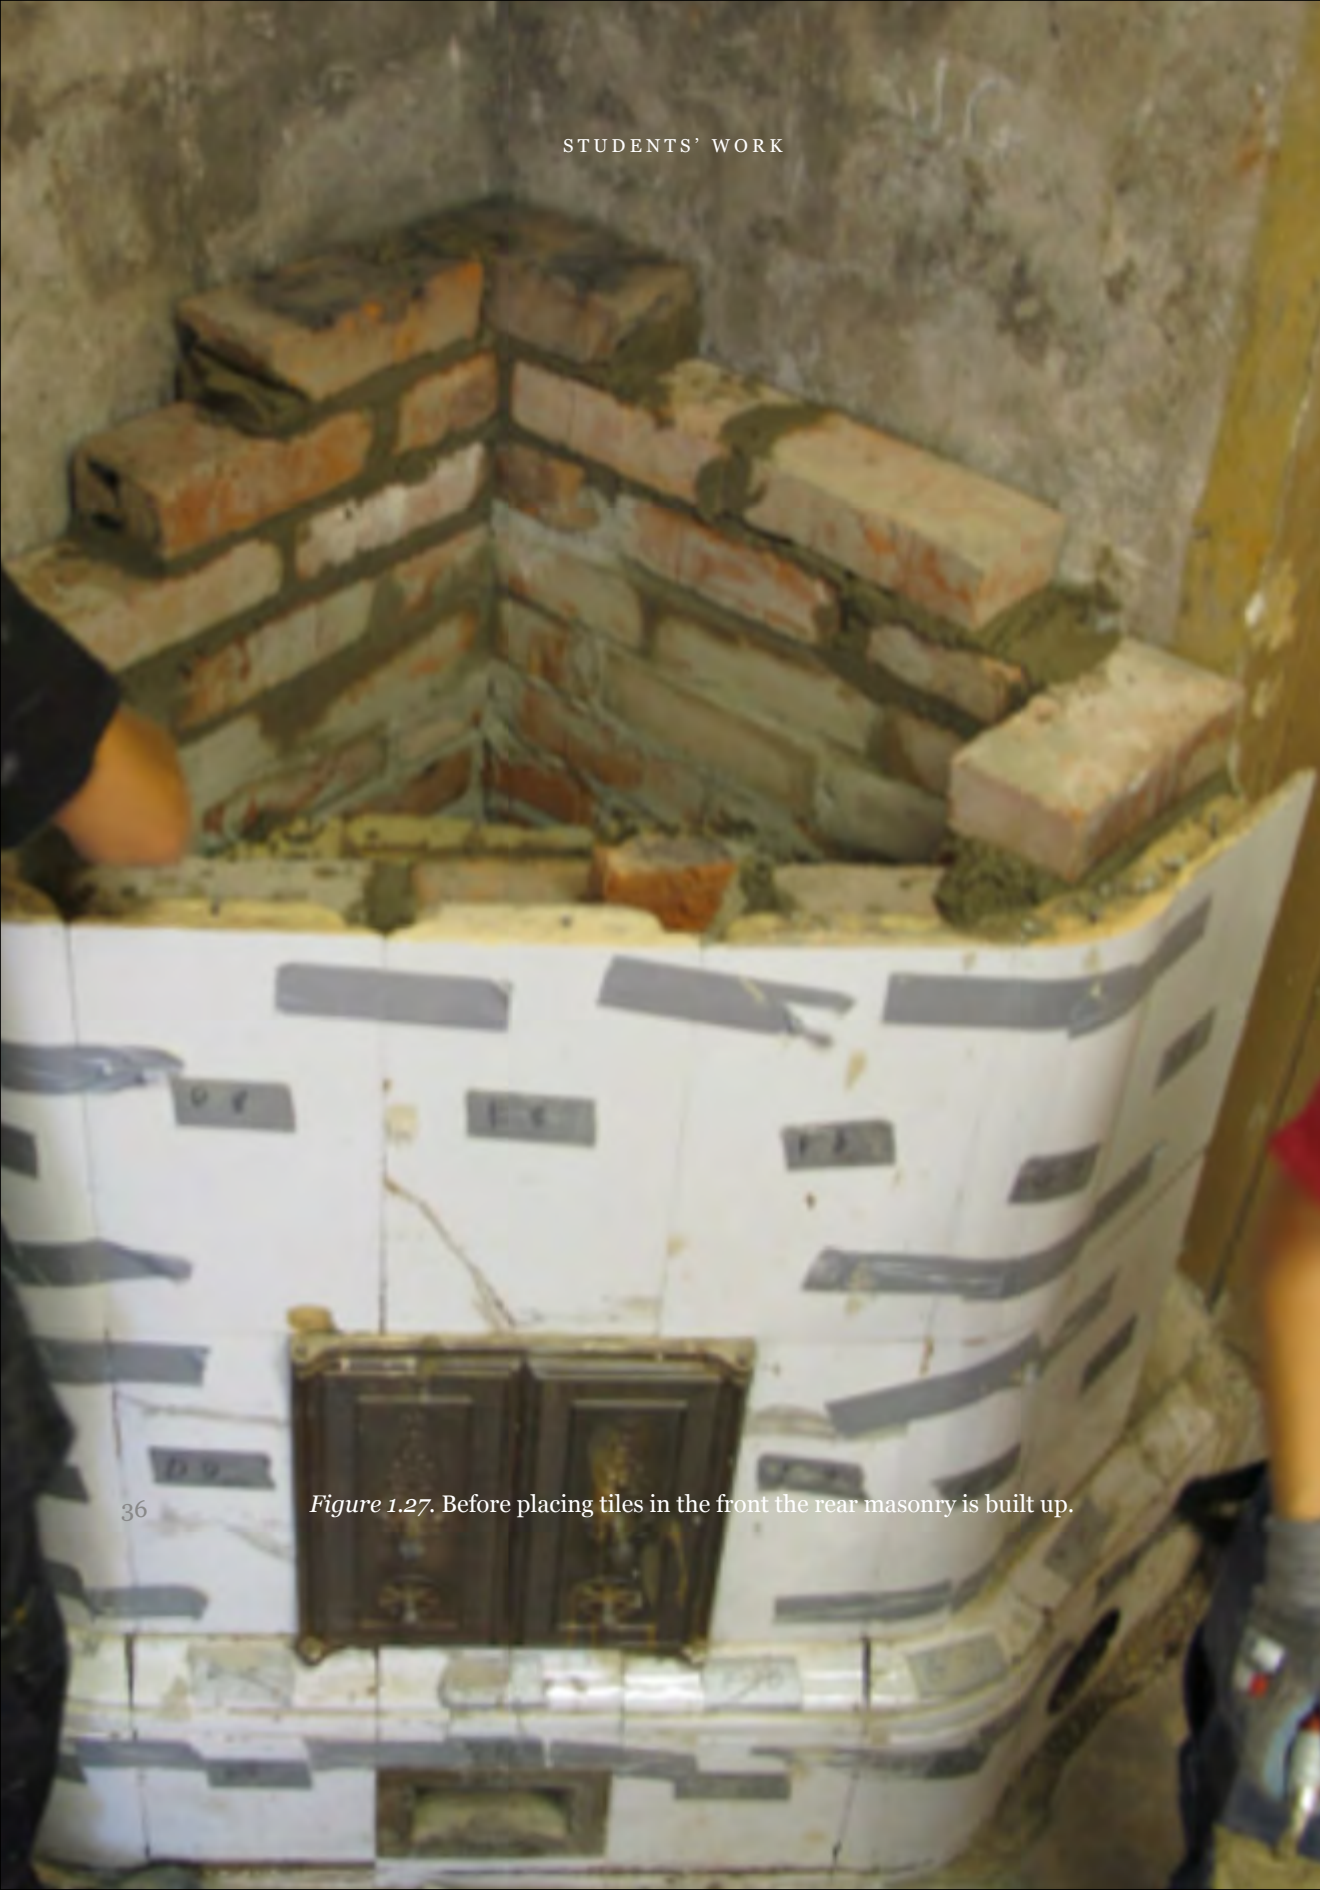
Figure 1.27. Before placing tiles in the front the rear masonry is built up.

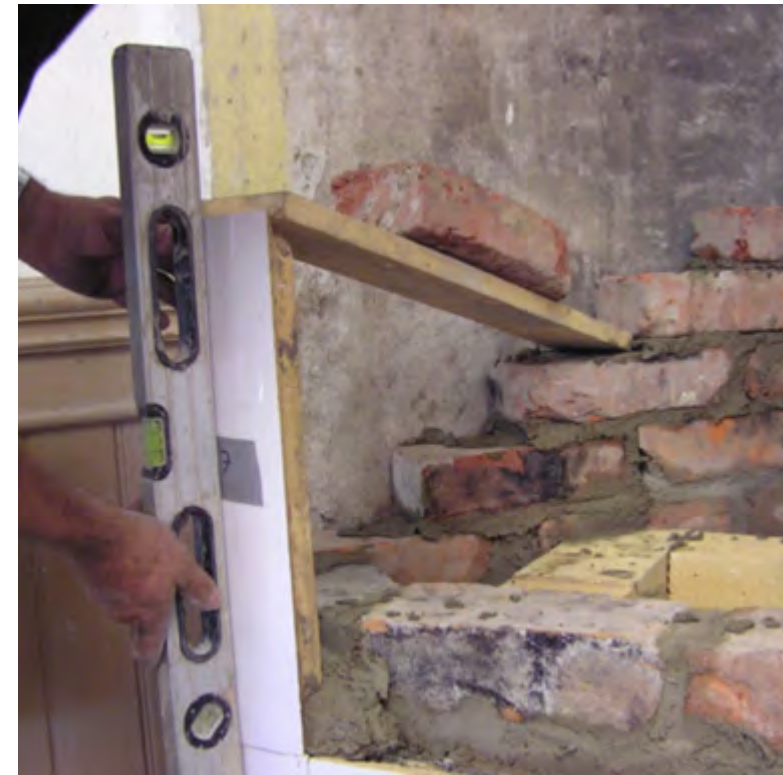
Figure 1.28. Corner tiles are the first to be installed. Therefore it is important to compare the distance between them with the width of the middle tiles. To keep the first tile in the right position and angle, it needs to be pressed downwards. A board with a weight is used. This is why the rear masonry needs to be built before the tiles are placed.

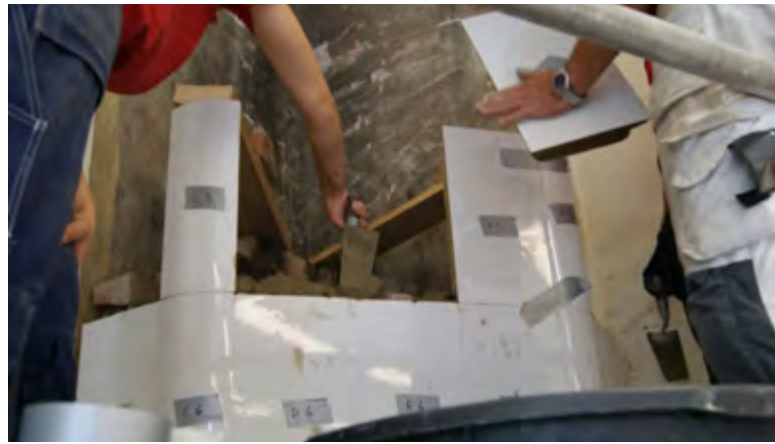
Figure 1.29. Installing the middle tiles on a bed of mortar.

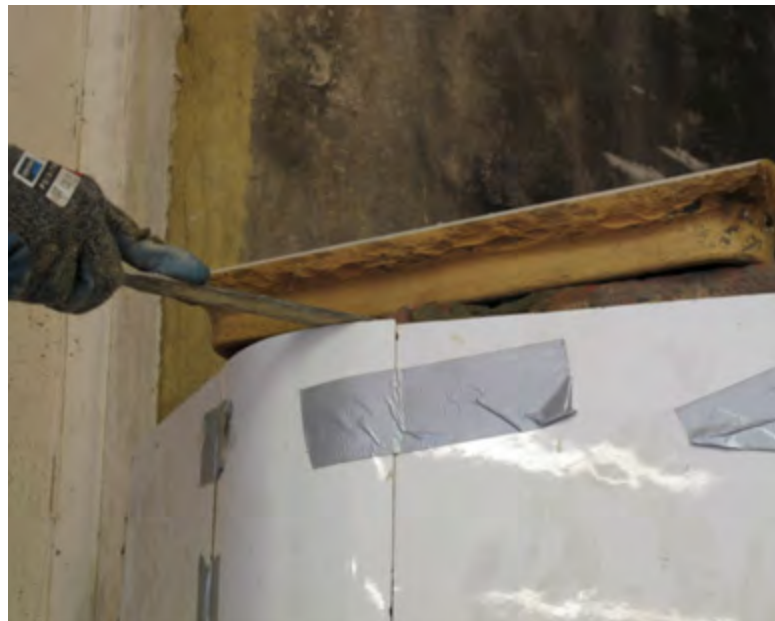
Figure 1.30. Correcting the size of the tiles can be done either by filing or using an electric saw.

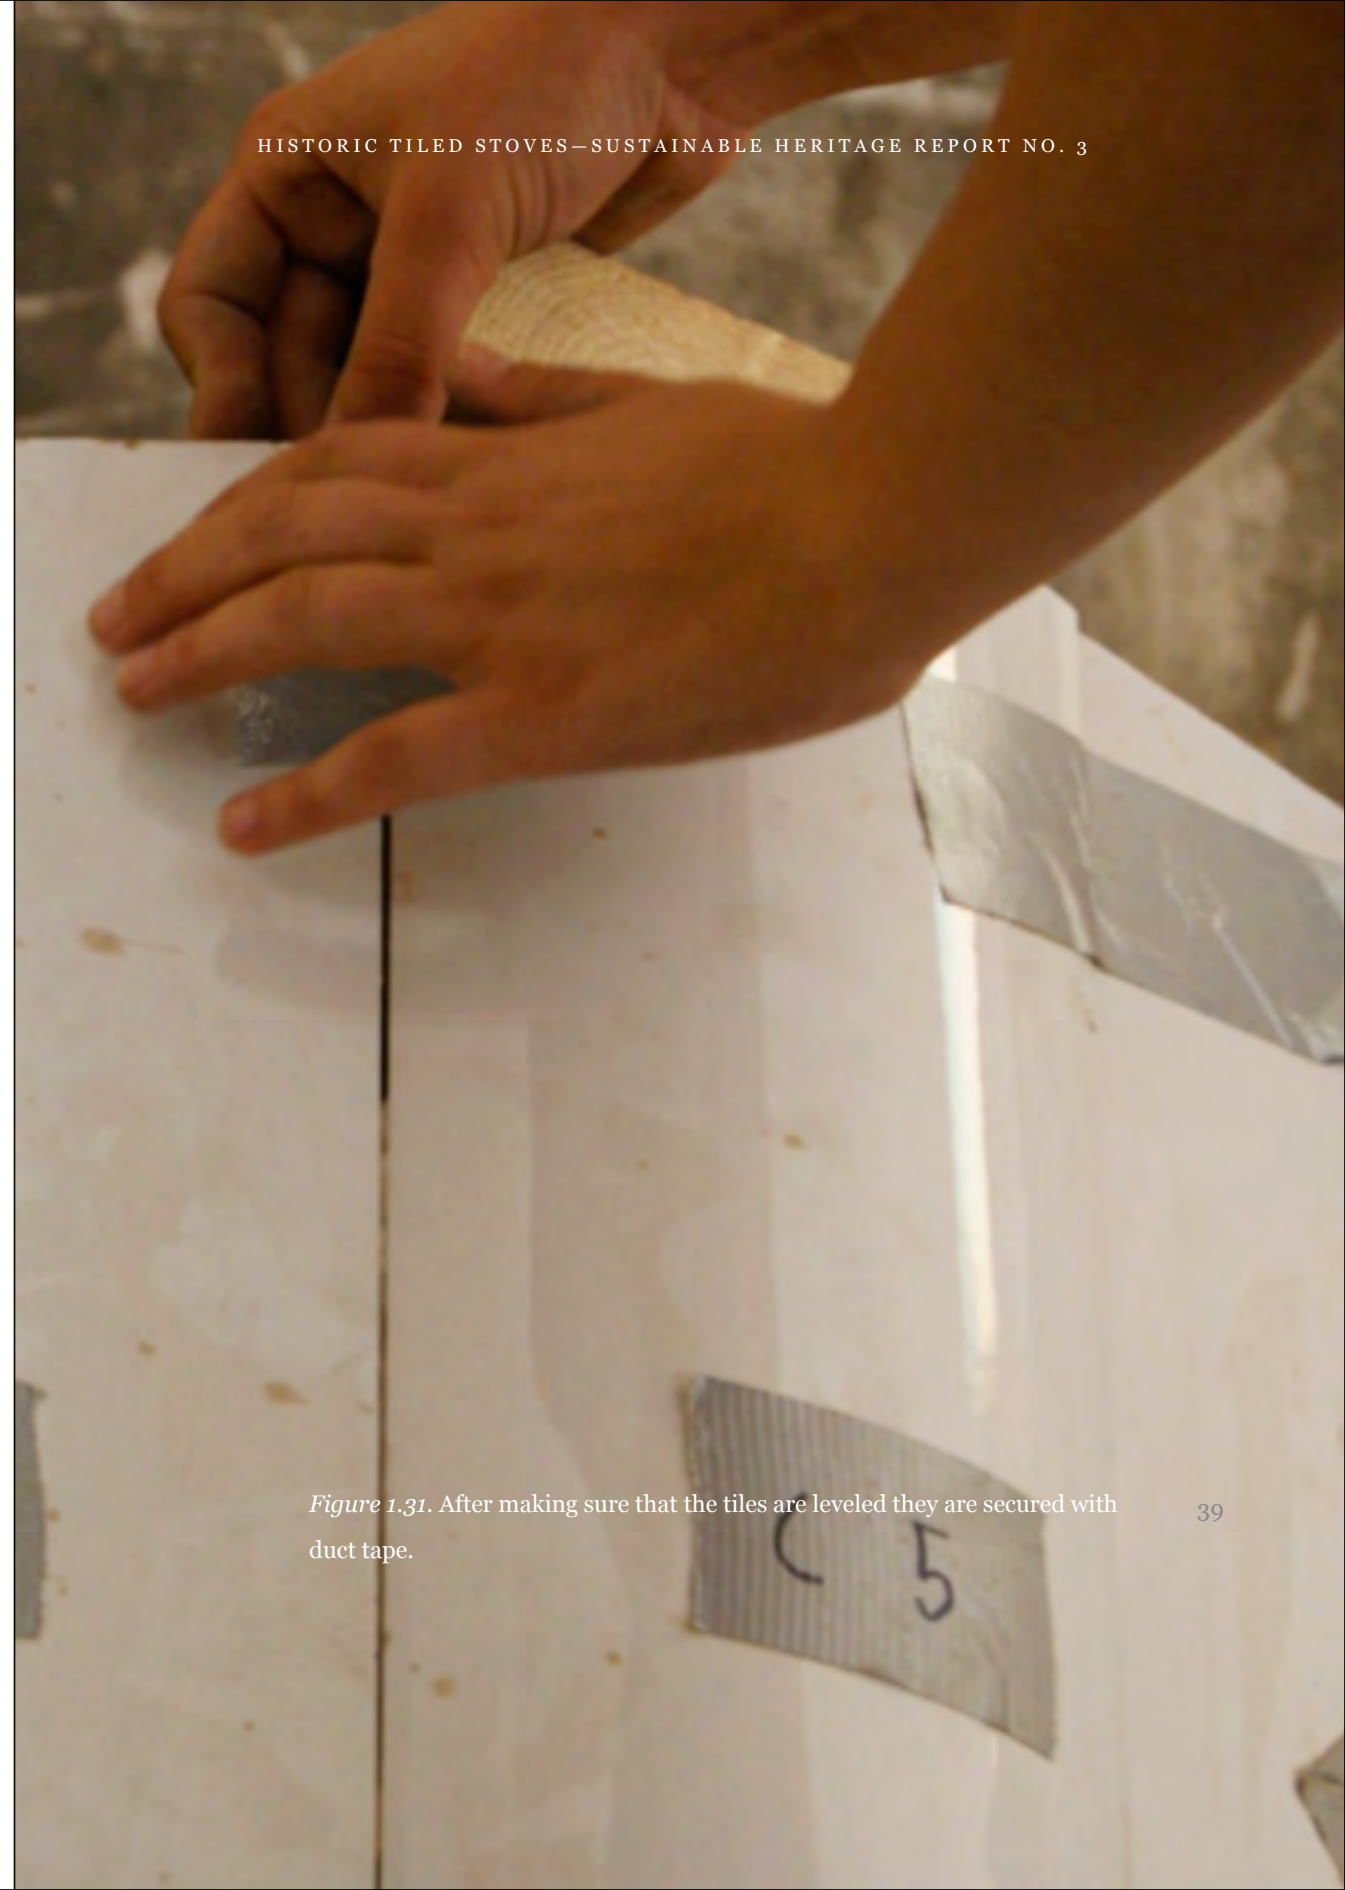
Figure 1.31. After making sure that the tiles are leveled they are secured with duct tape.

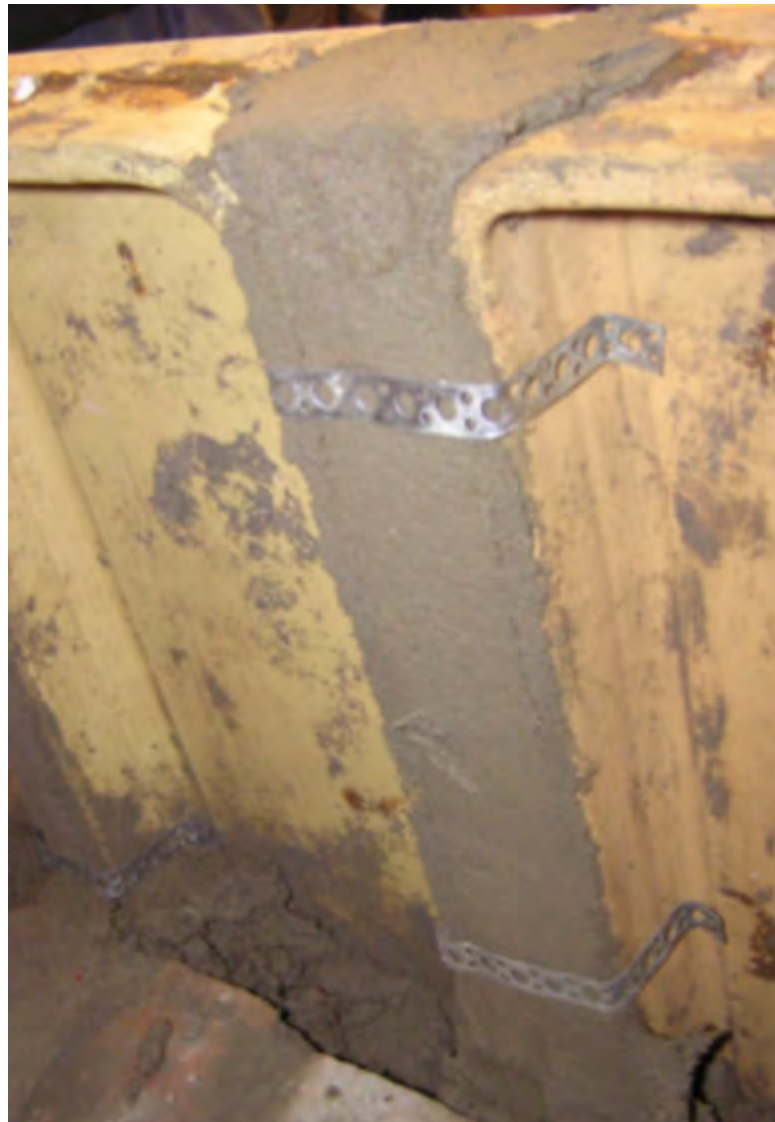
*Figure 1.32–33.* When the tiles are in place, the gap between them is filled with clay-mortar. Then two clamps made of perforated metal strap are bent to hold them together. The cavity on the backside of the tiles is then filled with mortar and thin bricks. Inside this a wall of bricks is built to finally stabilize the front.

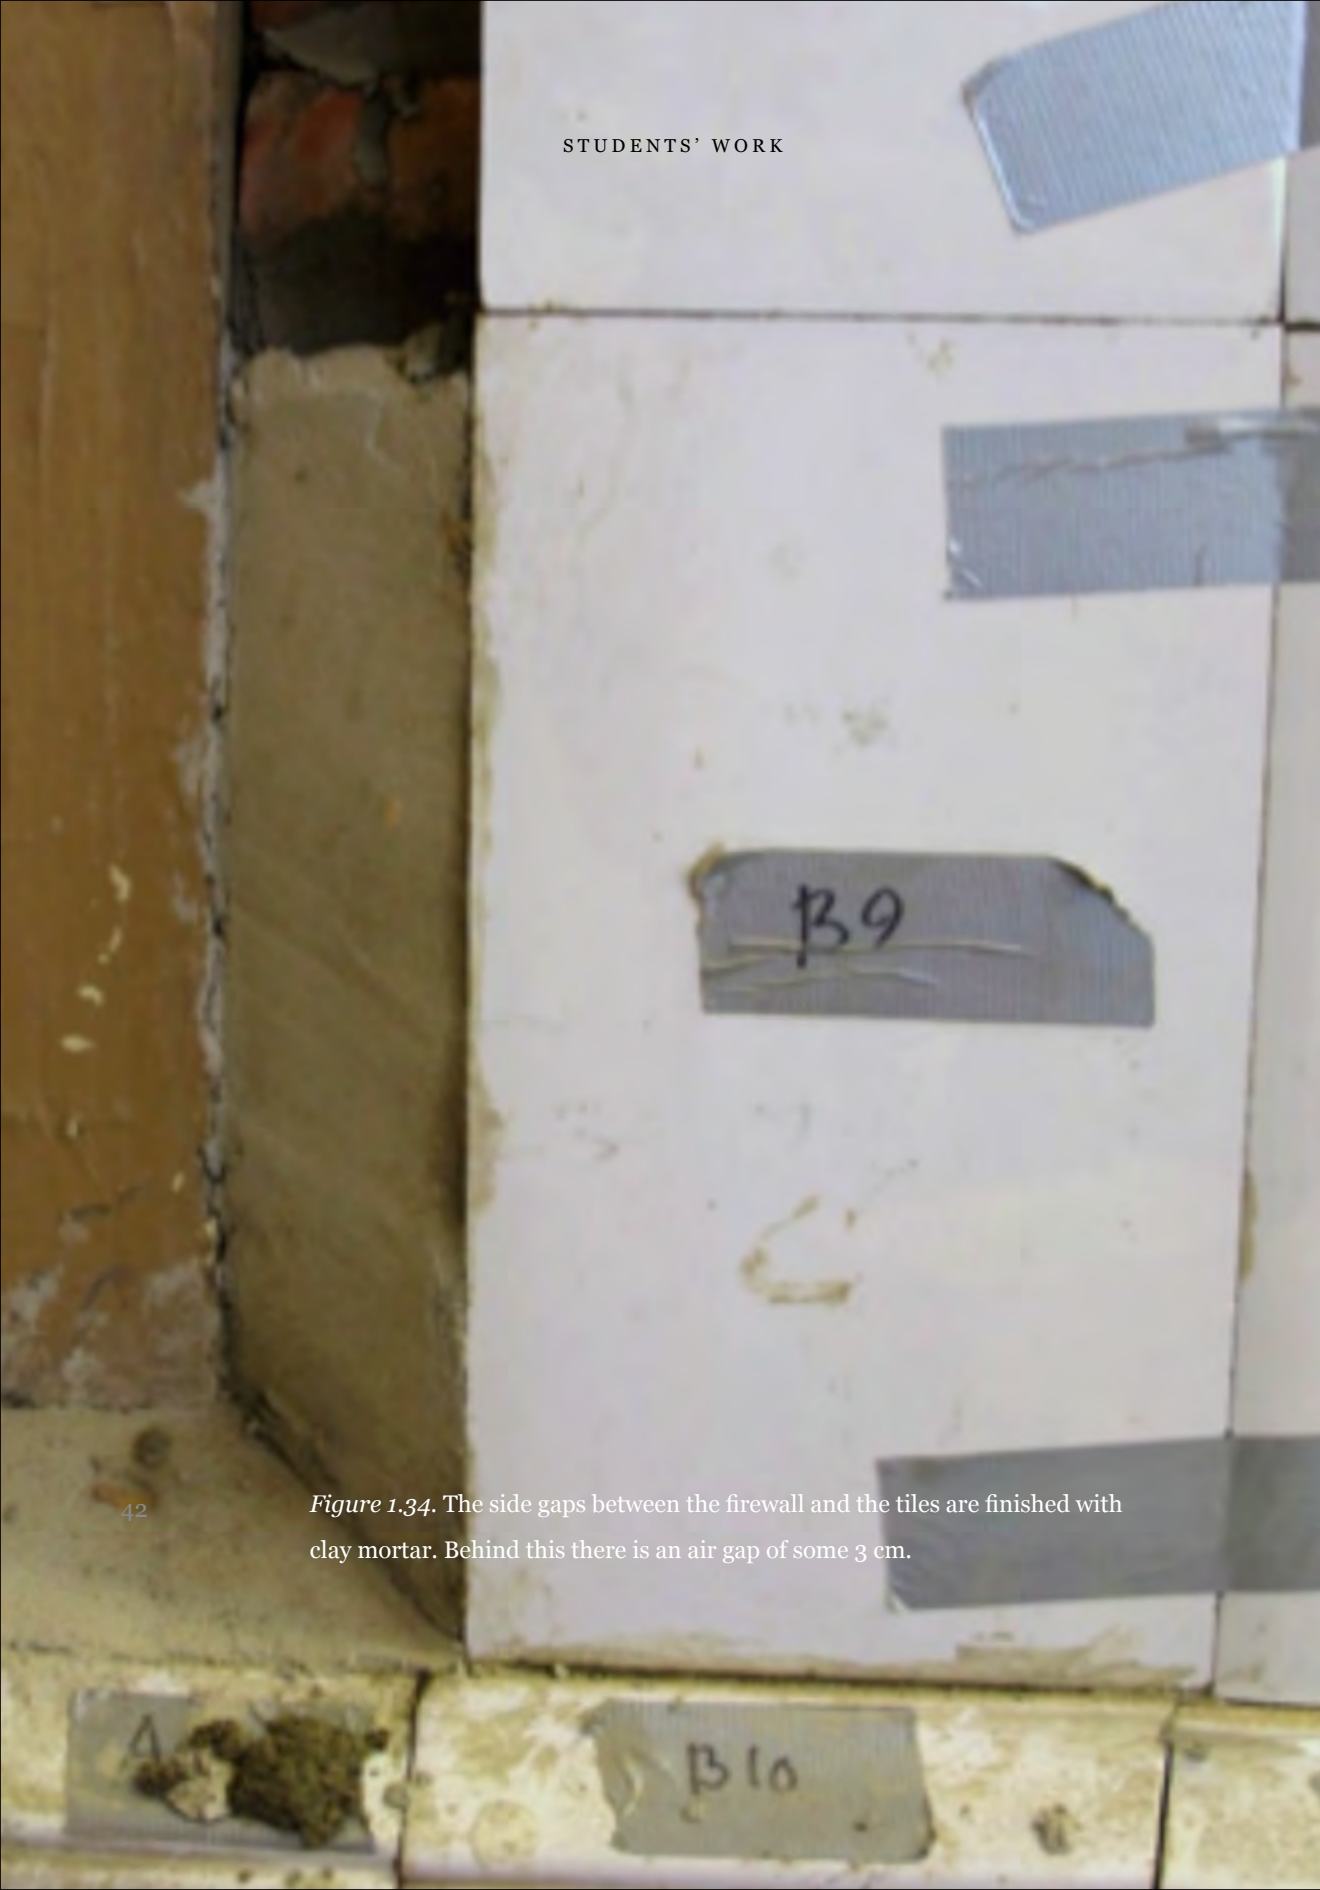
Figure 1.34. The side gaps between the firewall and the tiles are finished with clay mortar. Behind this there is an air gap of some 3 cm.

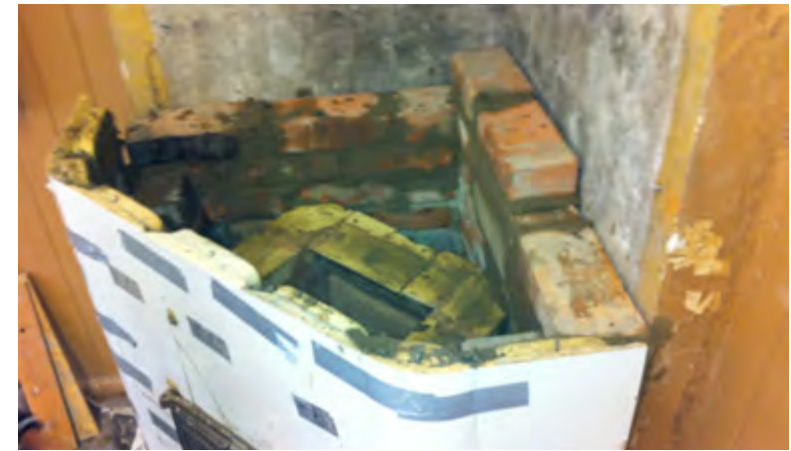
Figure 1.35. Interior of the stove at the end of day 1.

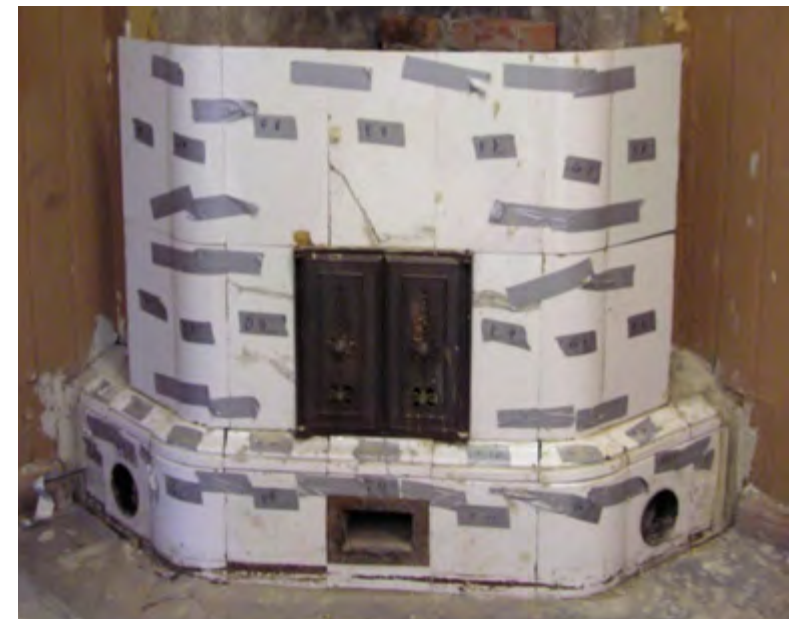
Figure 1.36. End of day 1. We had built our first row of tiles and the furnace behind it.

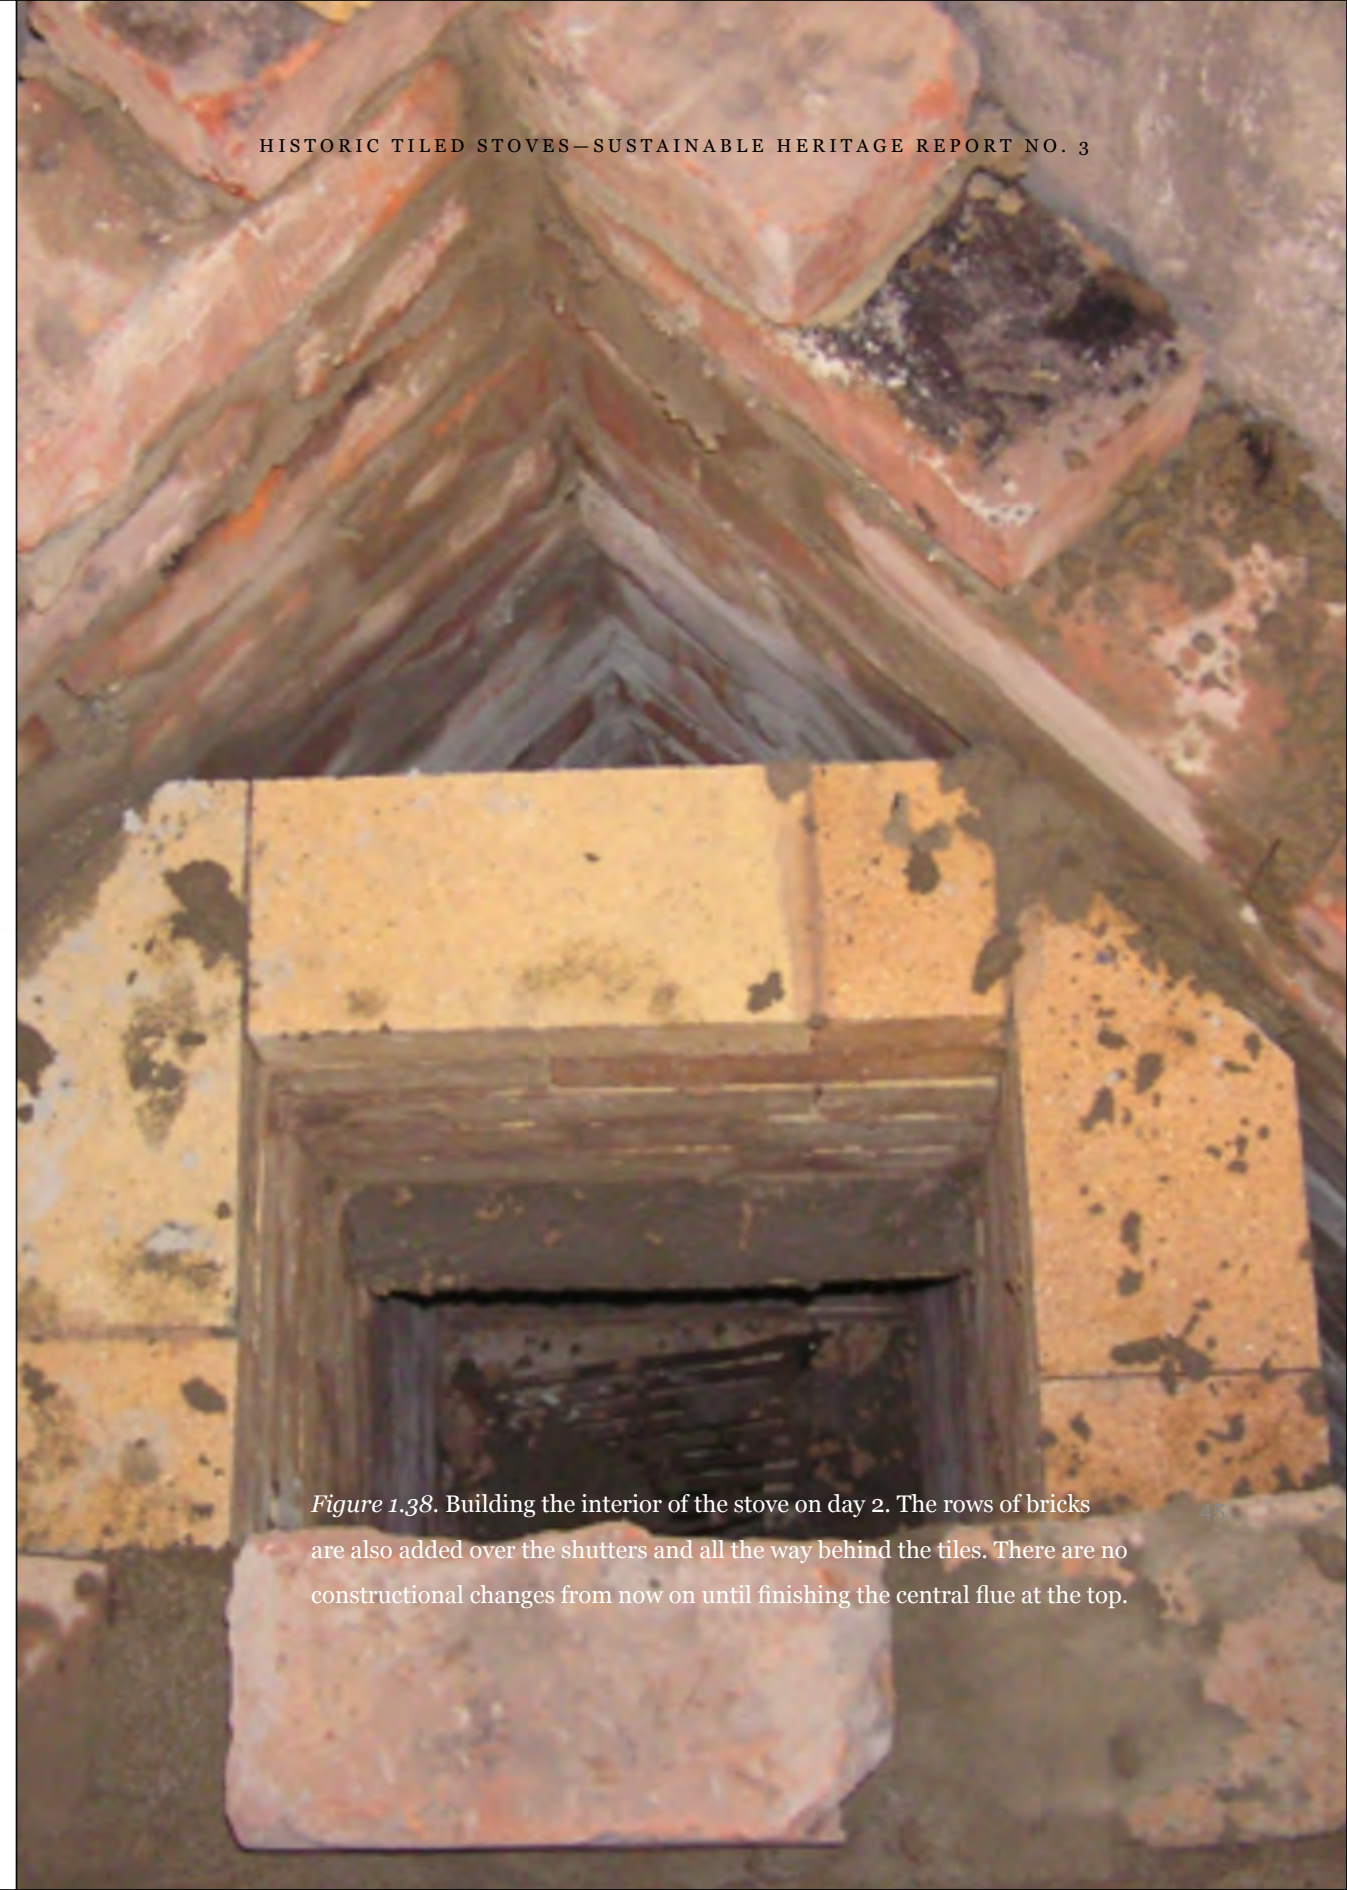
Figure 1.38. Building the interior of the stove on day 2. The rows of bricks are also added over the shutters and all the way behind the tiles. There are no constructional changes from now on until finishing the central flue at the top.

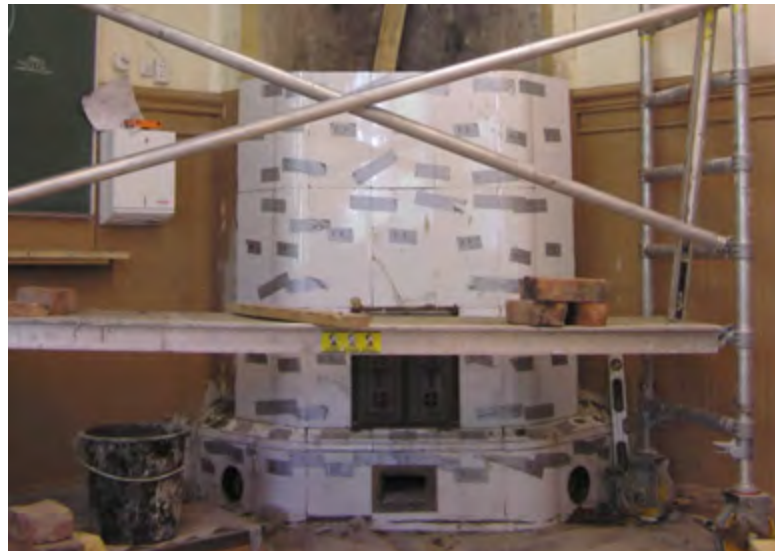
Figure 1.39. End of day 2.

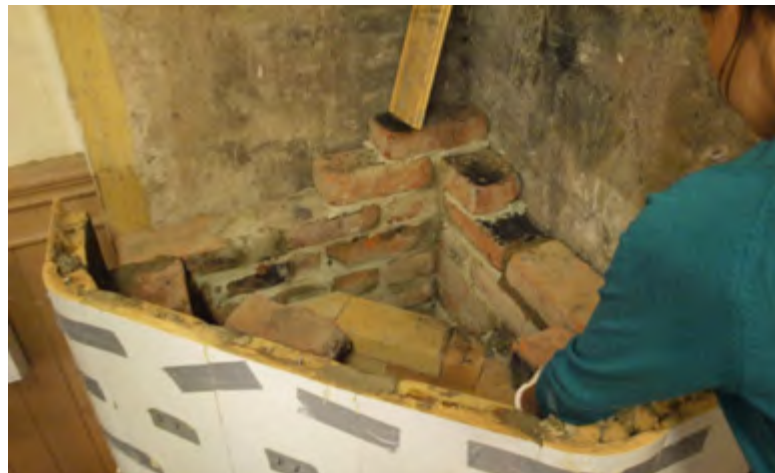
Figure 1.40. Five more rows of fire-proof bricks are layed up from the furnace. From then on the central flue is built using ordinary bricks and clay mortar.

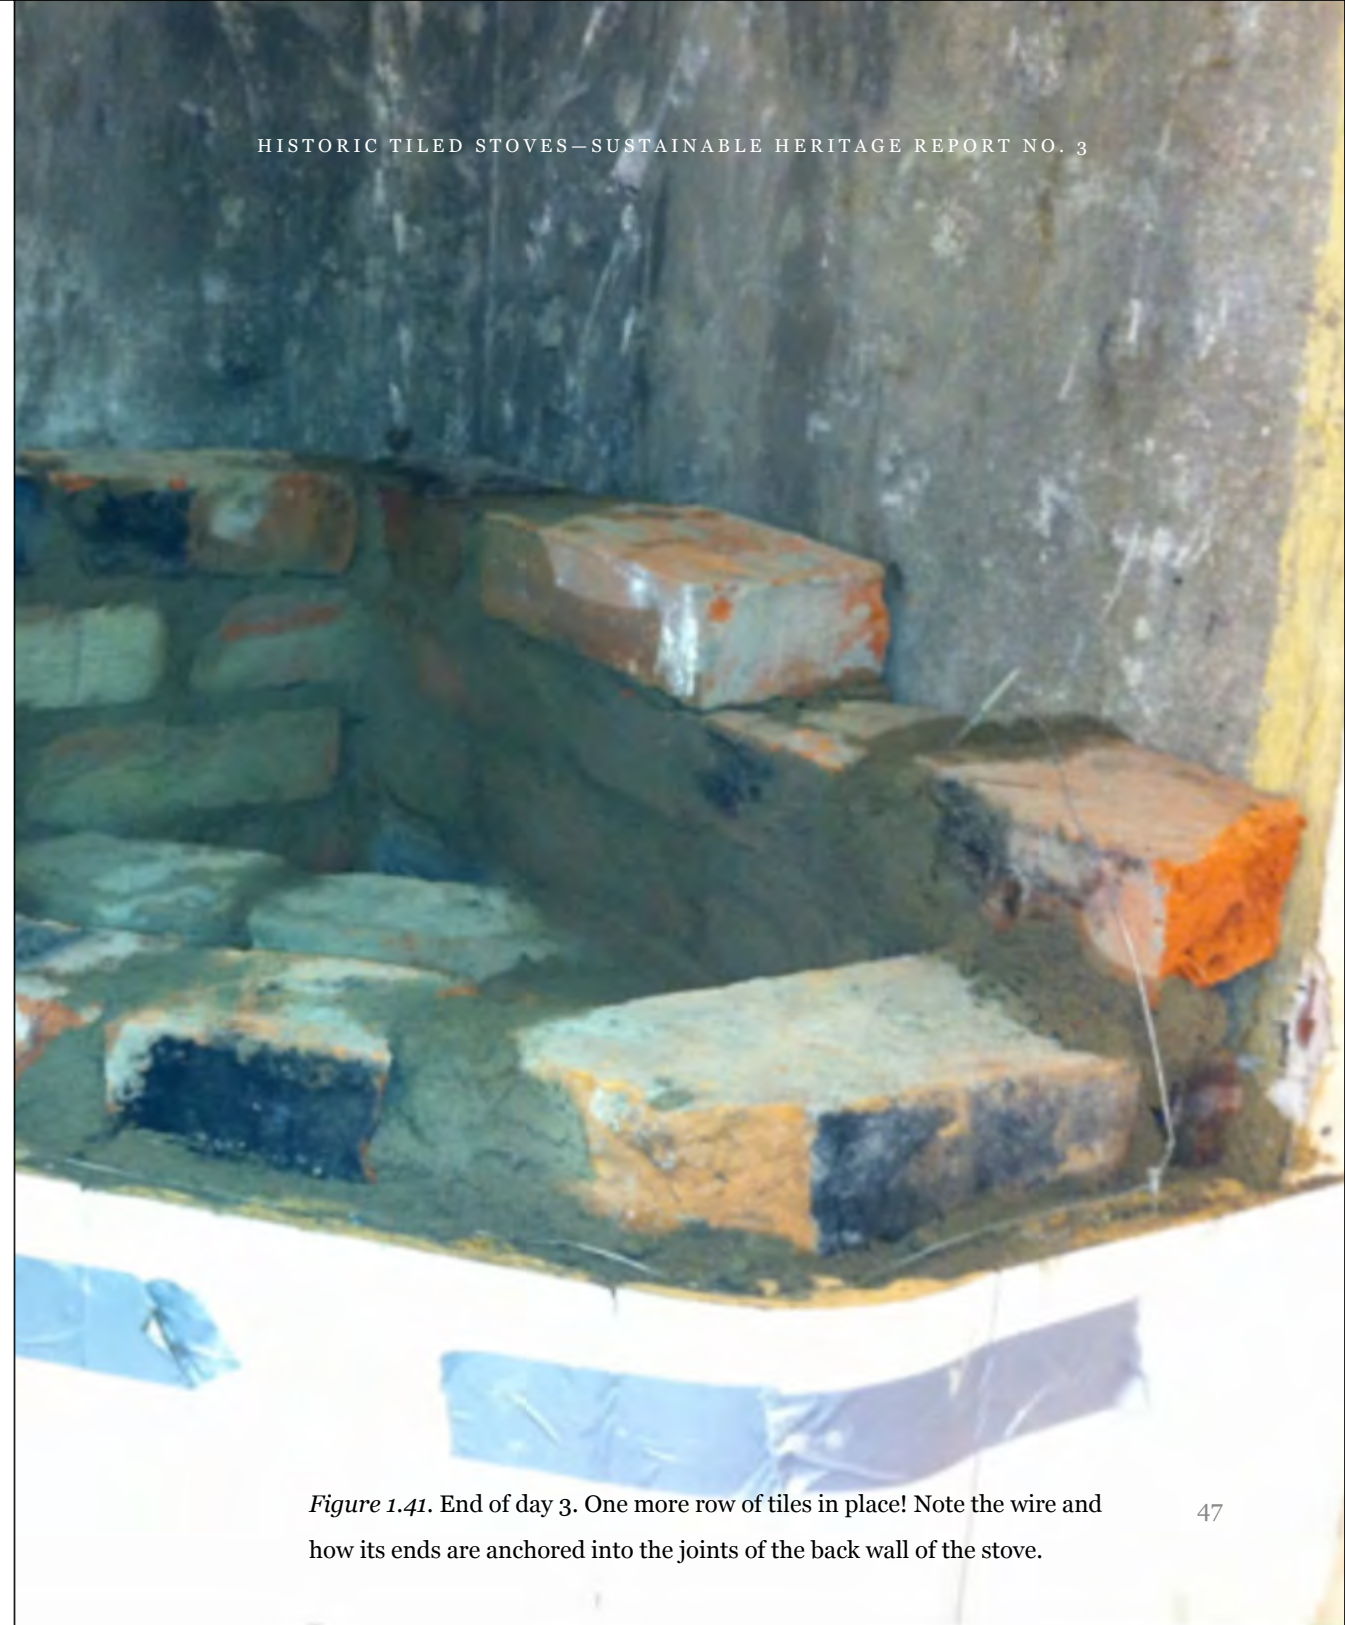
Figure 1.41. End of day 3. One more row of tiles in place! Note the wire and how its ends are anchored into the joints of the back wall of the stove.
