# Manual for Dismantling, Documenting and Rebuilding Historic Tiled Stoves

**—Sustainable Heritage Report No. 3**

Novia Publications and Productions,  
series S: Student Works, 2/2012

A joint project between Gotland University, Estonian Academy of Arts  
and Novia University of Applied Sciences.

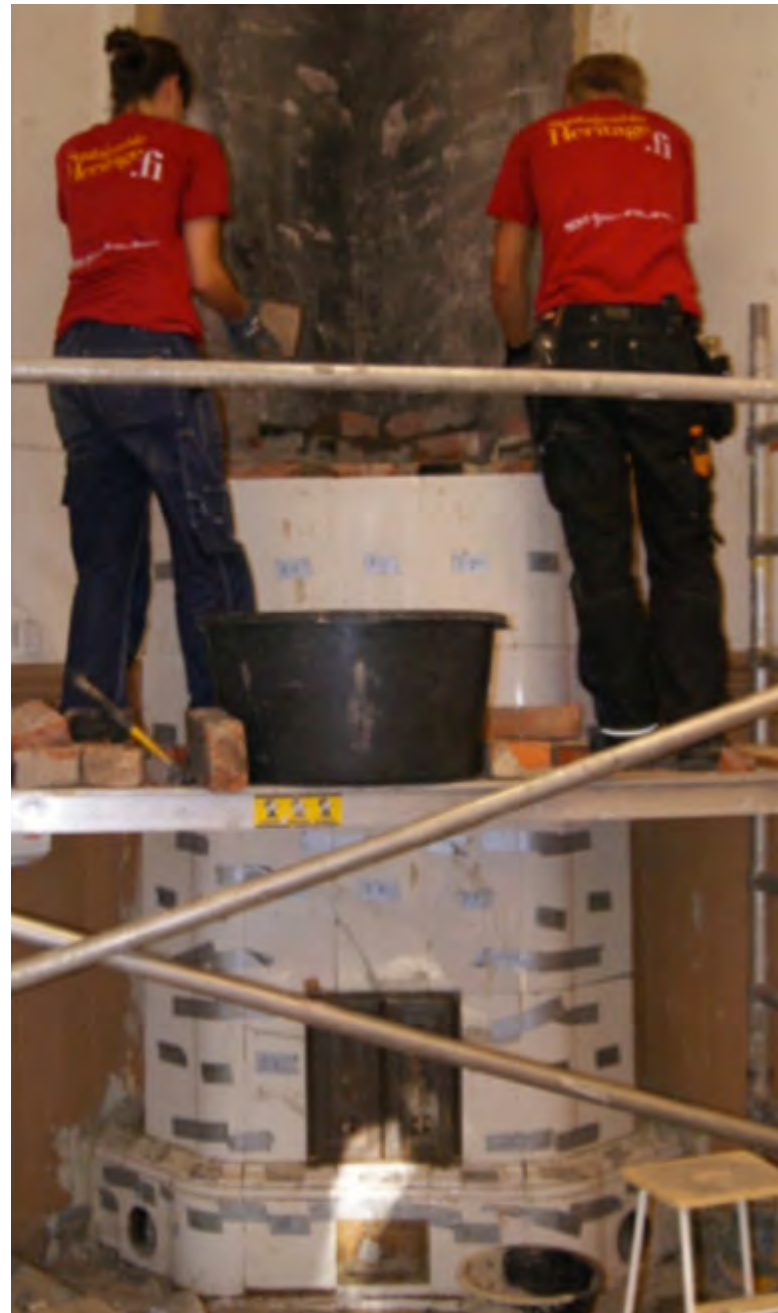
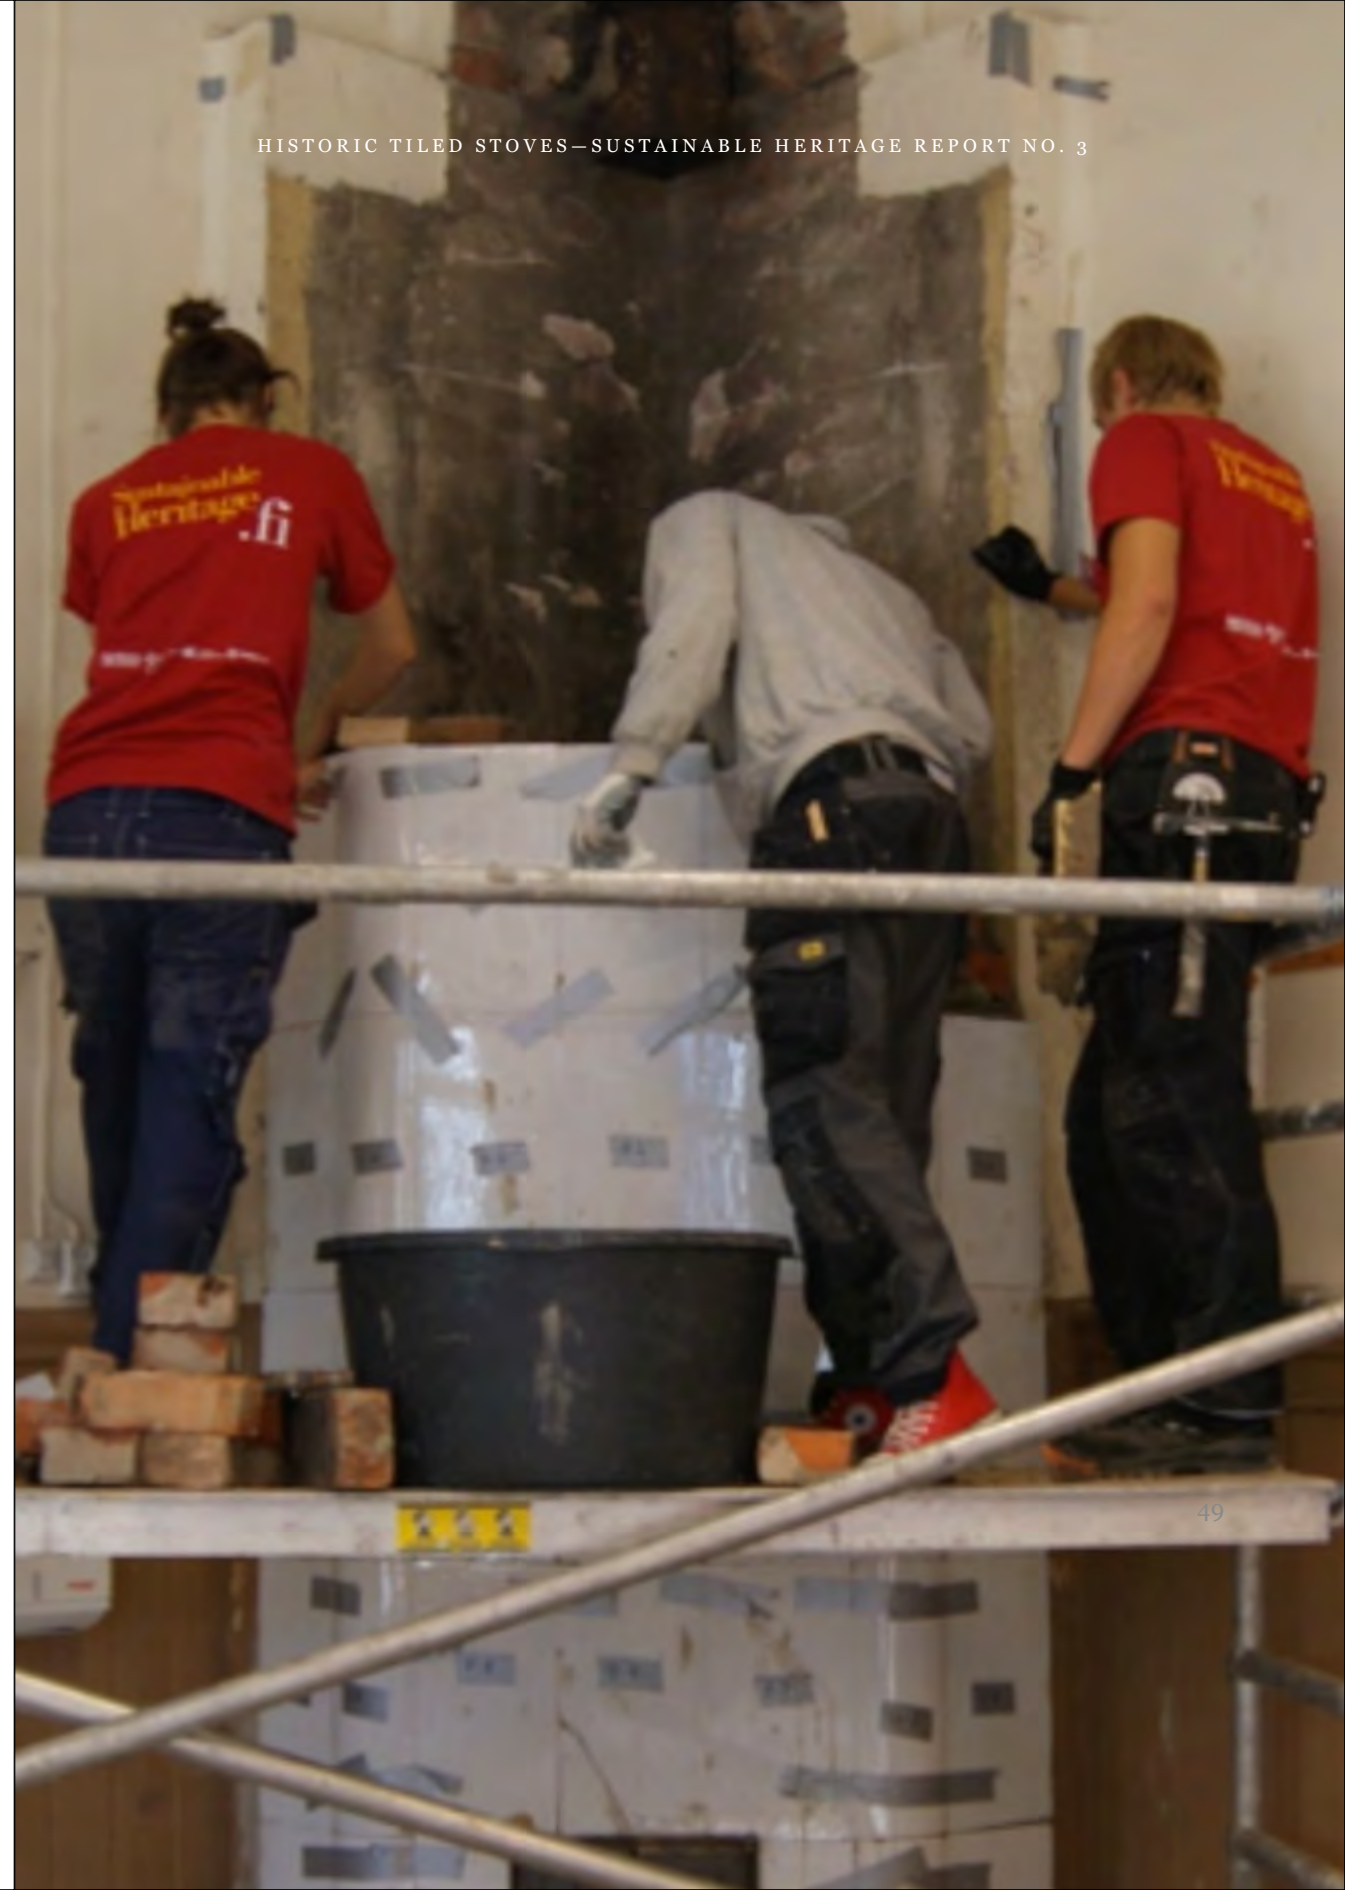
Figures 1.42–43. On day 4 two rows of tiles were installed.

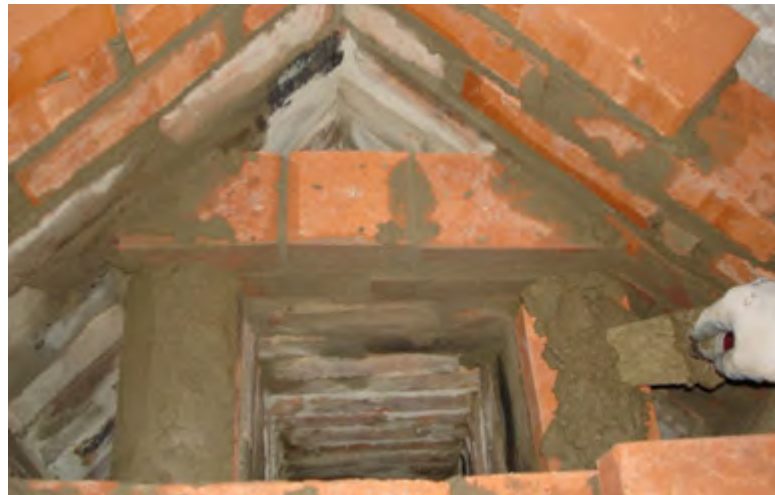
Figure 1.44. Day 5. Finishing the central flue just before installation of the last row of flat tiles. The tops of the side walls of the central flue are rounded to direct the air-flow to the flue pipes.

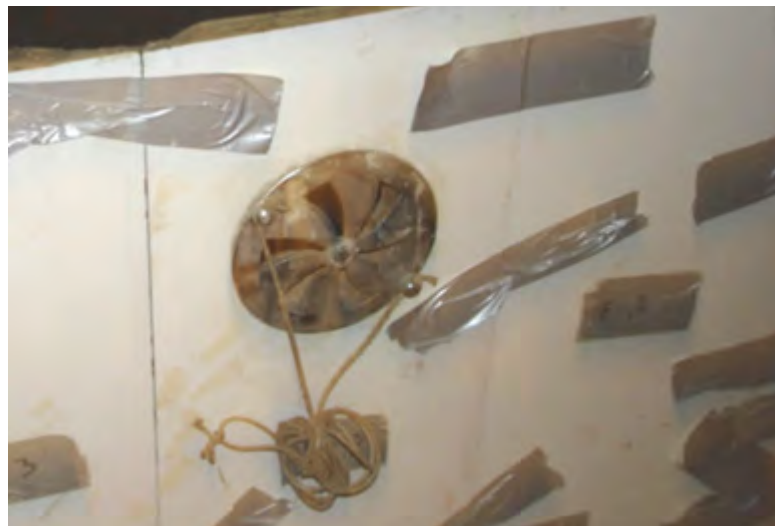
Figure 1.45. Rosette air vent in the last row of tiles before installing cornice.

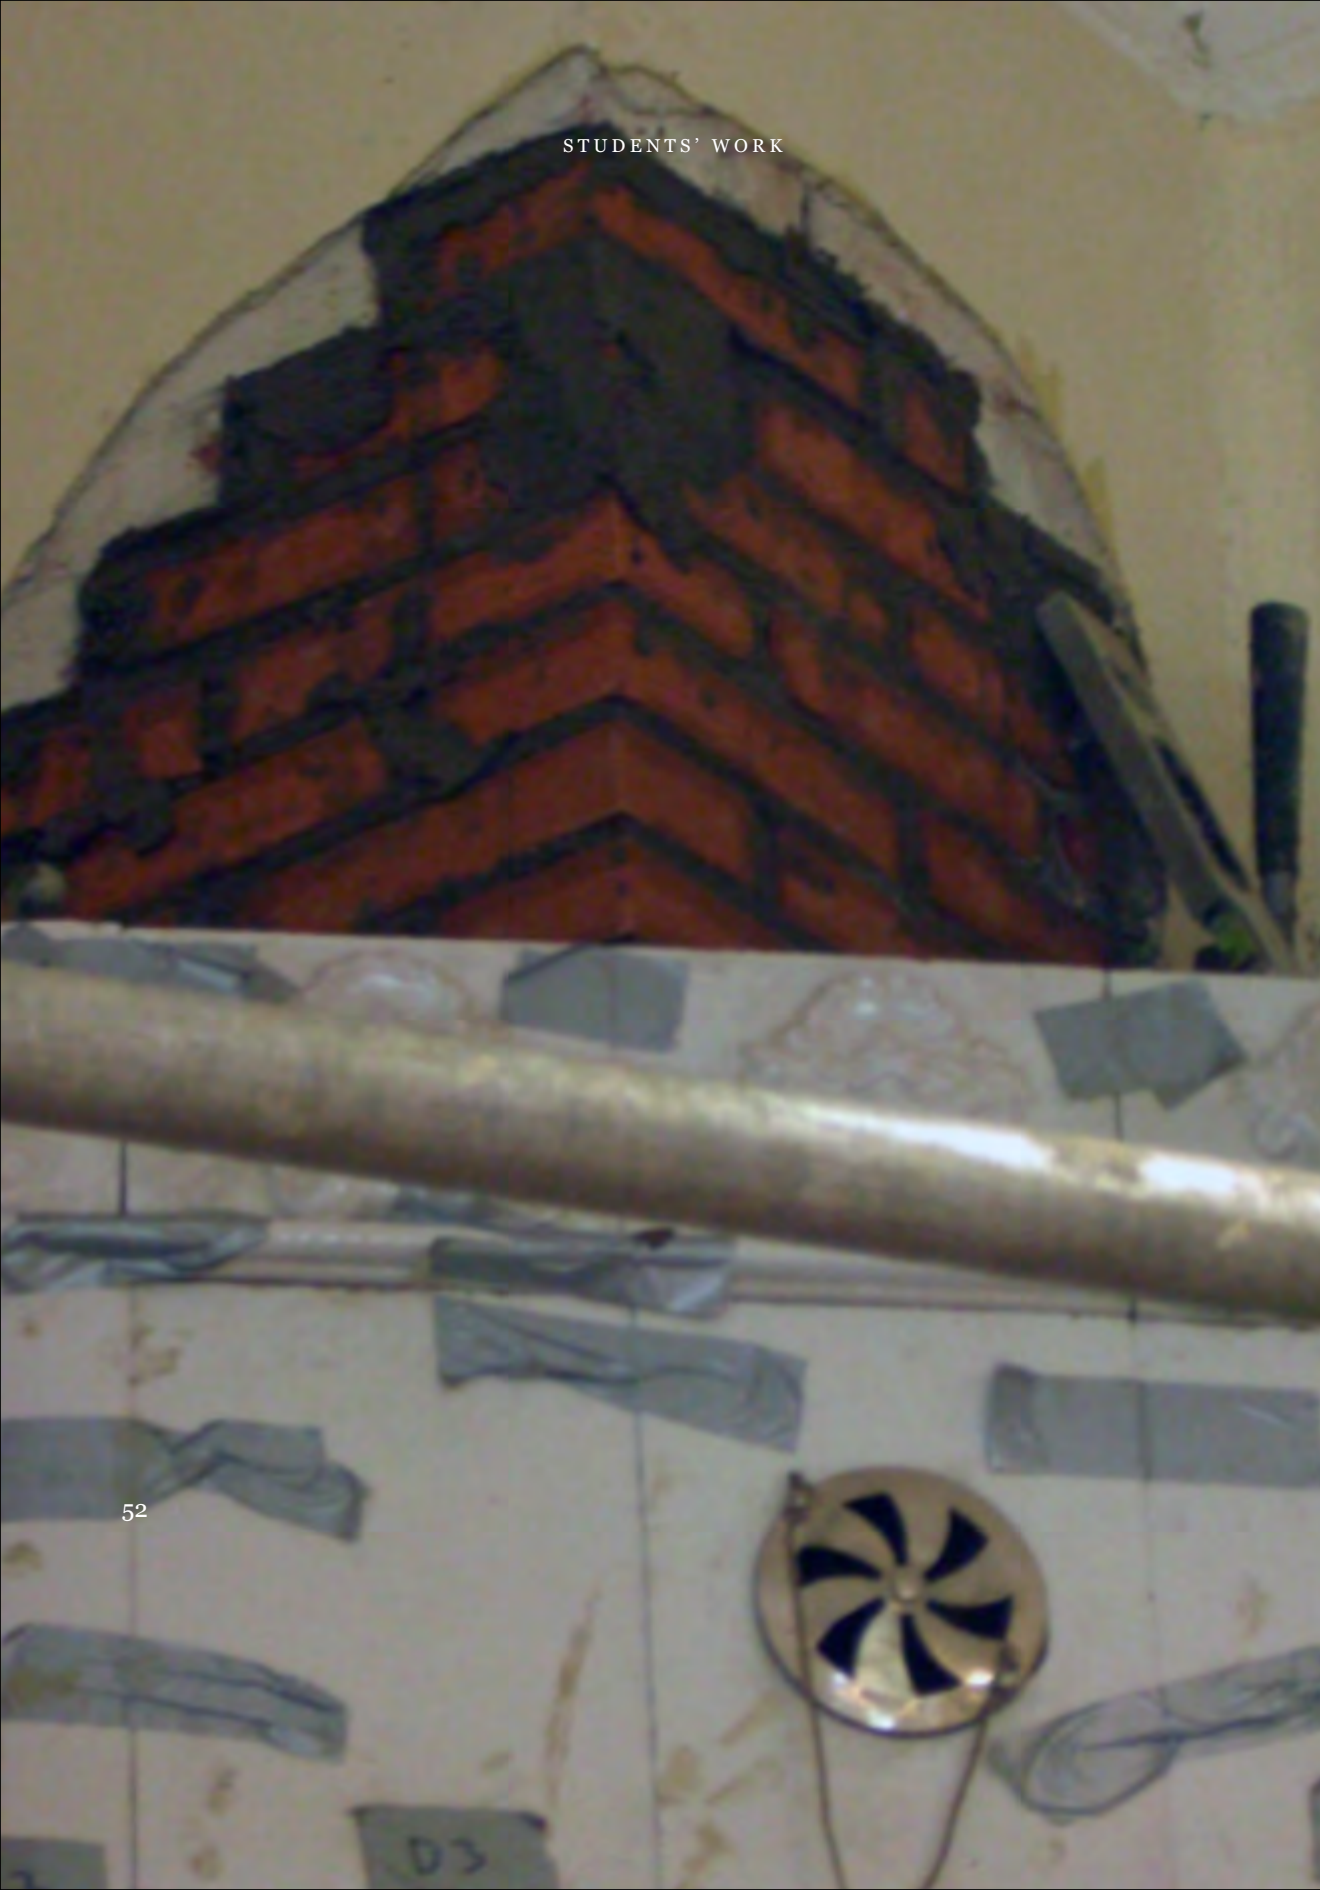
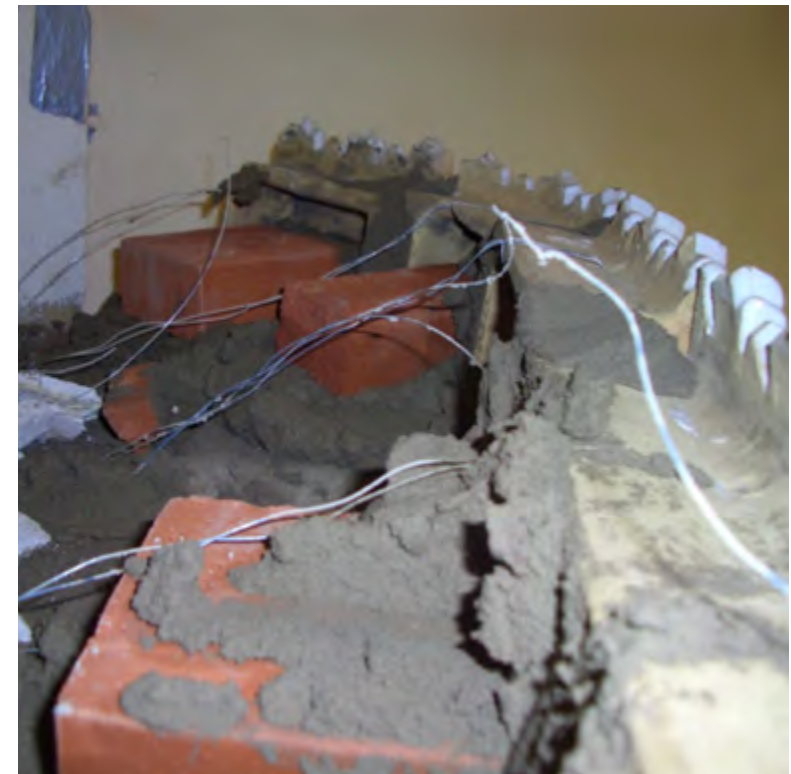
*Figures 1.47–48.* The chimney was repaired (*left*), before the crown tiles were finally inserted.

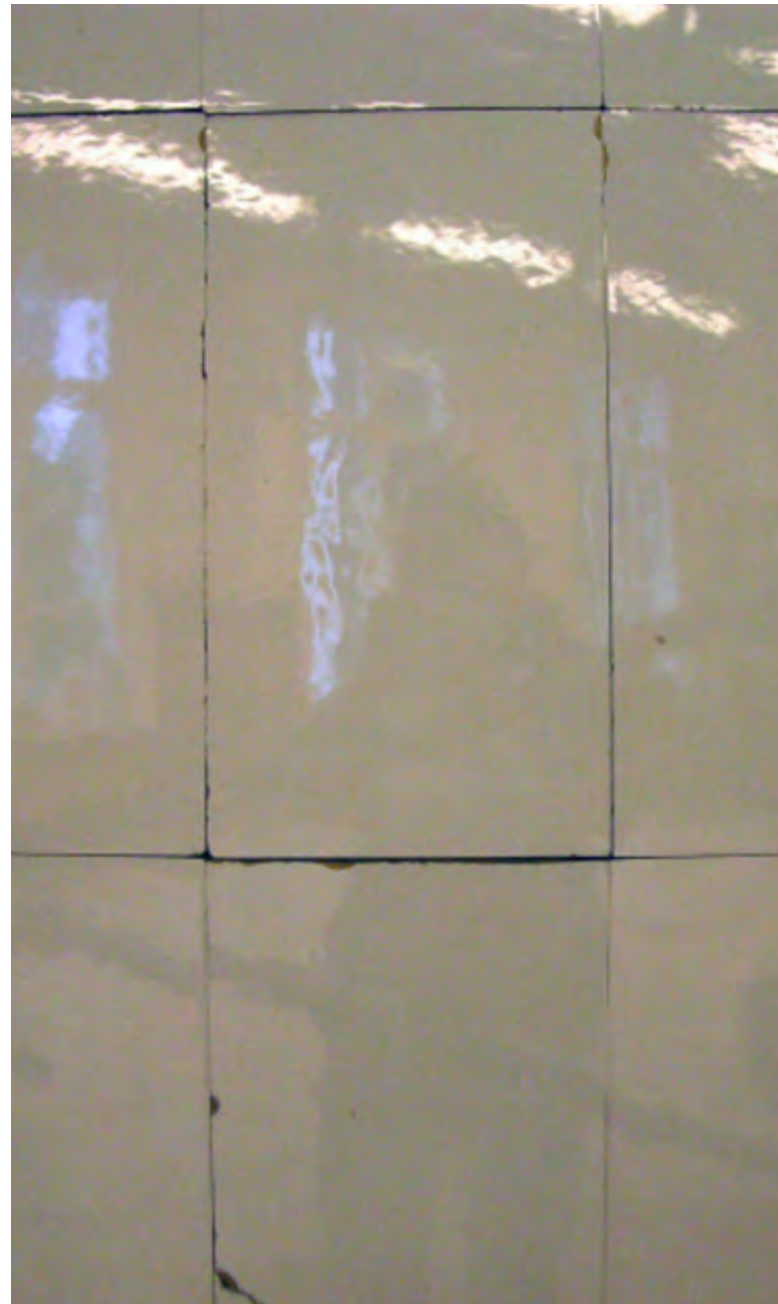
Figure 1.49. The face of the stove before joints and cracks were filled.

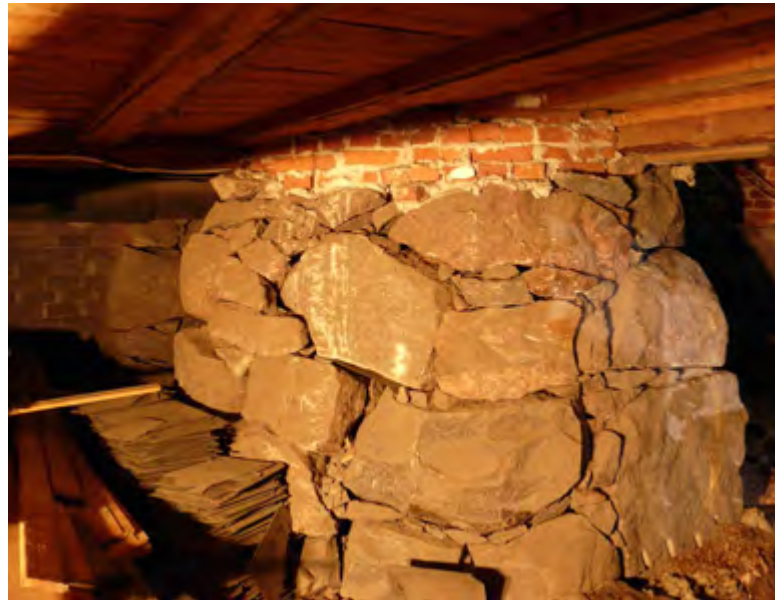
Figure 2.1. Every kind of stove or fireplace has to stand secure and immobile since movements in the masonry would lead to cracks and obvious fire hazard. This enormous dry laid foundation supports the stove whose dismantling and consequent rebuilding is described in the following. The stove itself weighs several tons.

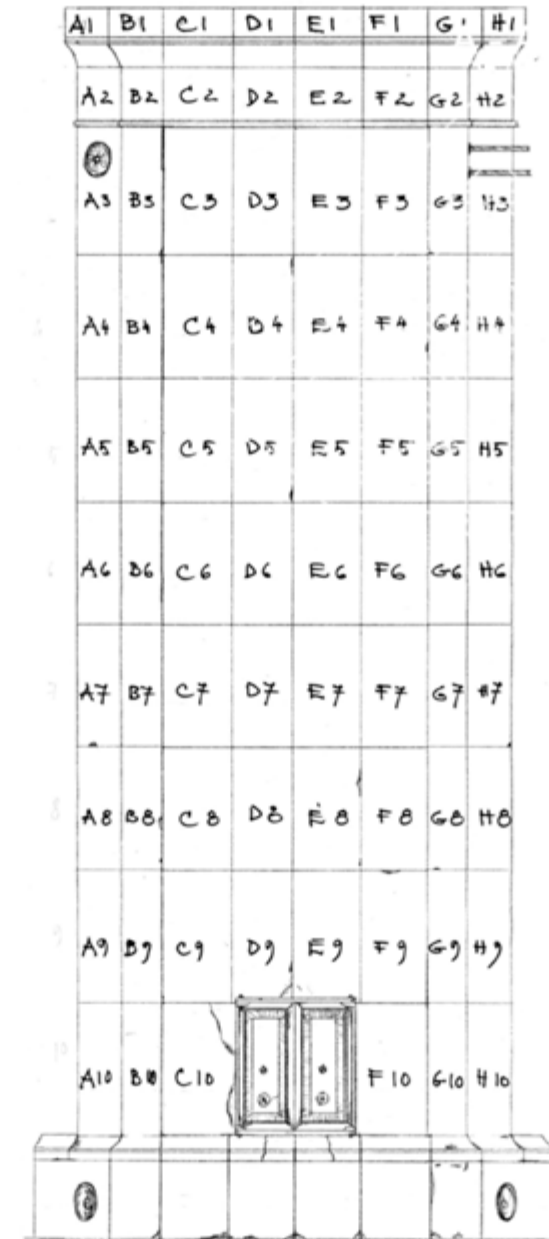
Figure 2.2. Measured drawing of the stove with a symbol for each tile. There are always slight variations in the measurements of tiles and therefore it is important to keep them in the same position when you rebuild the stove.

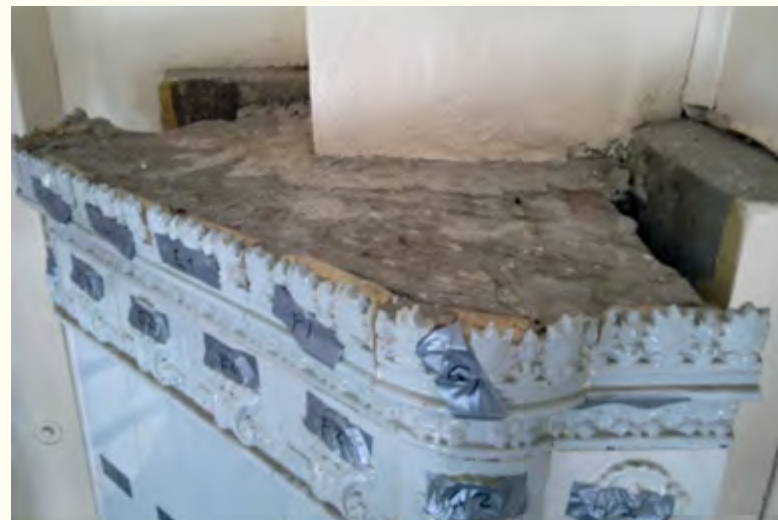
Figures 2.3 a, b. View of the top of the tiled stove before we began dismantling it. Above: a measured drawing of the same. Note the masonry fire walls that separate the stove from surrounding log constructions.

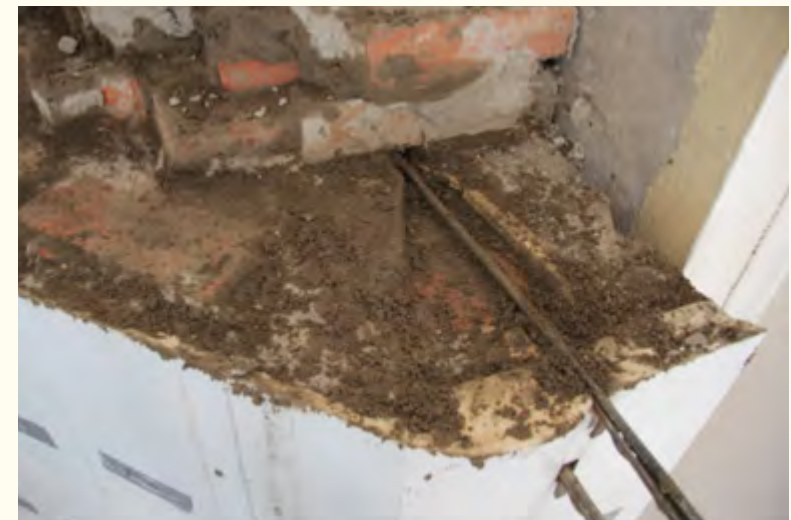
Figures 2.4 a, b. Two top rows of tiles have been removed and the top damper is now visible. Above: drawing of the same.

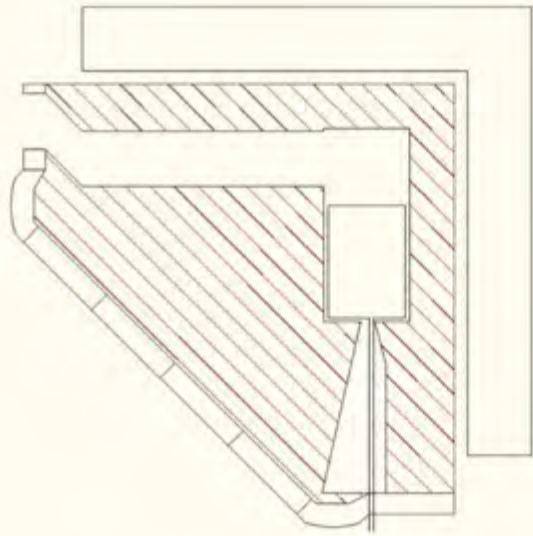
*Figures 2.5 a, b.* Top air duct was then revealed on the left hand side. Tiled stoves often have an air duct for ventilation in the summer months when the natural air conditioning through the furnace is not in use. This is why there are two dampers: in summer the bottom damper is closed so as to enhance the air flow through the vent into the chimney. When the stove is heated both dampers must be open and when the fire is down the top damper is closed in order to keep the heat from escaping. Also if you want to ventilate after heating you can close the bottom damper and open the top one. The warm chimney will accelerate the flow of air. Ingenious!

*Above:* drawing of the same.

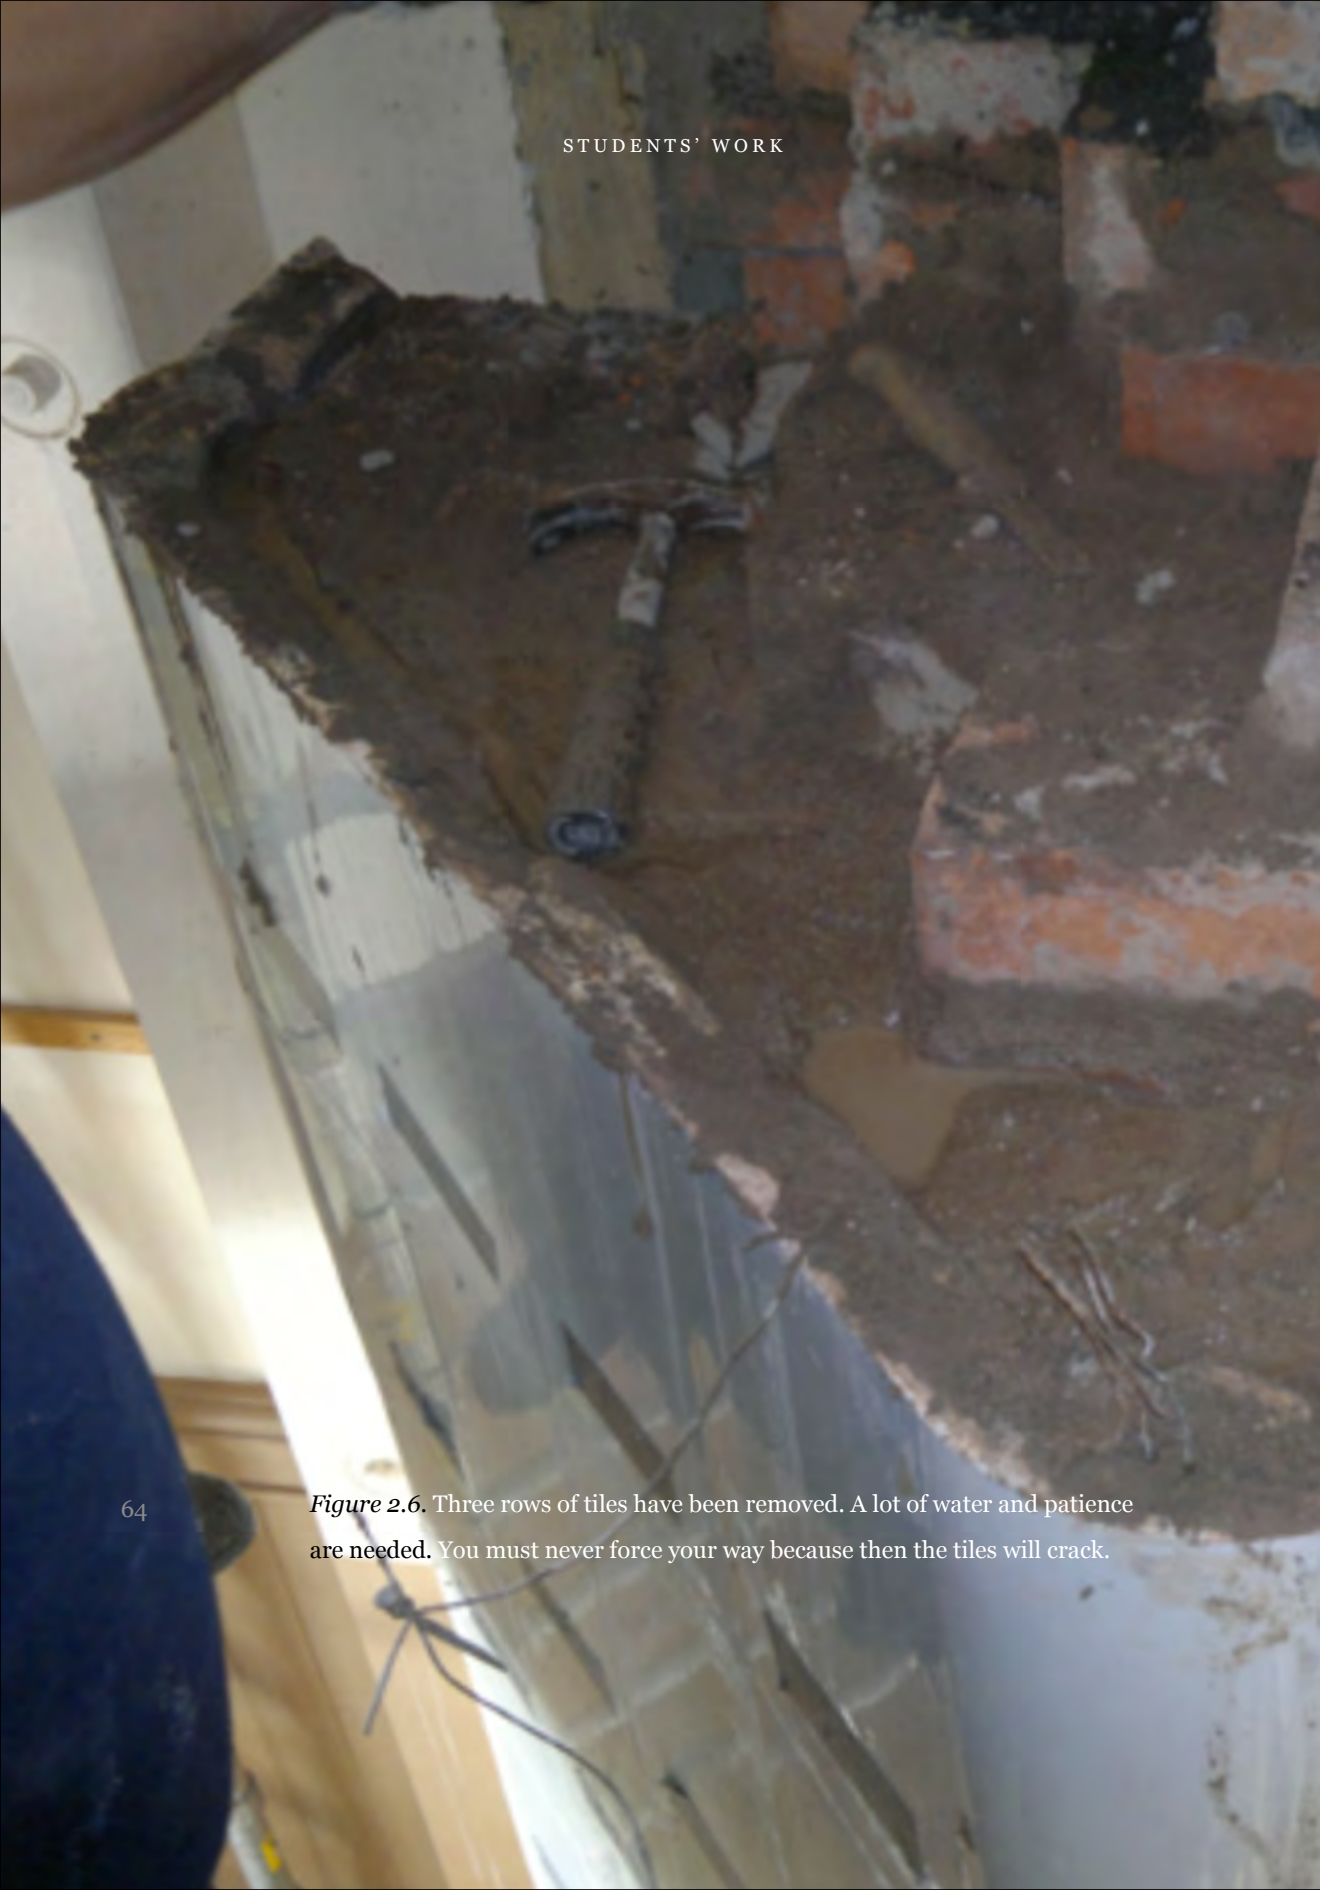
*Figure 2.6.* Three rows of tiles have been removed. A lot of water and patience are needed. You must never force your way because then the tiles will crack.

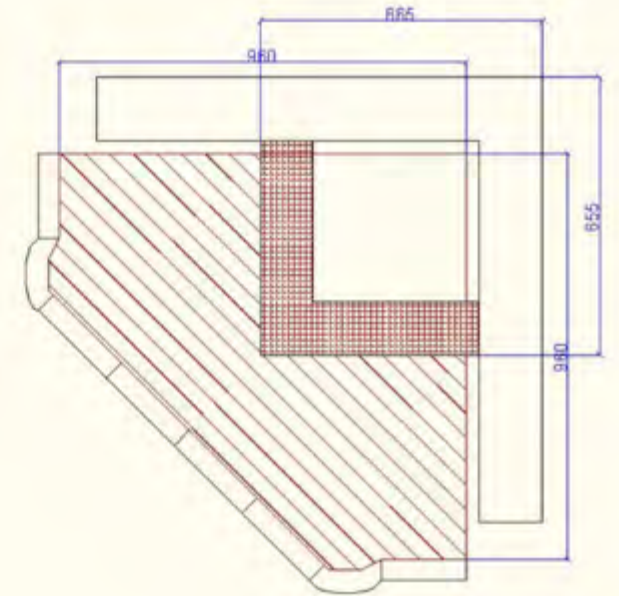
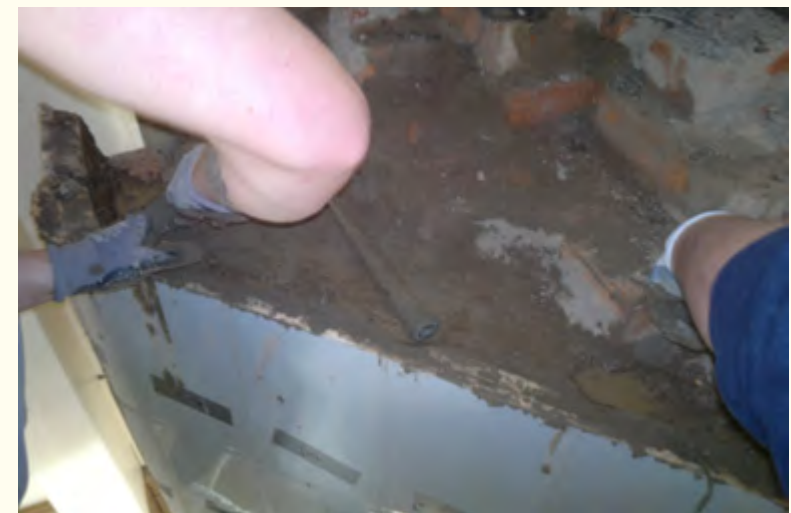
*Figures 2.7 a, b.* Top view of the fourth row of tiles. The brick work is still solid, i.e. none of the smoke flues that we were looking for are visible yet. *Above:* measured drawing of the same.

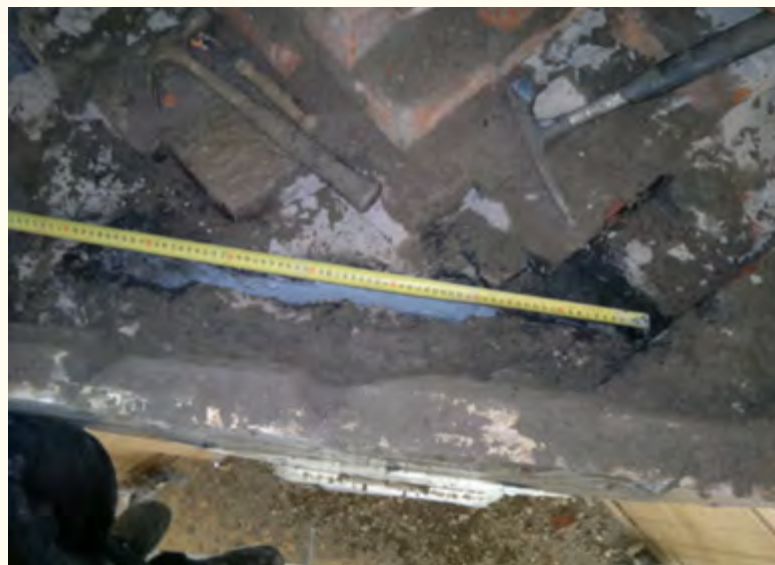
Figures 2.8 a, b. The smoke flue becomes visible two bricks down from the top of the fourth tile row. Above: measured drawing of the same.

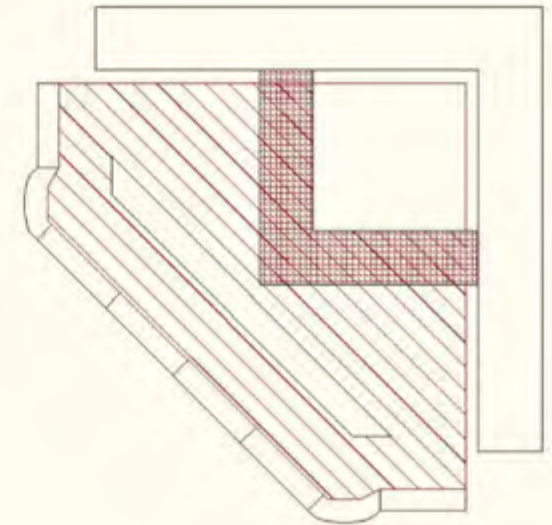
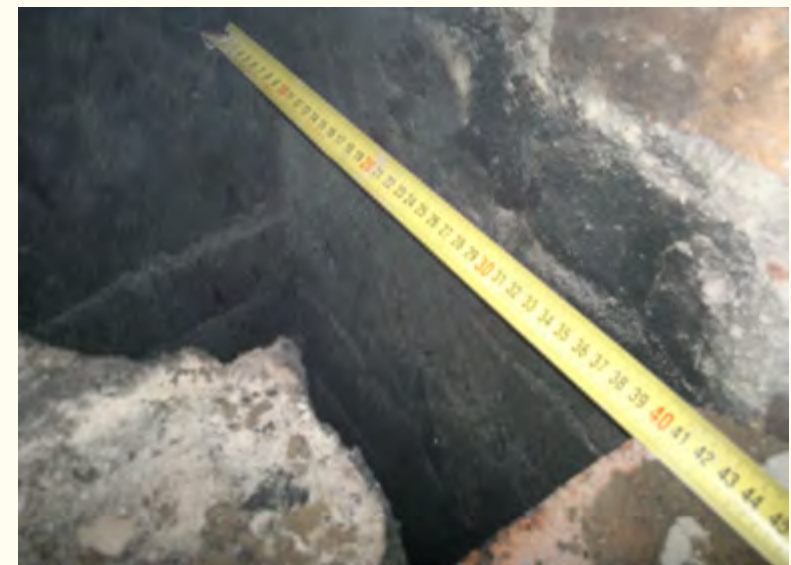
Figures 2.9 a, b. The rear smoke flue which leads to the chimney is found at the top of the fifth tile row. Above: drawing of the same.

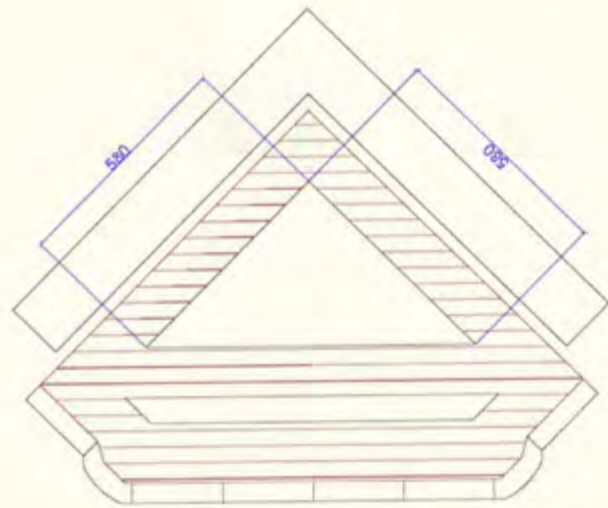
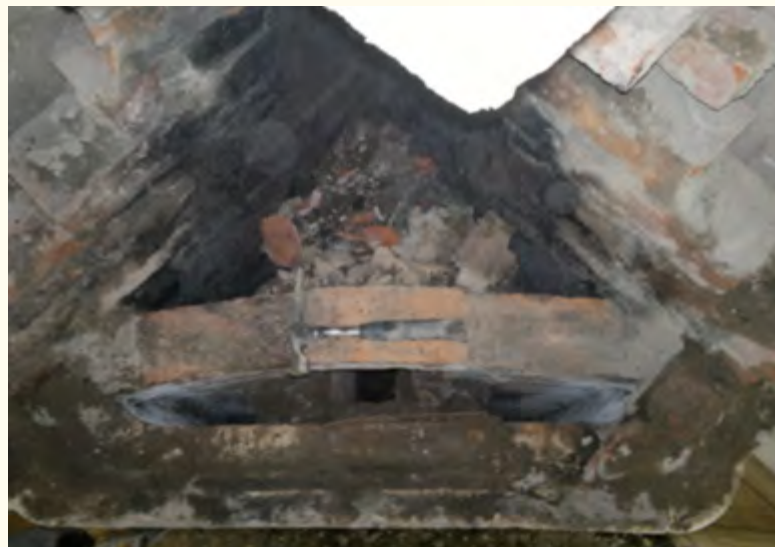
*Figures 2.10 a, b.* One row of bricks below the top of the fifth tile row: At last we can see the basic structure of the stove with its 5 flues. *Above:* measured drawing of the same.

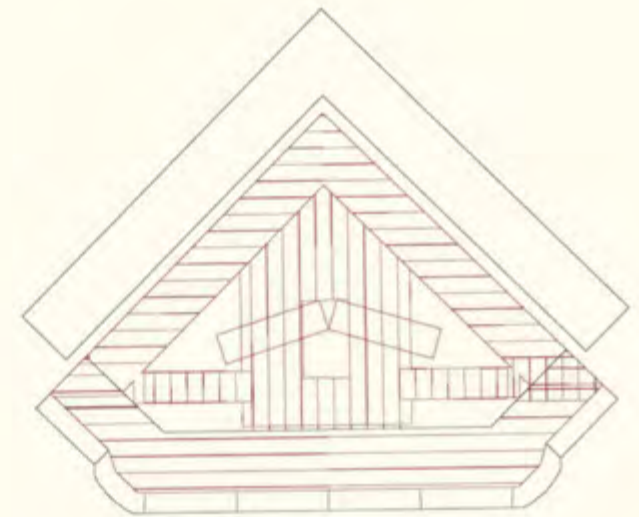
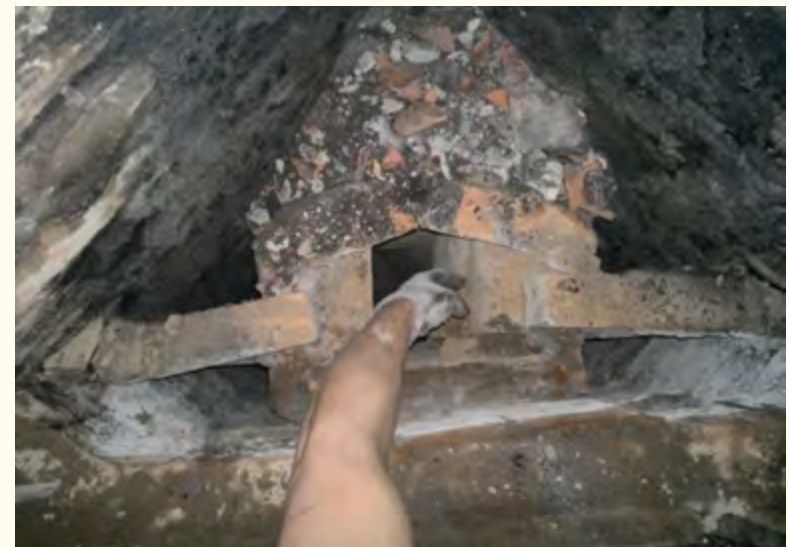
*Figures 2.11 a, b.* Three bricks down from the top of the fifth tile row: a clear view of the interior. *Above:* measured drawing of the same.

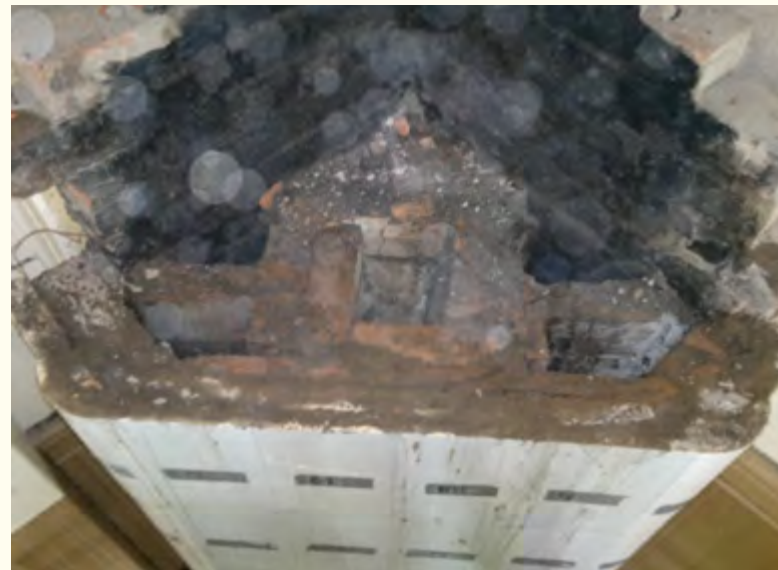
Figures 2.12 a, b. The sixth tile row, top view. This arrangement continued to row 9. Above: drawing of the same.

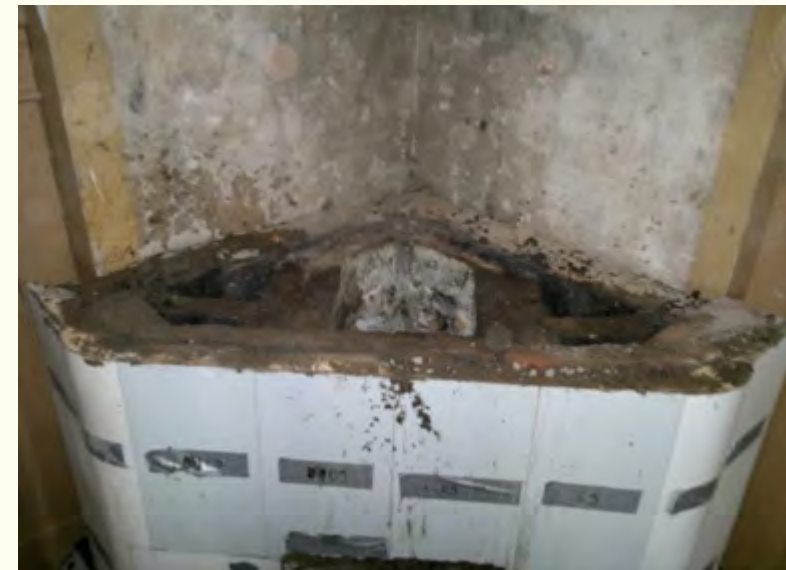
Figures 2.13 a, b. Top view of the ninth row of tiles. Here we can see the top of the furnace. Above: measured drawing of the same.

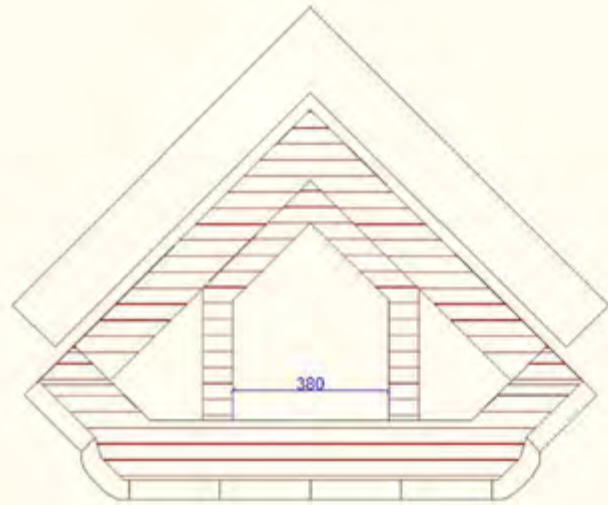
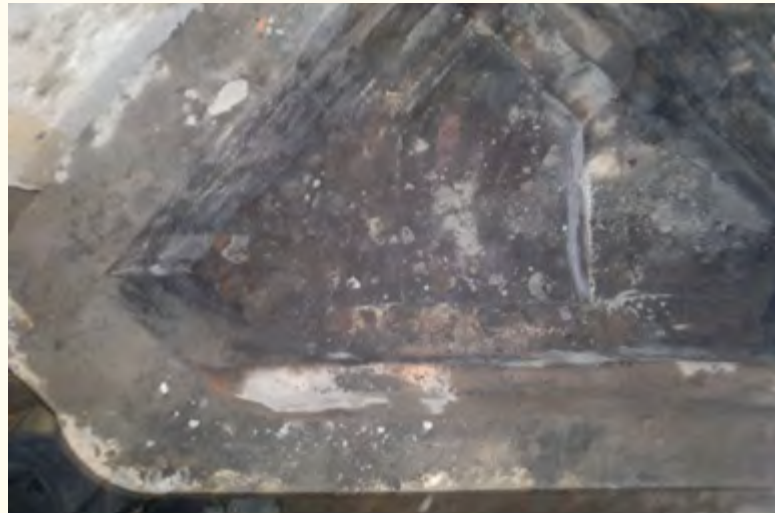
*Figures 2.14 a, b.* The ninth tile row is still in place but several rows of brick have been taken out from behind it. Here the floor of the furnace can be seen. This is where the dismantling was stopped because the bottom of the stove was intact and it was of course easier to start the rebuilding from a foundation that was of the correct size and shape. *Above:* measured drawing of the same.

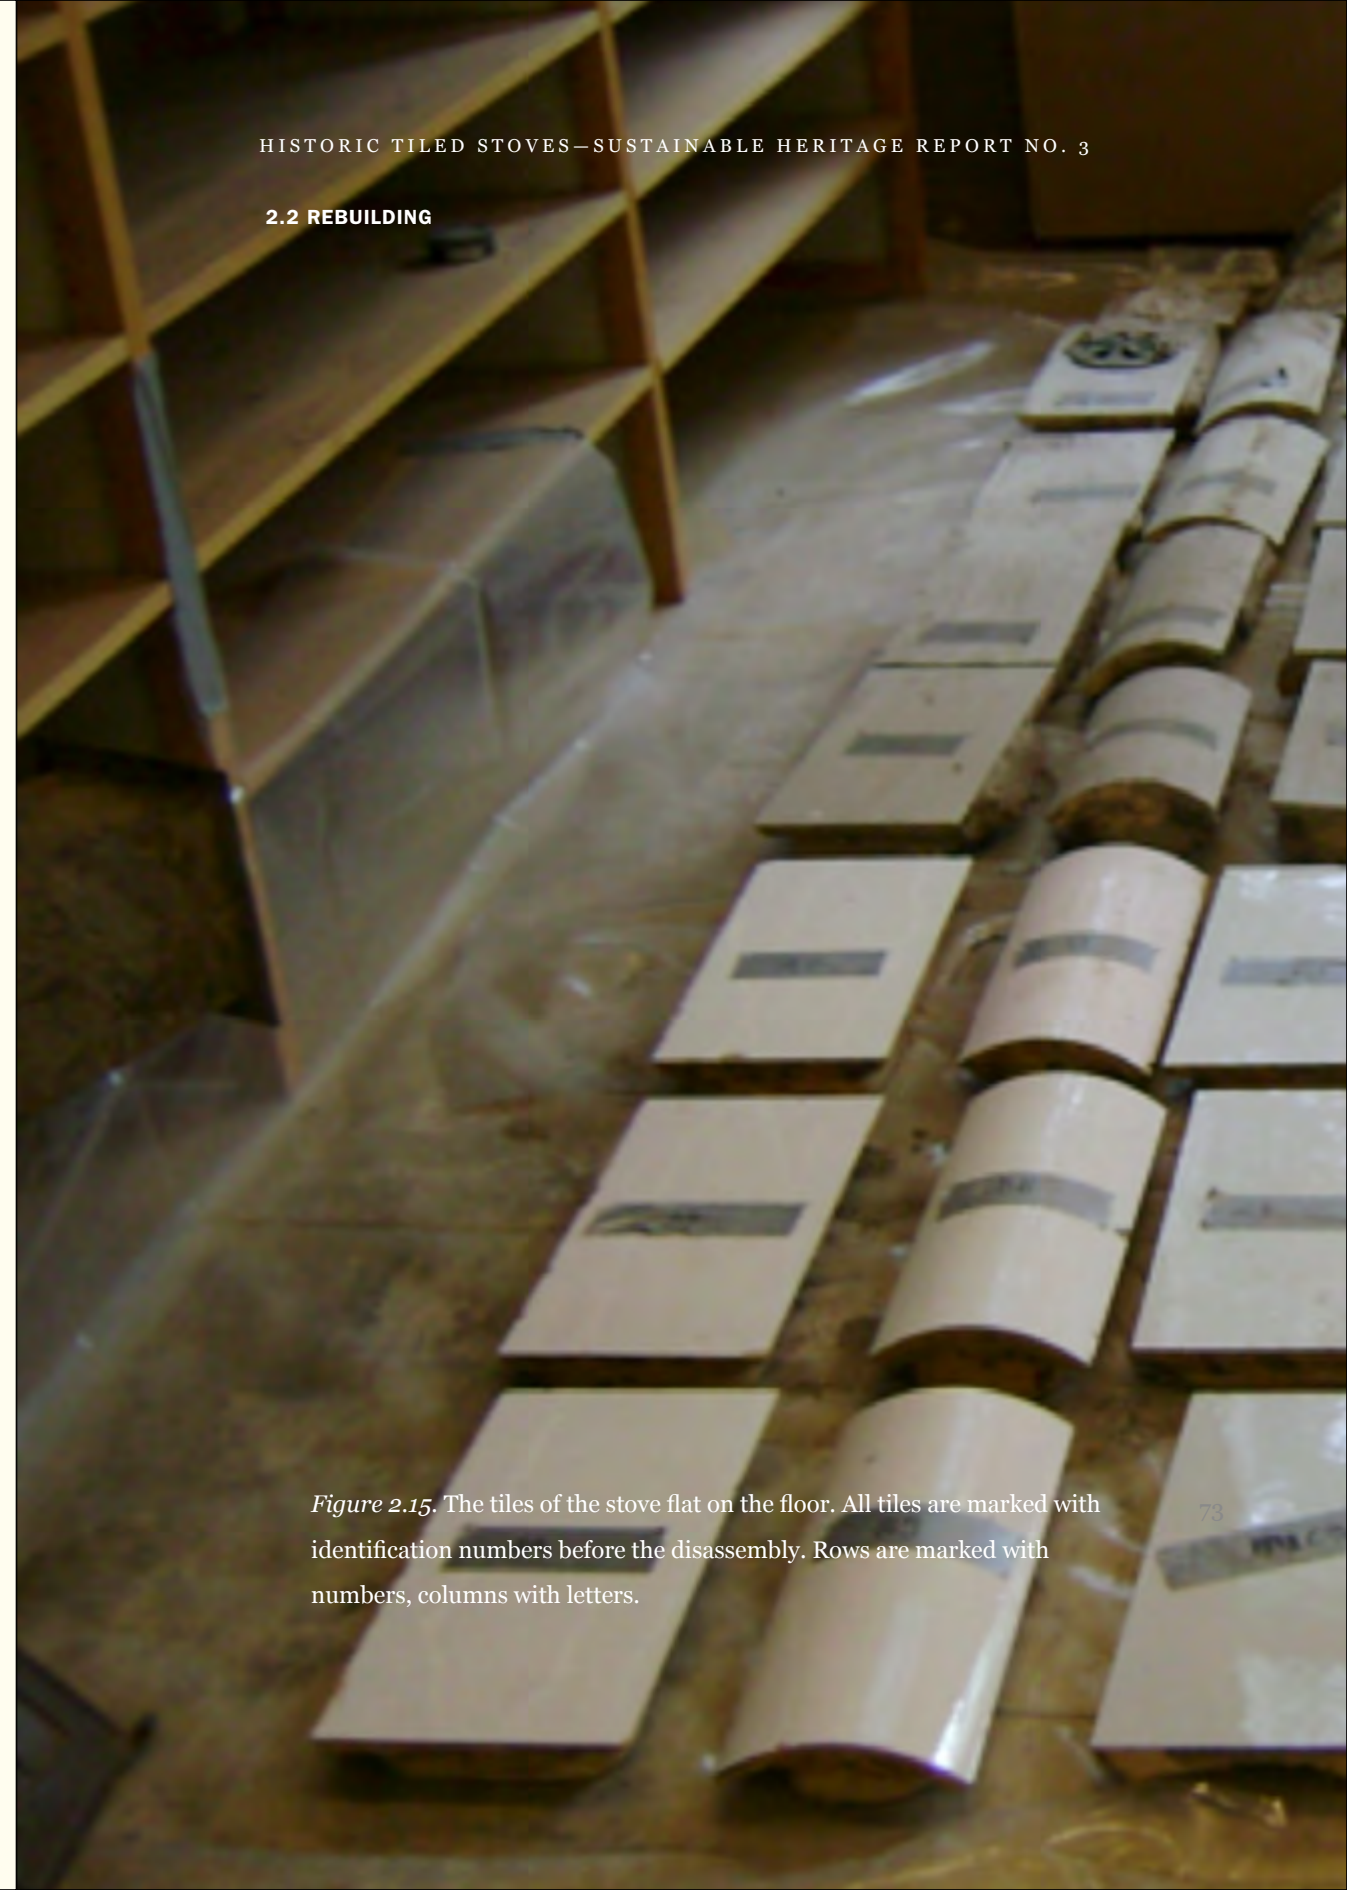
*Figure 2.15.* The tiles of the stove flat on the floor. All tiles are marked with identification numbers before the disassembly. Rows are marked with numbers, columns with letters.
