# Manual for Dismantling, Documenting and Rebuilding Historic Tiled Stoves

**—Sustainable Heritage Report No. 3**

Novia Publications and Productions,  
series S: Student Works, 2/2012

A joint project between Gotland University, Estonian Academy of Arts  
and Novia University of Applied Sciences.

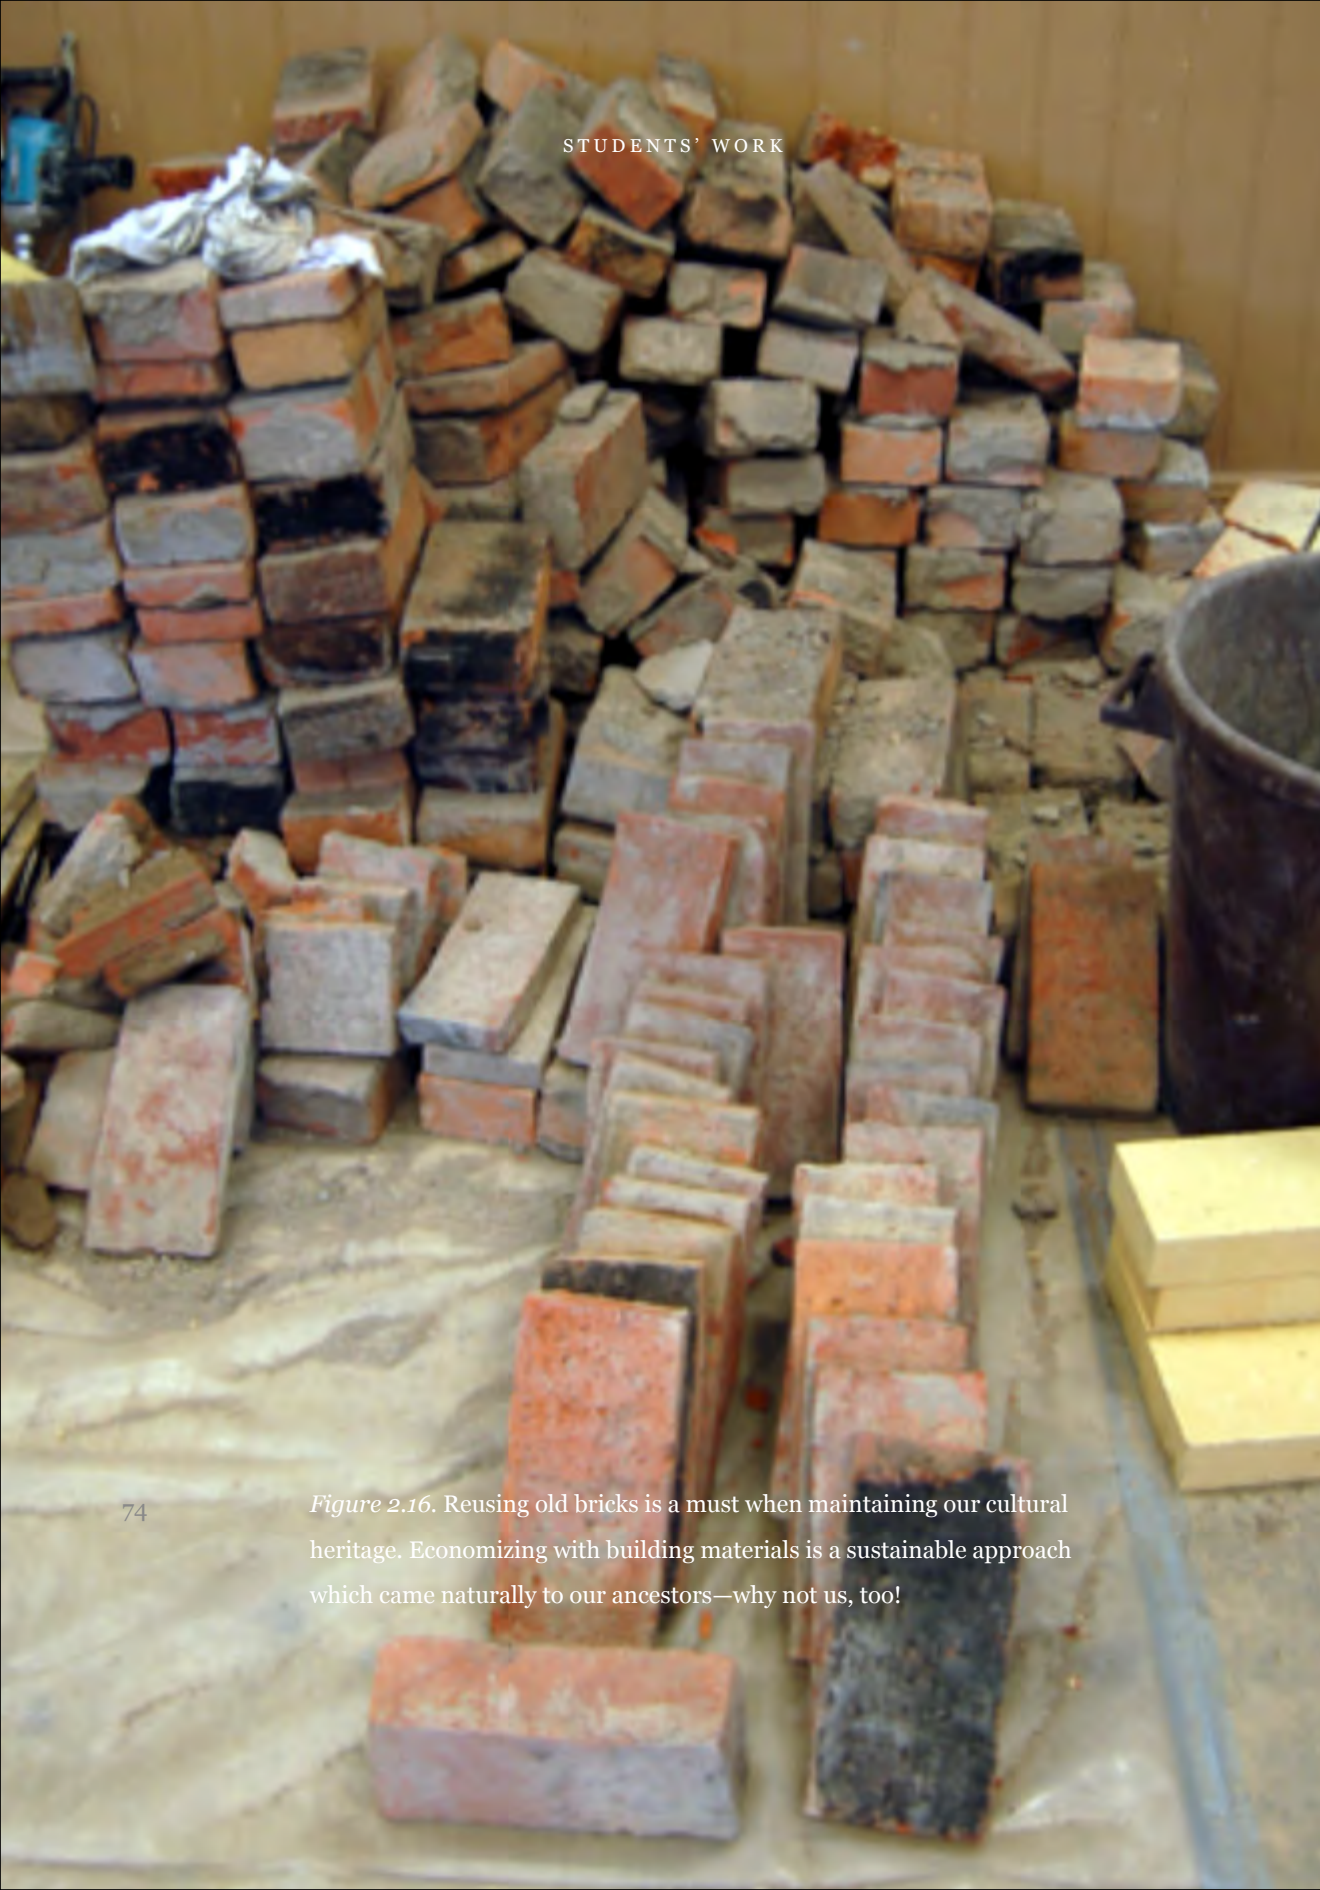
*Figure 2.16.* Reusing old bricks is a must when maintaining our cultural heritage. Economizing with building materials is a sustainable approach which came naturally to our ancestors—why not us, too!

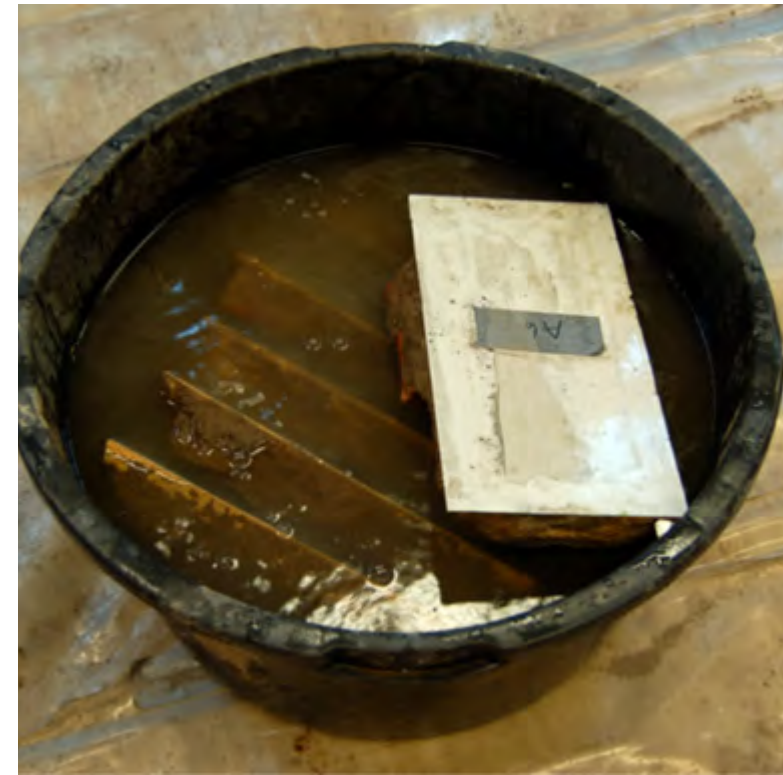
*Figure 2.17.* The rebuilding of the stove started with removing the mortar from the tiles and the thin bricks in the cavity on the back of each tile. The tiles are sunken in water for about half an hour in order to soften the old mortar before they are washed and cleaned. This is why it is important to use clay mortar: cement would not dissolve in water and the tiles would crack if they were cleaned with force.

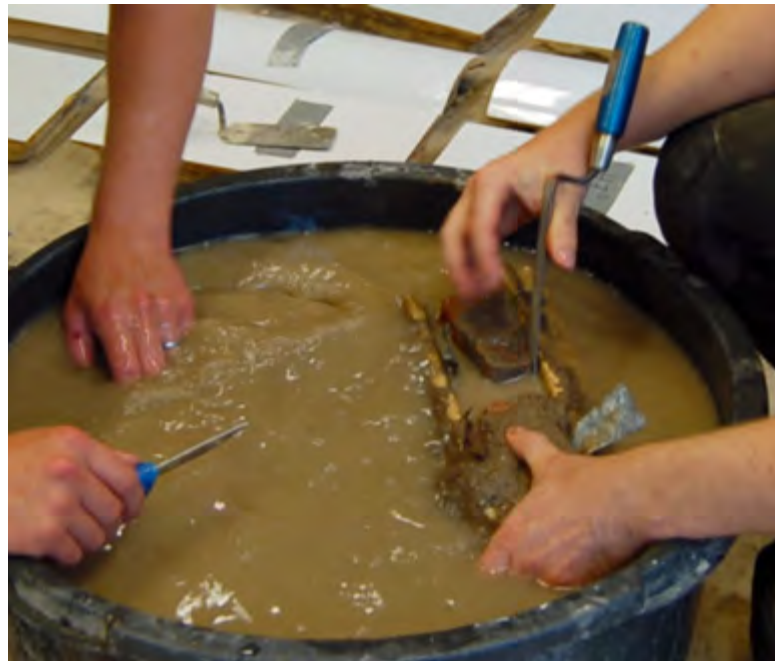
*Figure 2.18.* The bricks, the metal clamps and mortar on the backside of the tiles are being removed. This takes time and you have to be patient because the edges and corners chip easily. Traditionally also the metal parts were reused but we ran out of time for that.

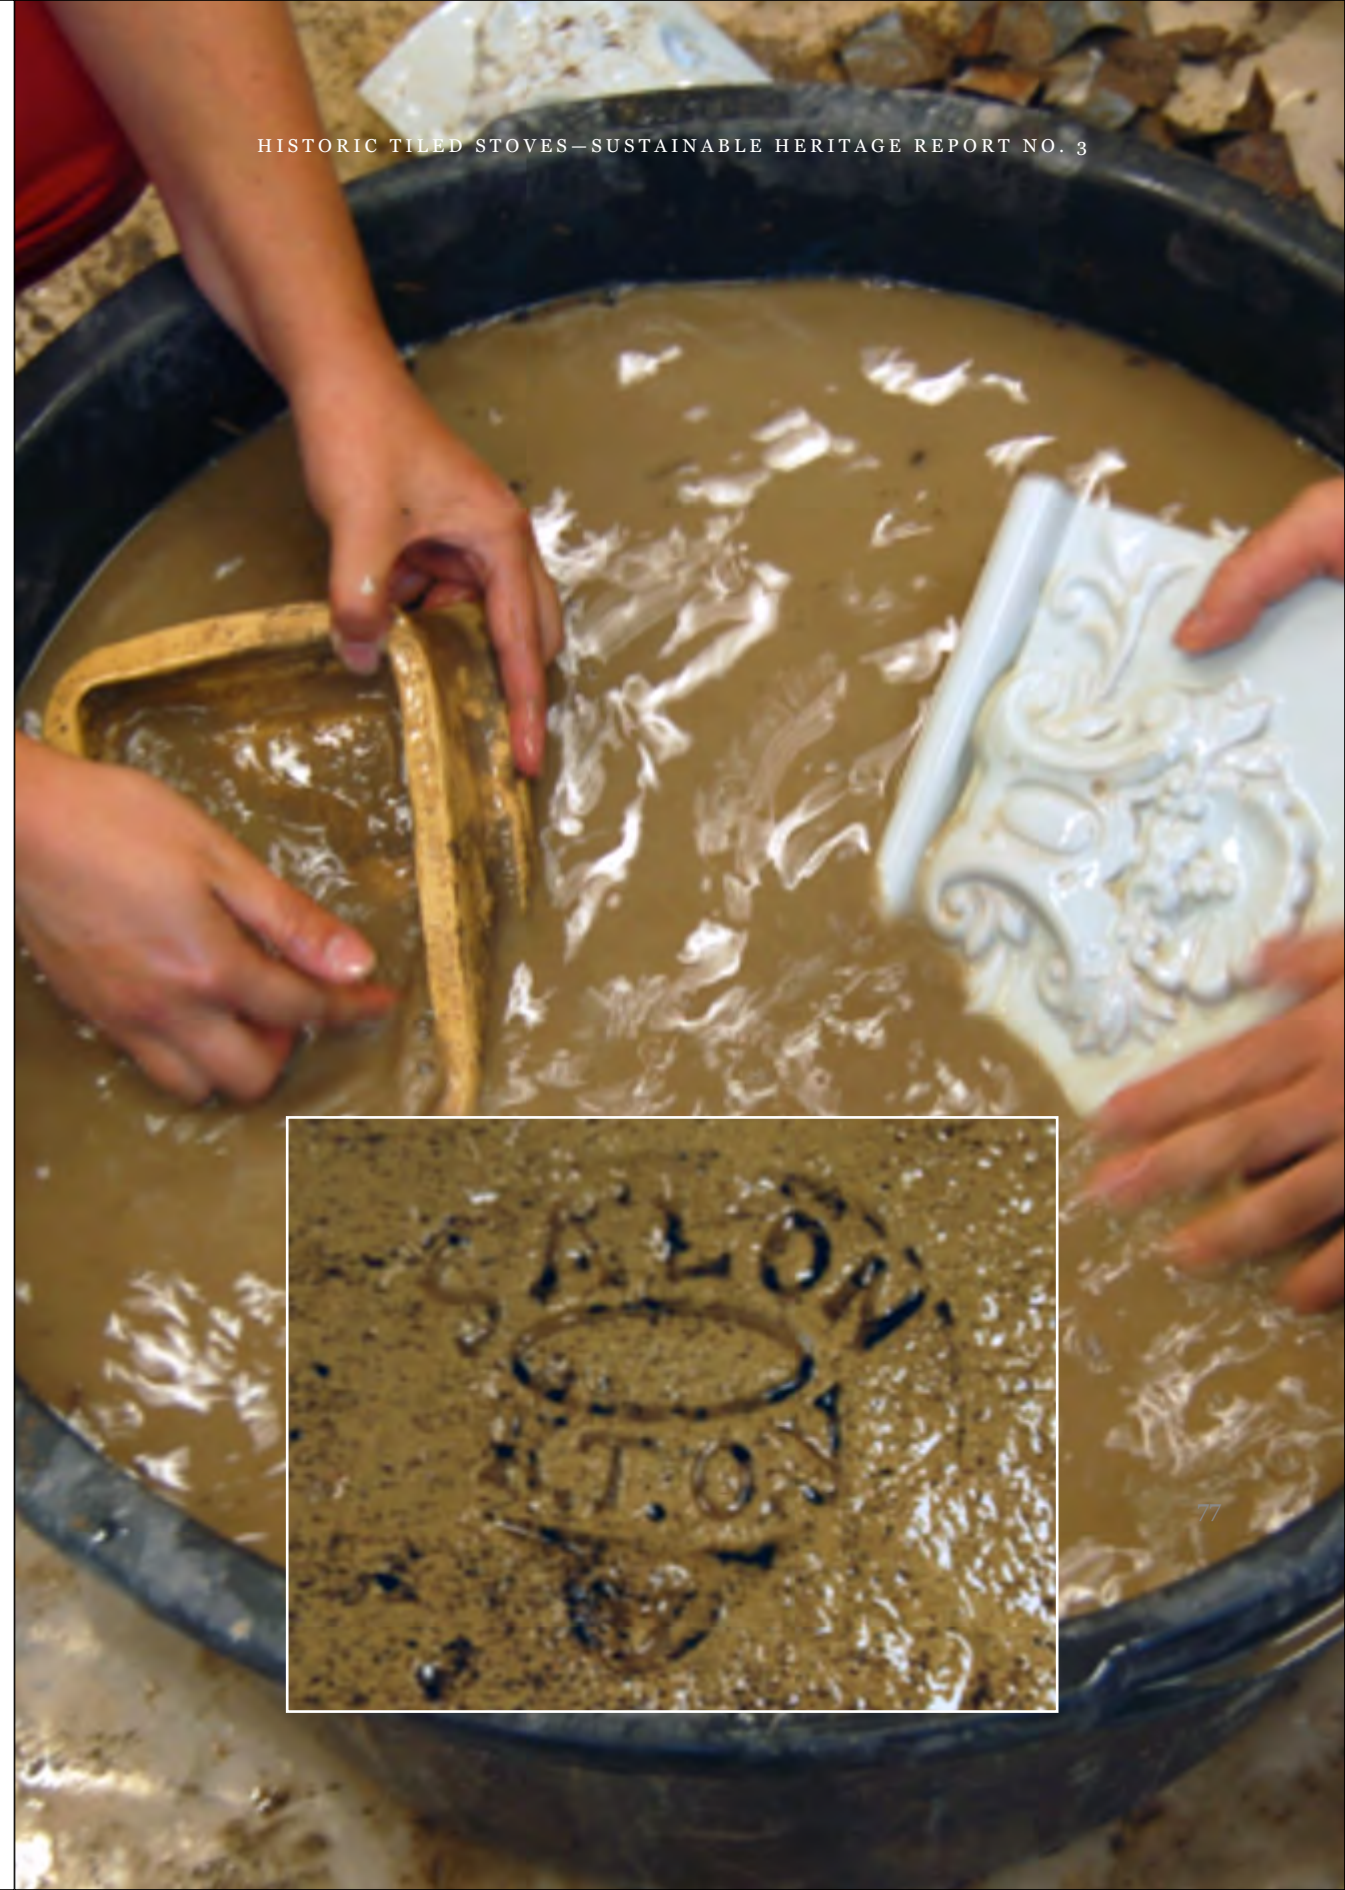
*Figure 2.19–20.* There is usually a stamp behind every industrially made tile. The stamp of SALON K.T.OY (Salon Kaakelitehdas Oy) was found on the back of some the tiles in this stove. This stove is a patchwork of tiles from several factories. It has most probably been taken down several times and each time the broken tiles have been replaced with new or recycled tiles. Salon Kaakelitehdas was owned by Turun Kaakelitehdas which was the largest producer of tiled stoves in the Nordic countries at the end of the 19<sup>th</sup> C. The model of this stove was one of the most popular ones through decades from the 1880's onwards.

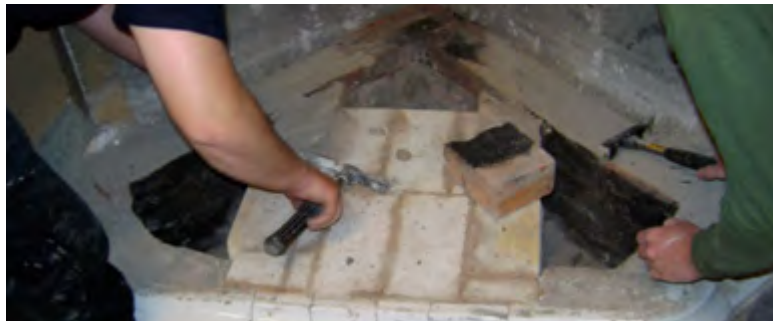
*Figure 2.21.* This is where we started the rebuilding of the stove. The bottom two rows of tiles were already in place (they were intact and therefore not dismantled). Before laying new bricks the base had to be cleaned and the old mortar removed.

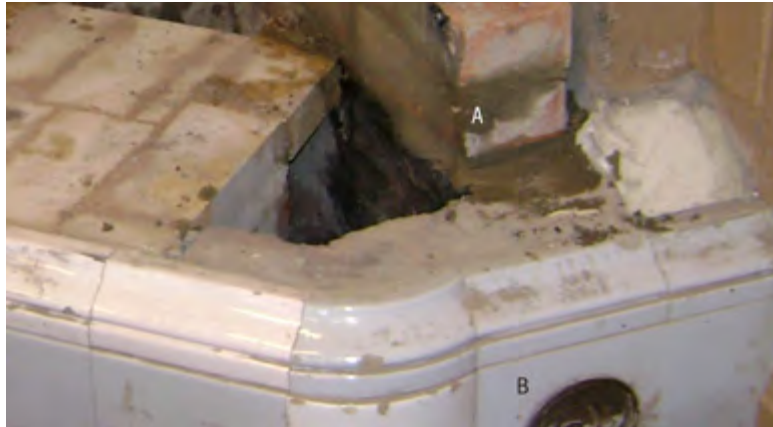
*Figure 2.22.* (A) The bricks are laid with clay mortar and with a 2 cm wide gap between the fire wall and the backside of the stove. (B) At the bottom of each side flue there is an opening with a metal cap. When the chimney (in the back corner of the stove) is swept the soot can be removed through these horizontal flues. The side cannels also join underneath the furnace floor and lead to the chimney in the back.

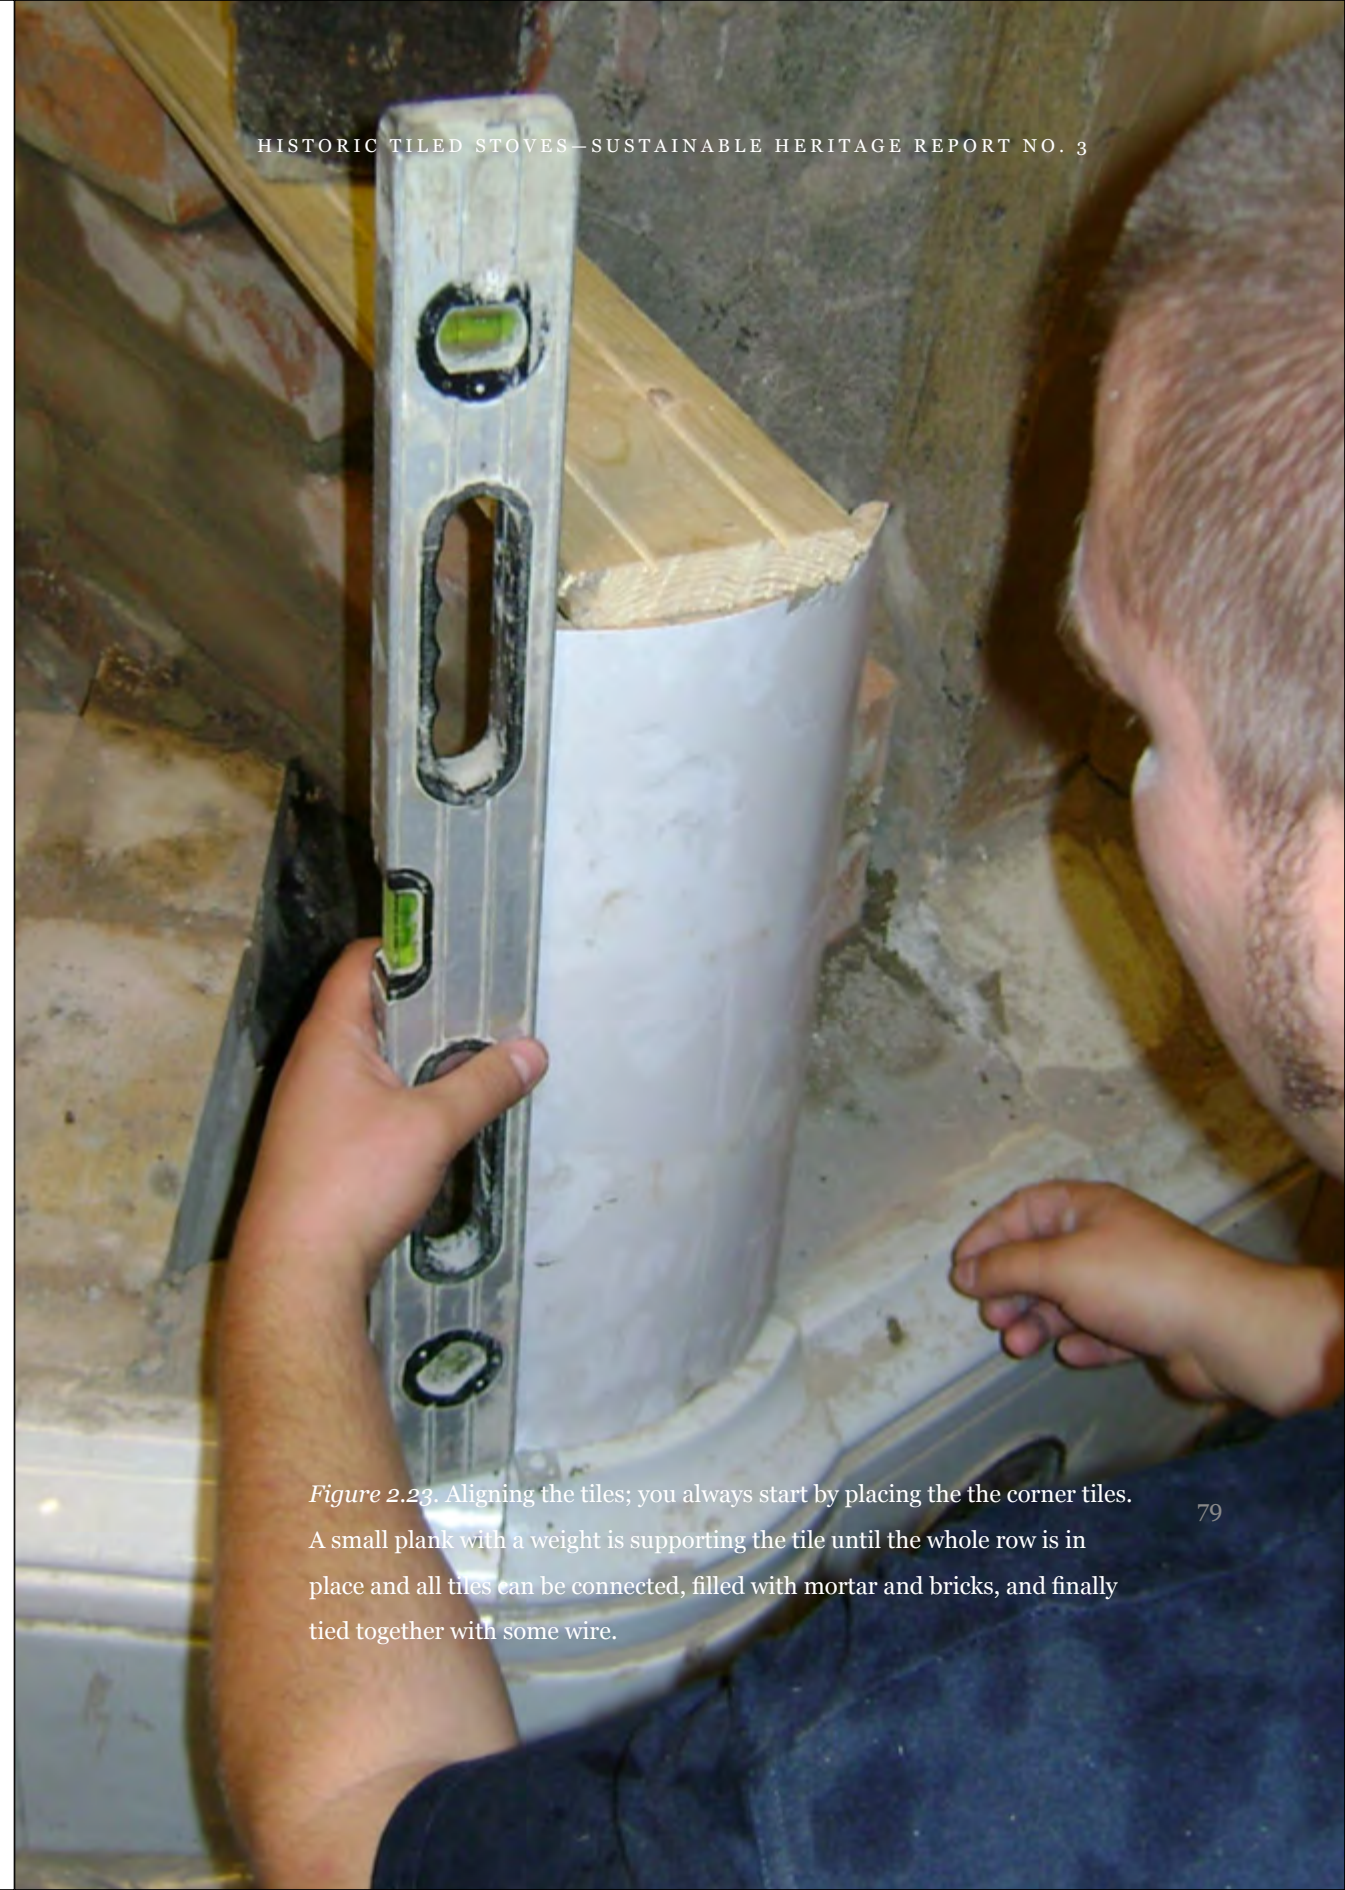
*Figure 2.23.* Aligning the tiles; you always start by placing the the corner tiles. A small plank with a weight is supporting the tile until the whole row is in place and all tiles can be connected, filled with mortar and bricks, and finally tied together with some wire.

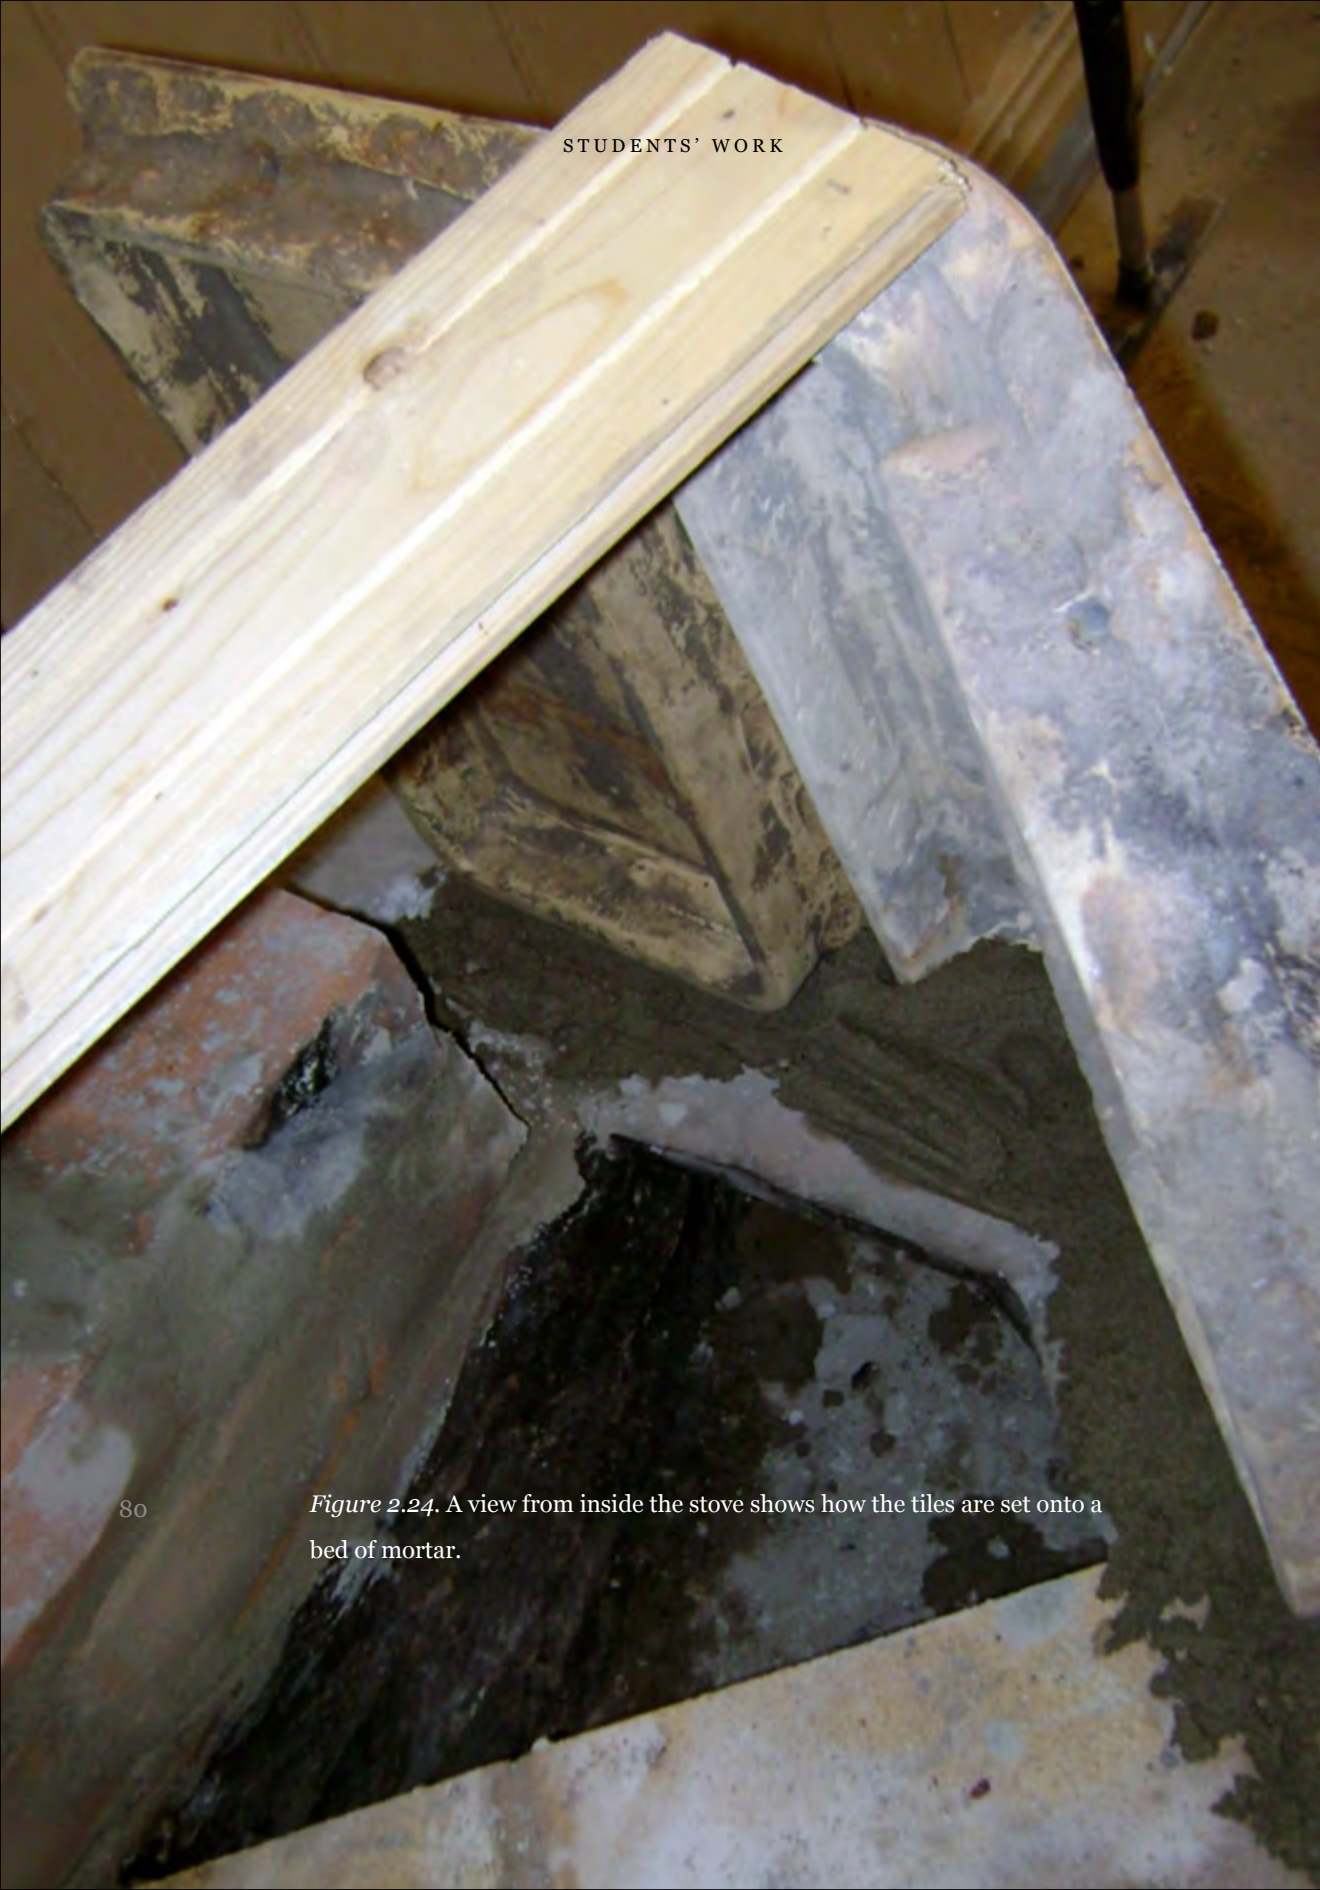
Figure 2.24. A view from inside the stove shows how the tiles are set onto a bed of mortar.

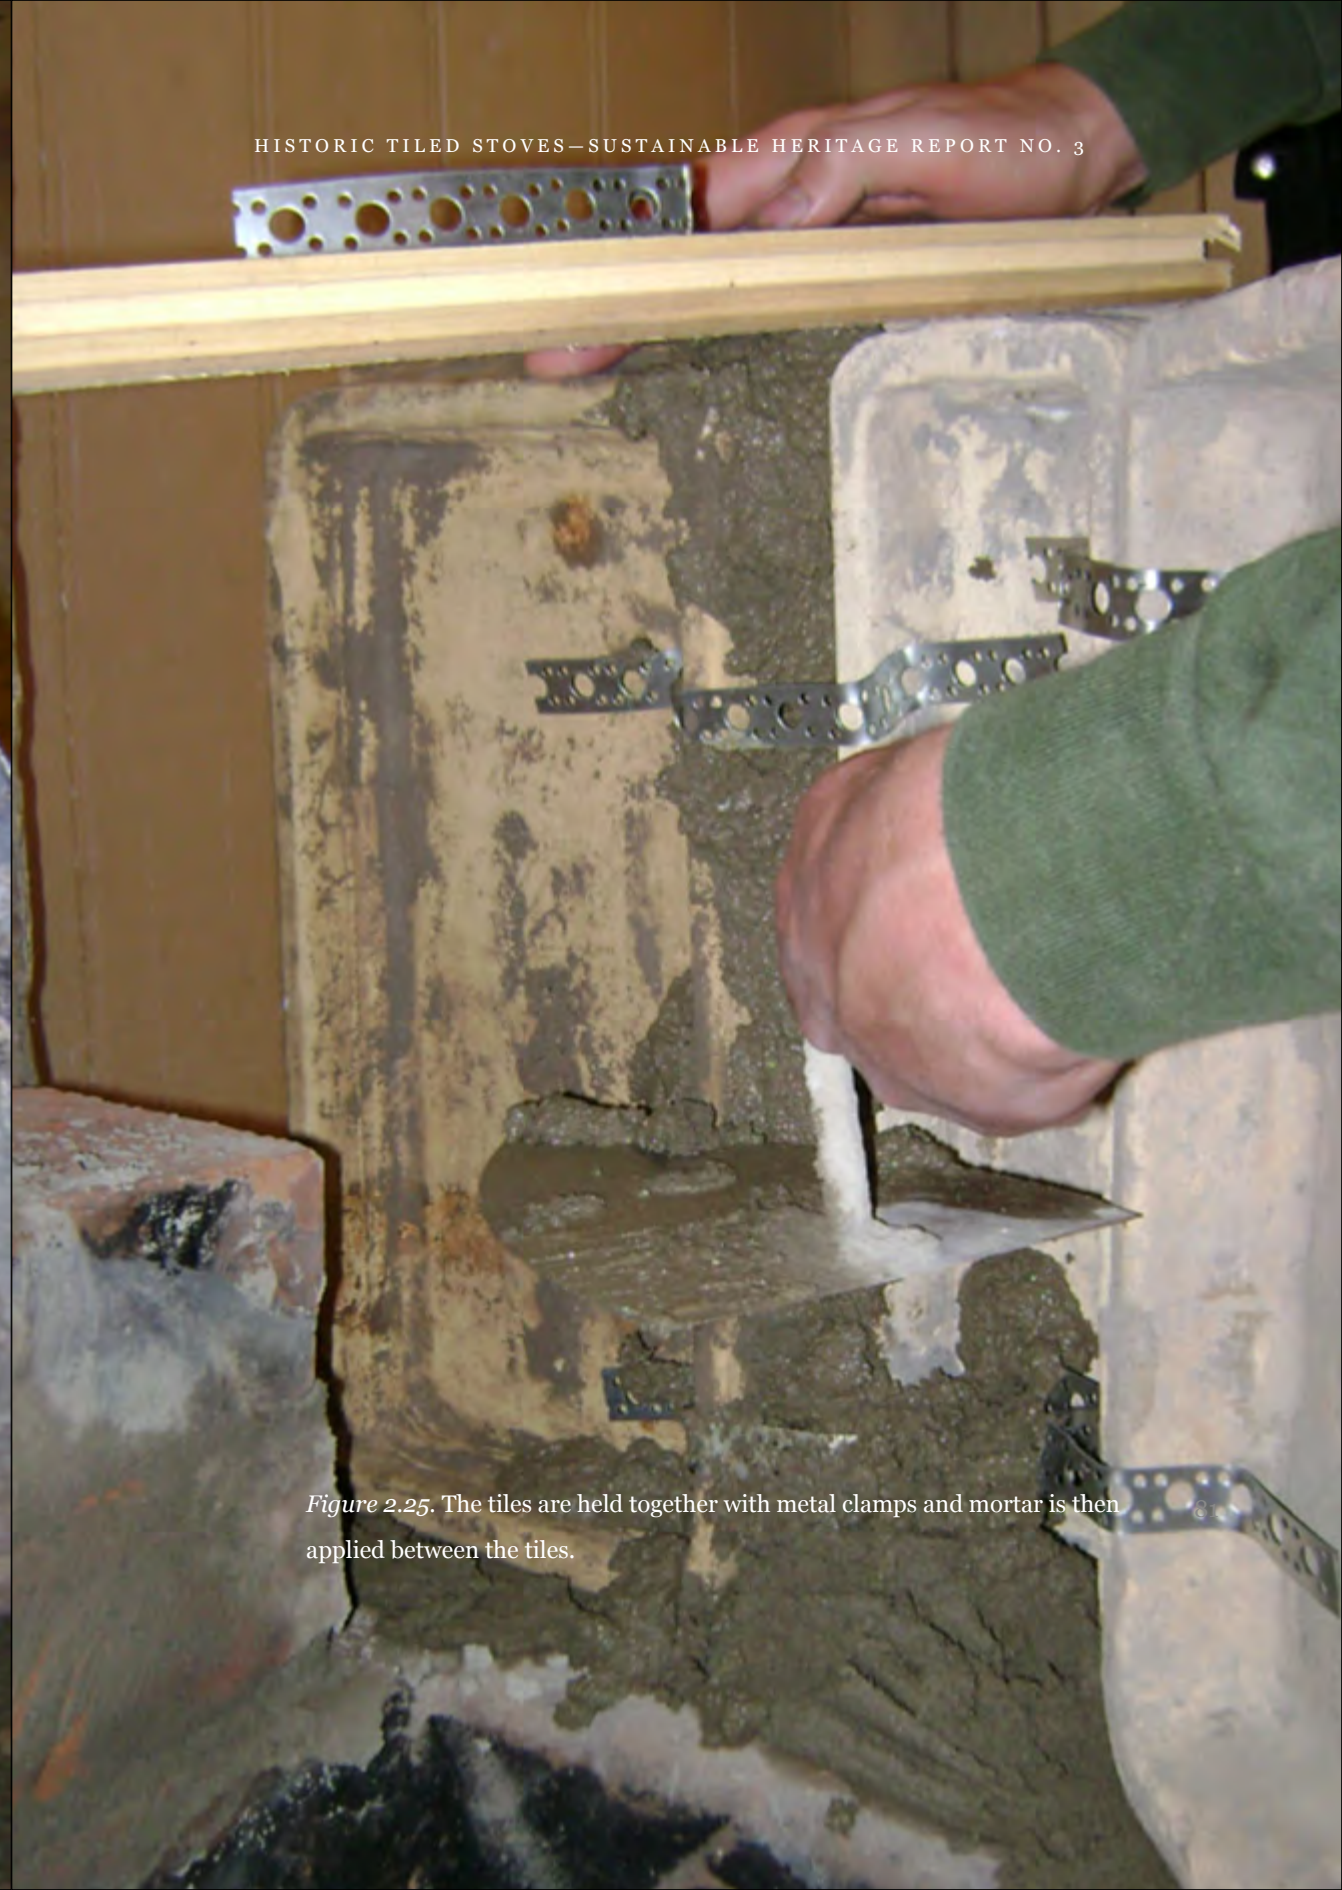
Figure 2.25. The tiles are held together with metal clamps and mortar is then applied between the tiles.

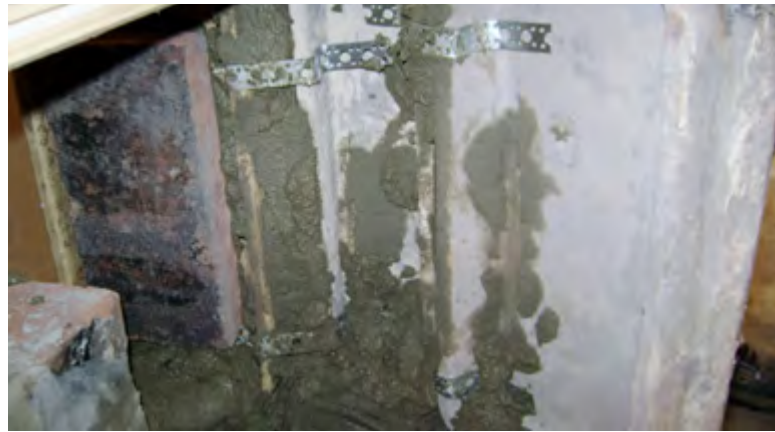
Figure 2.26. The cavity behind each tile is filled with thin bricks and clay mortar.

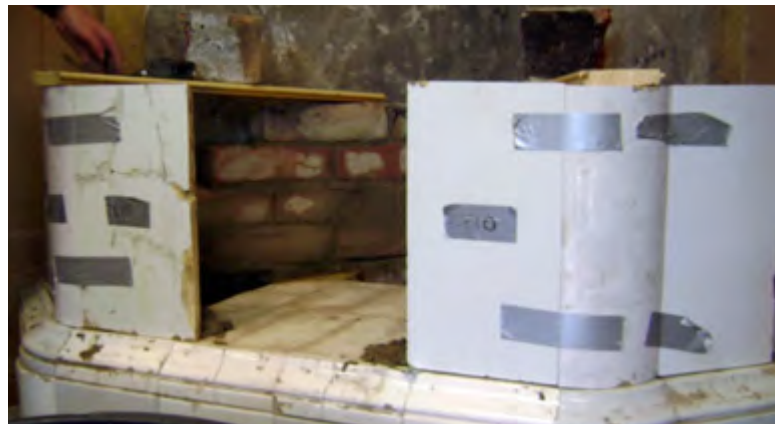
Figure 2.27. Our first row of tiles, marked number 10, is in place. Tape is used to hold the tiles until the mortar has set.

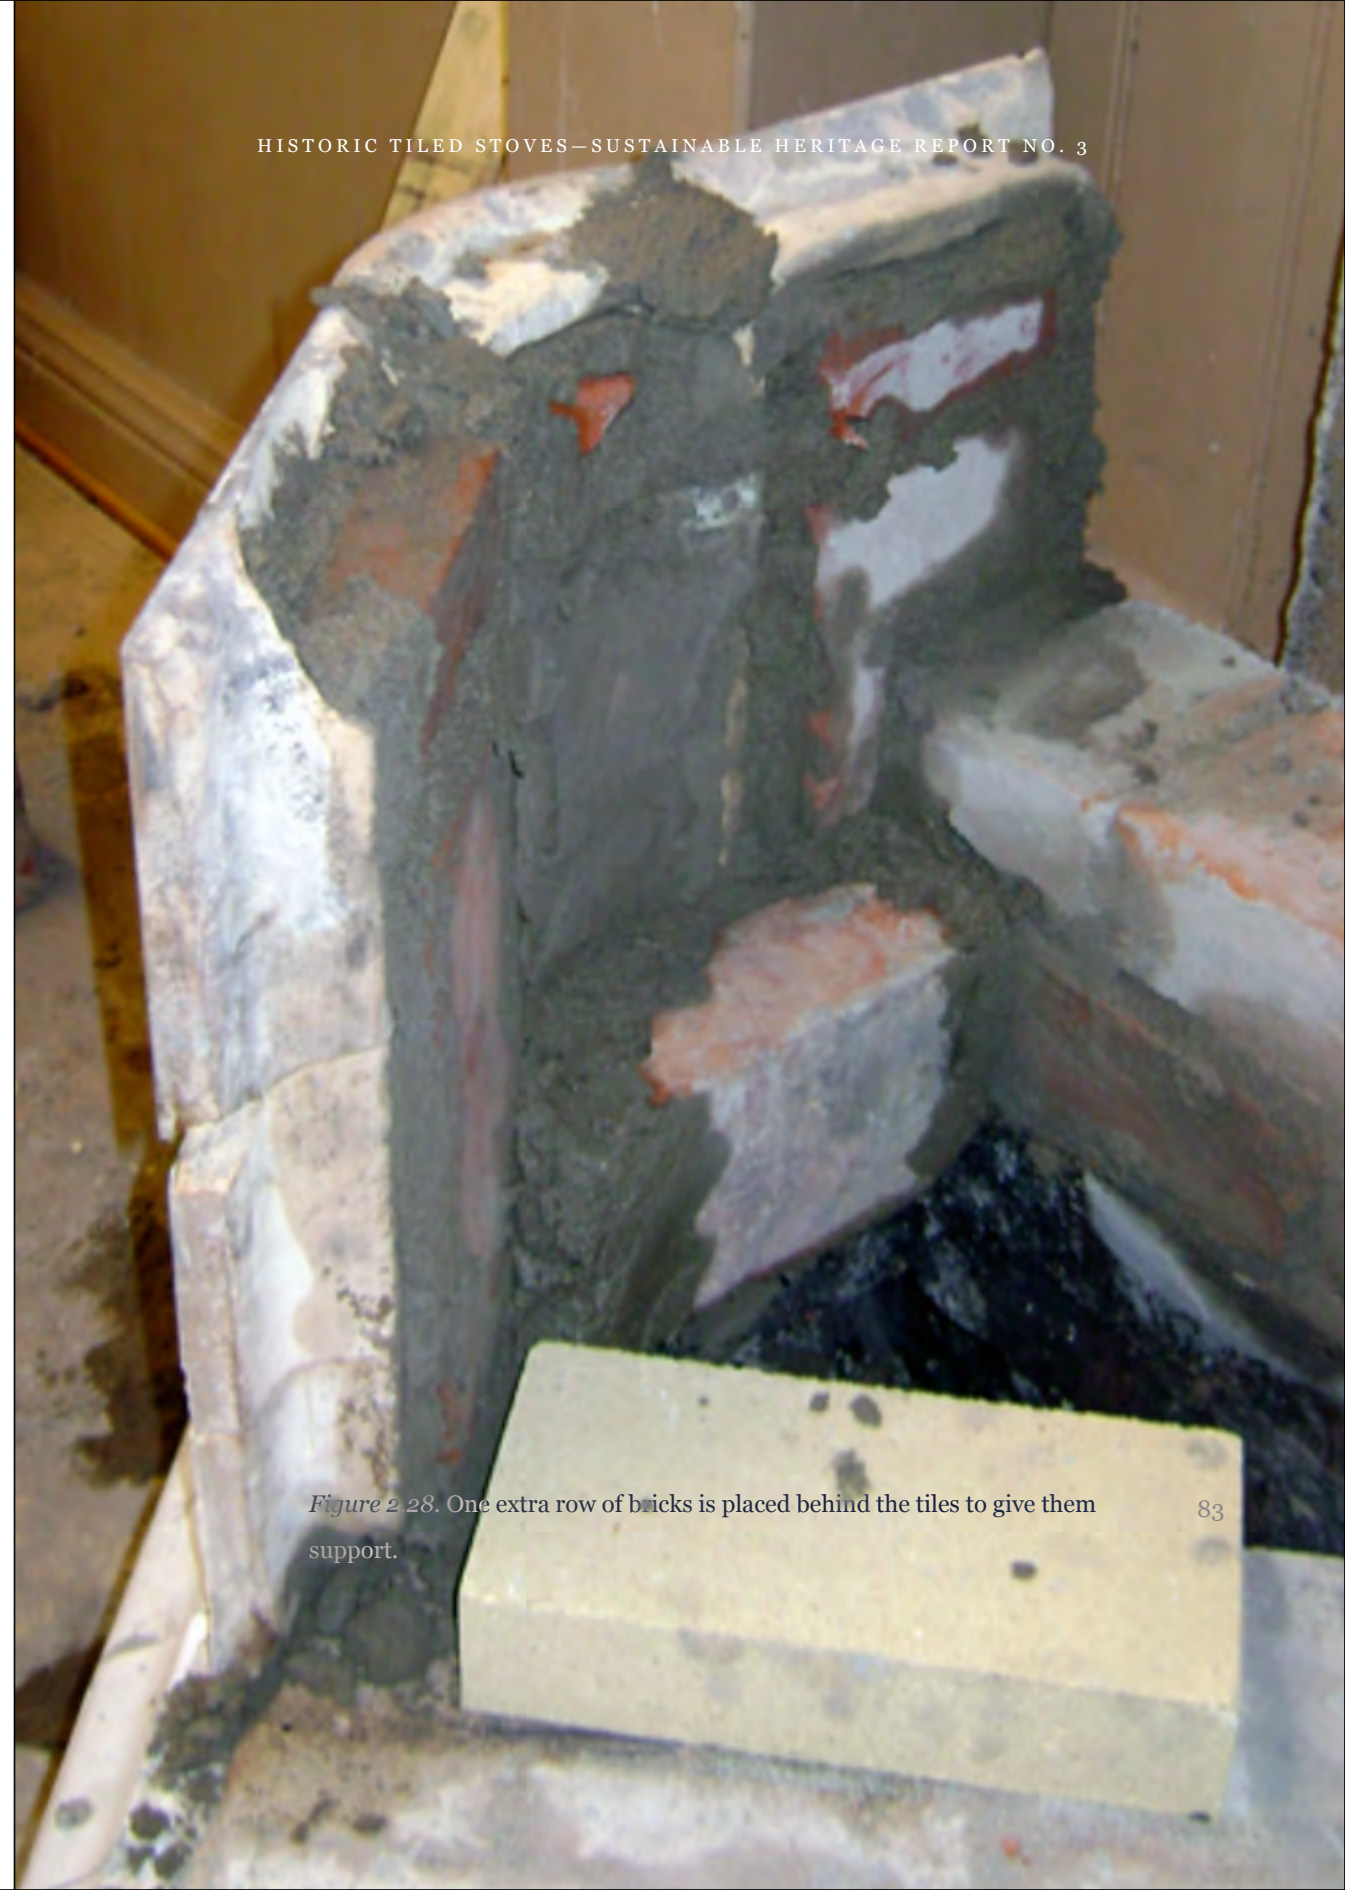
Figure 2.28. One extra row of bricks is placed behind the tiles to give them support.

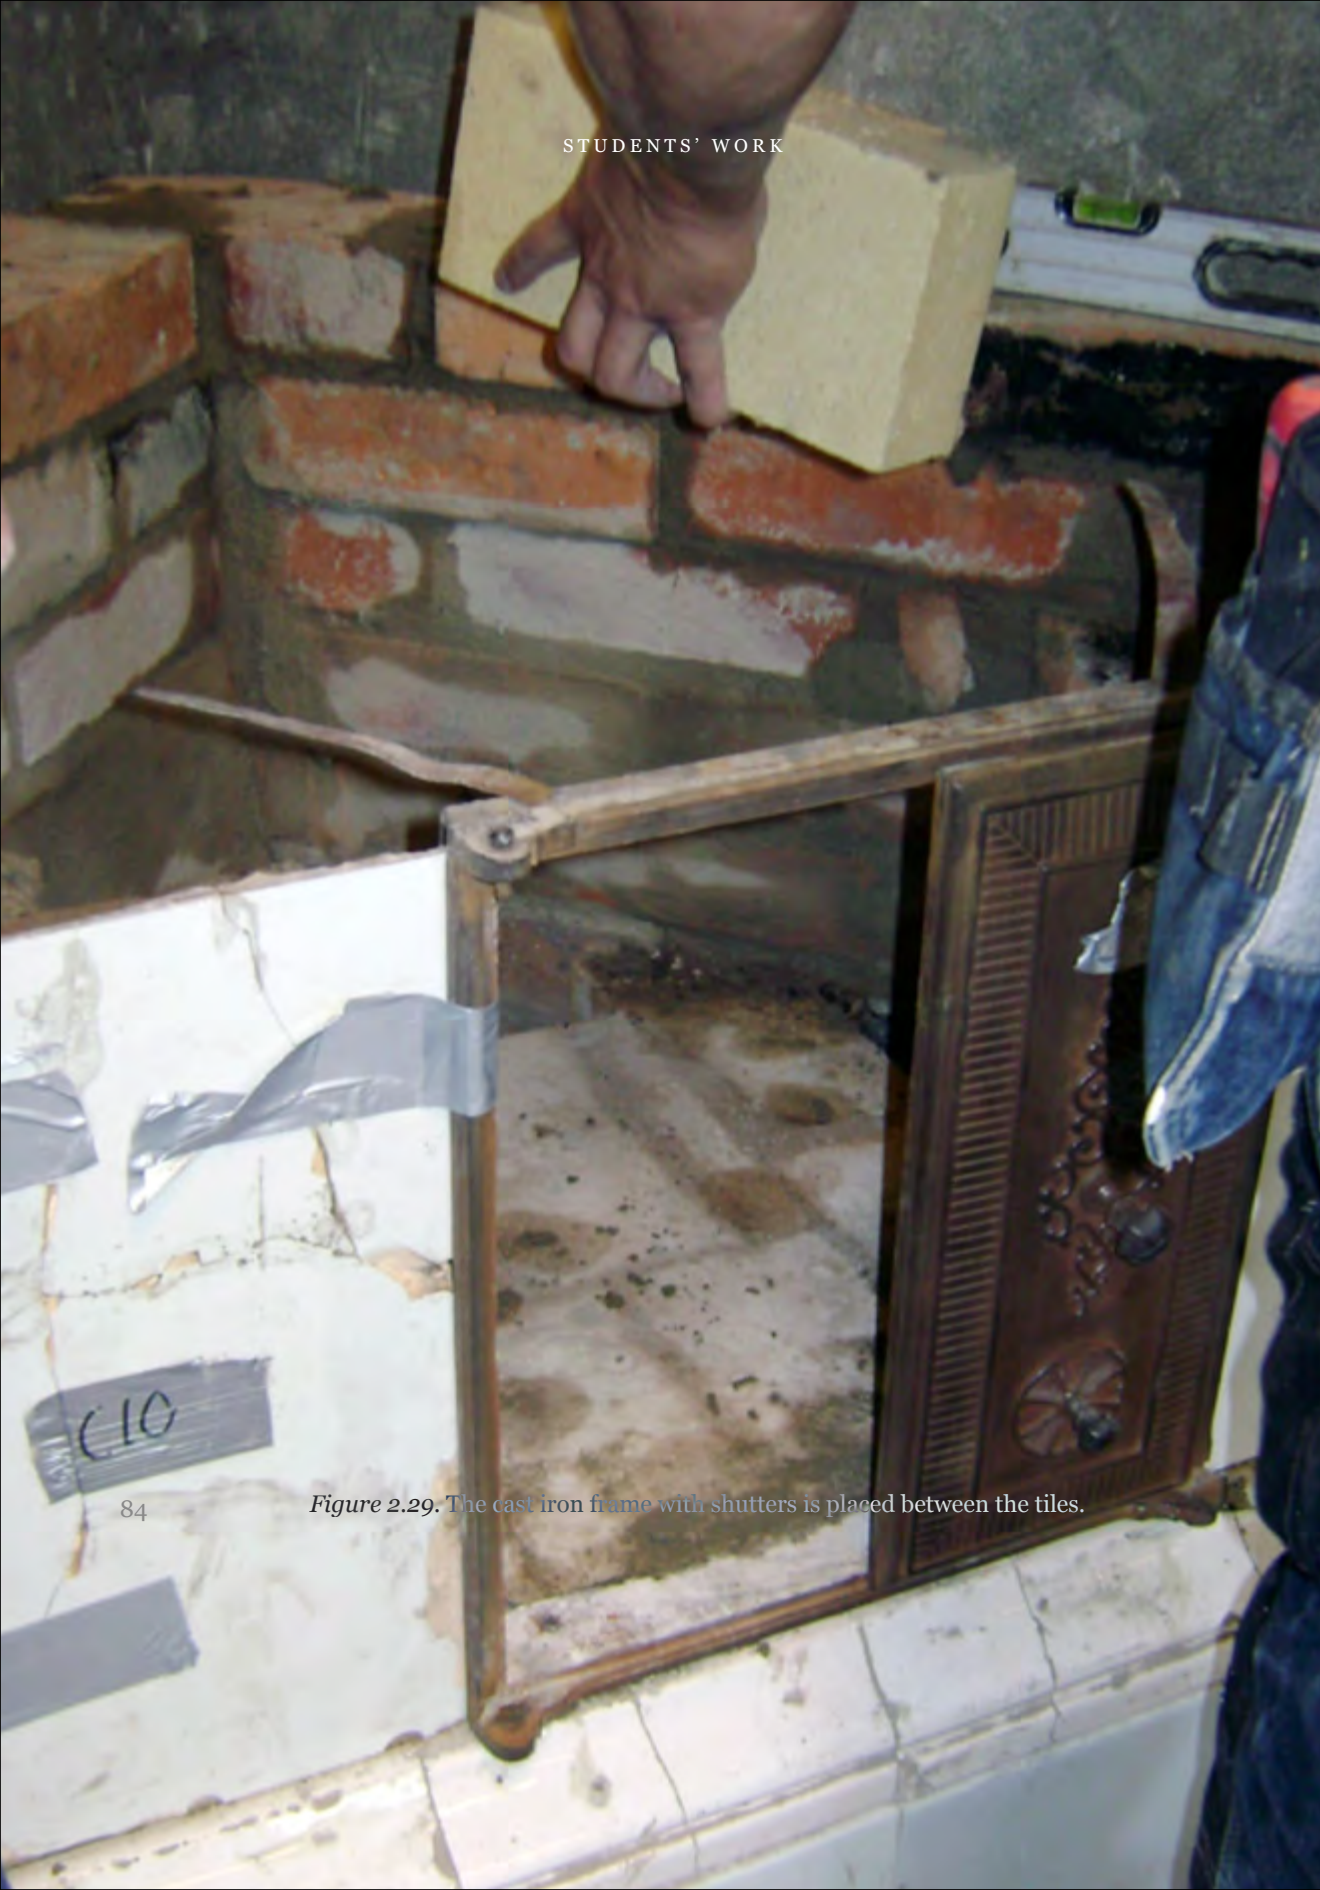
Figure 2.29. The cast iron frame with shutters is placed between the tiles.

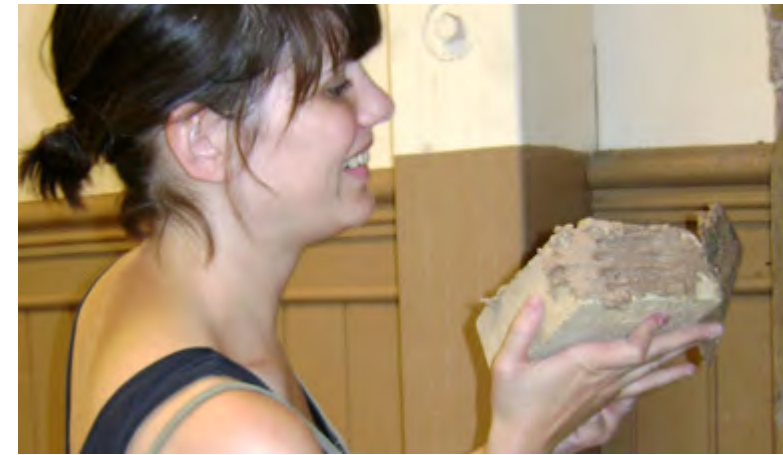
Figure 2.30. The fireproof mortar is applied directly on the fireproof bricks before they are put in place.

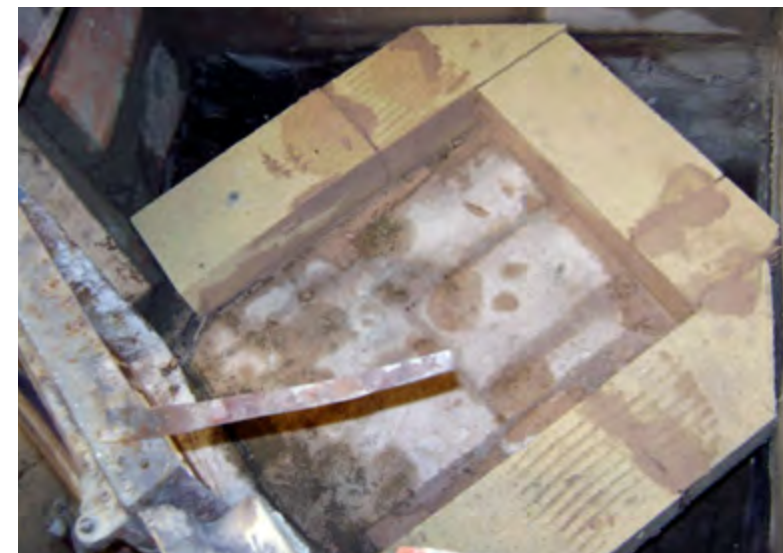
Figure 2.31. Metal straps connected to the cast iron frame are placed in the joints of the brickwork. The furnace is being constructed.

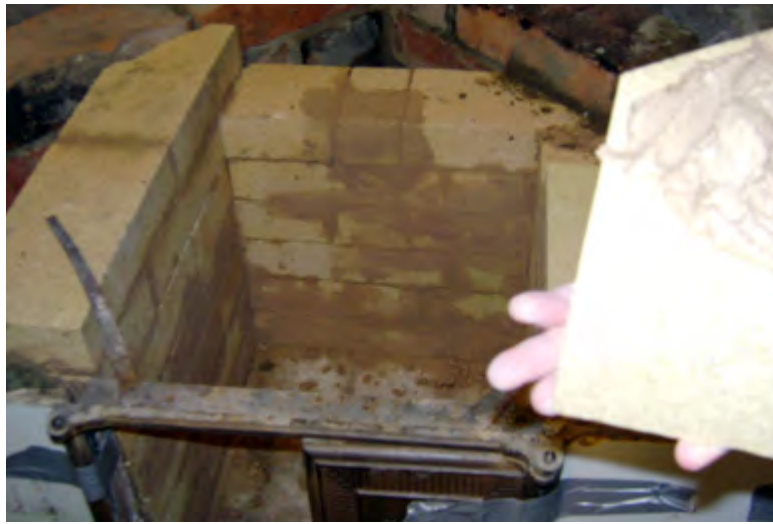
*Figure 2.32.* The fireproof bricks are built to the upper part of the cast iron frame of the shutters.

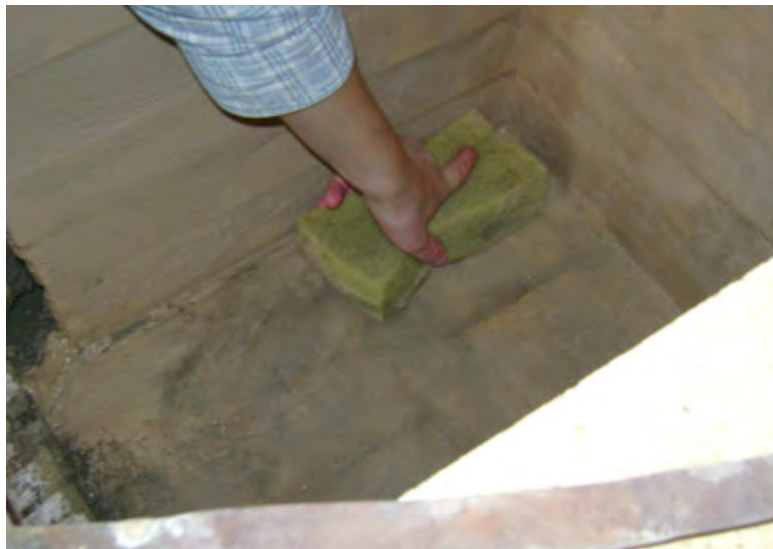
*Figure 2.33.* The bricks and joints are being washed with a moist sponge.

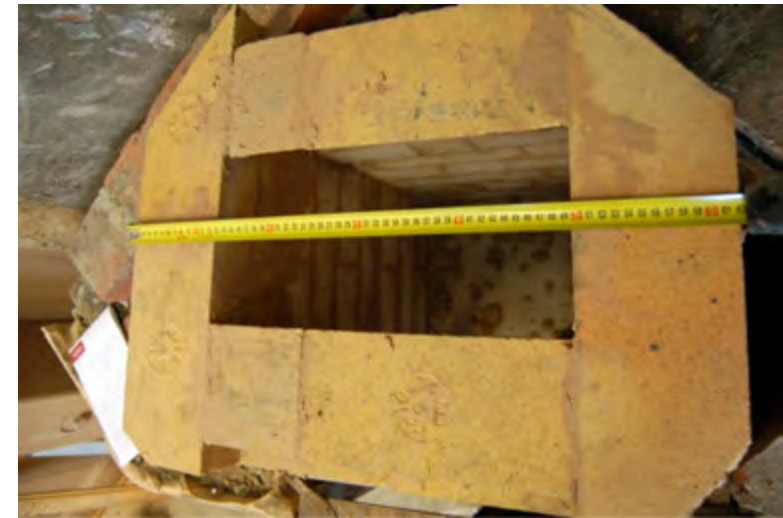
*Figure 2.34.* The middle flue is narrowed at the back and front of the furnace with a row of bricks that have been shaped with an angle grinder. This bottle neck will improve the draught in the flue.
