# Manual for Dismantling, Documenting and Rebuilding Historic Tiled Stoves

**—Sustainable Heritage Report No. 3**

Novia Publications and Productions,  
series S: Student Works, 2/2012

A joint project between Gotland University, Estonian Academy of Arts  
and Novia University of Applied Sciences.

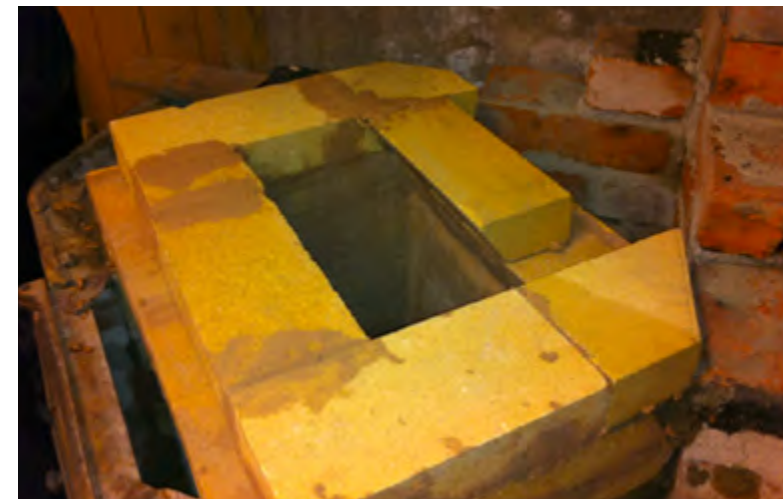
*Figure 2.35.* Side view of the top of the furnace.

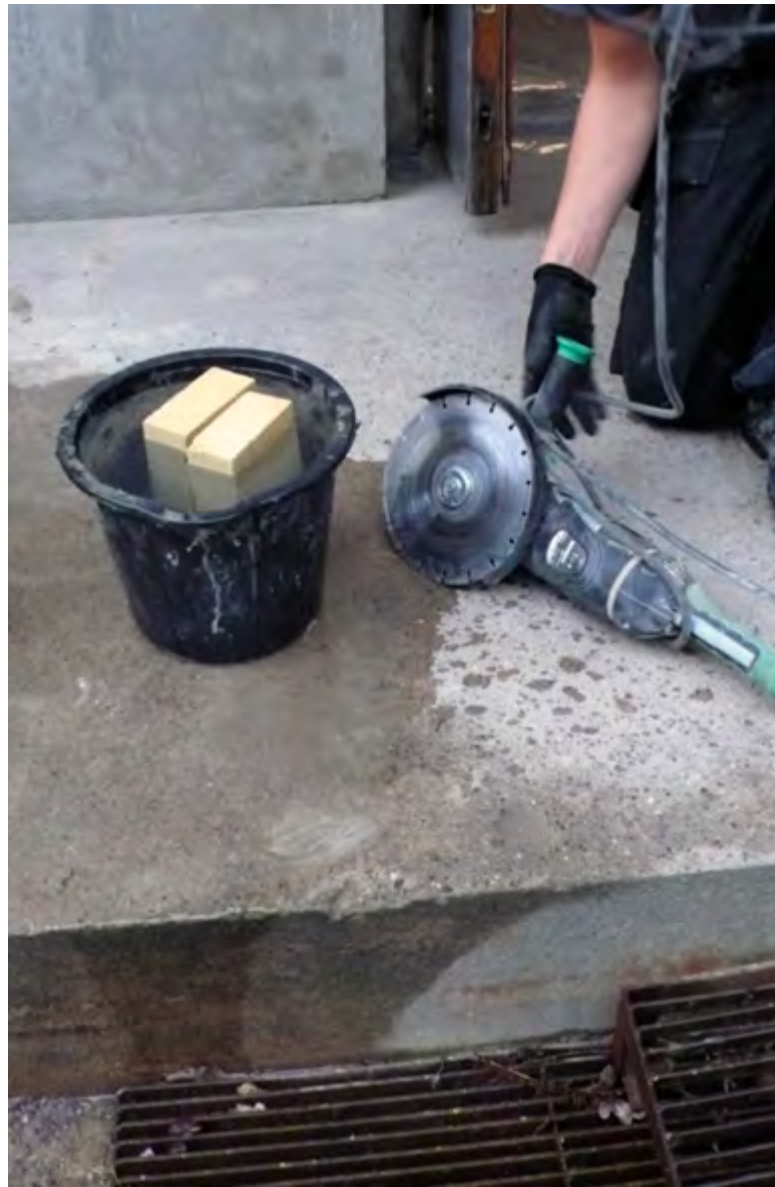
*Figure 2.36.* Before using the angle grinder the fireproof bricks are hydrated to avoid over-heating the blade.

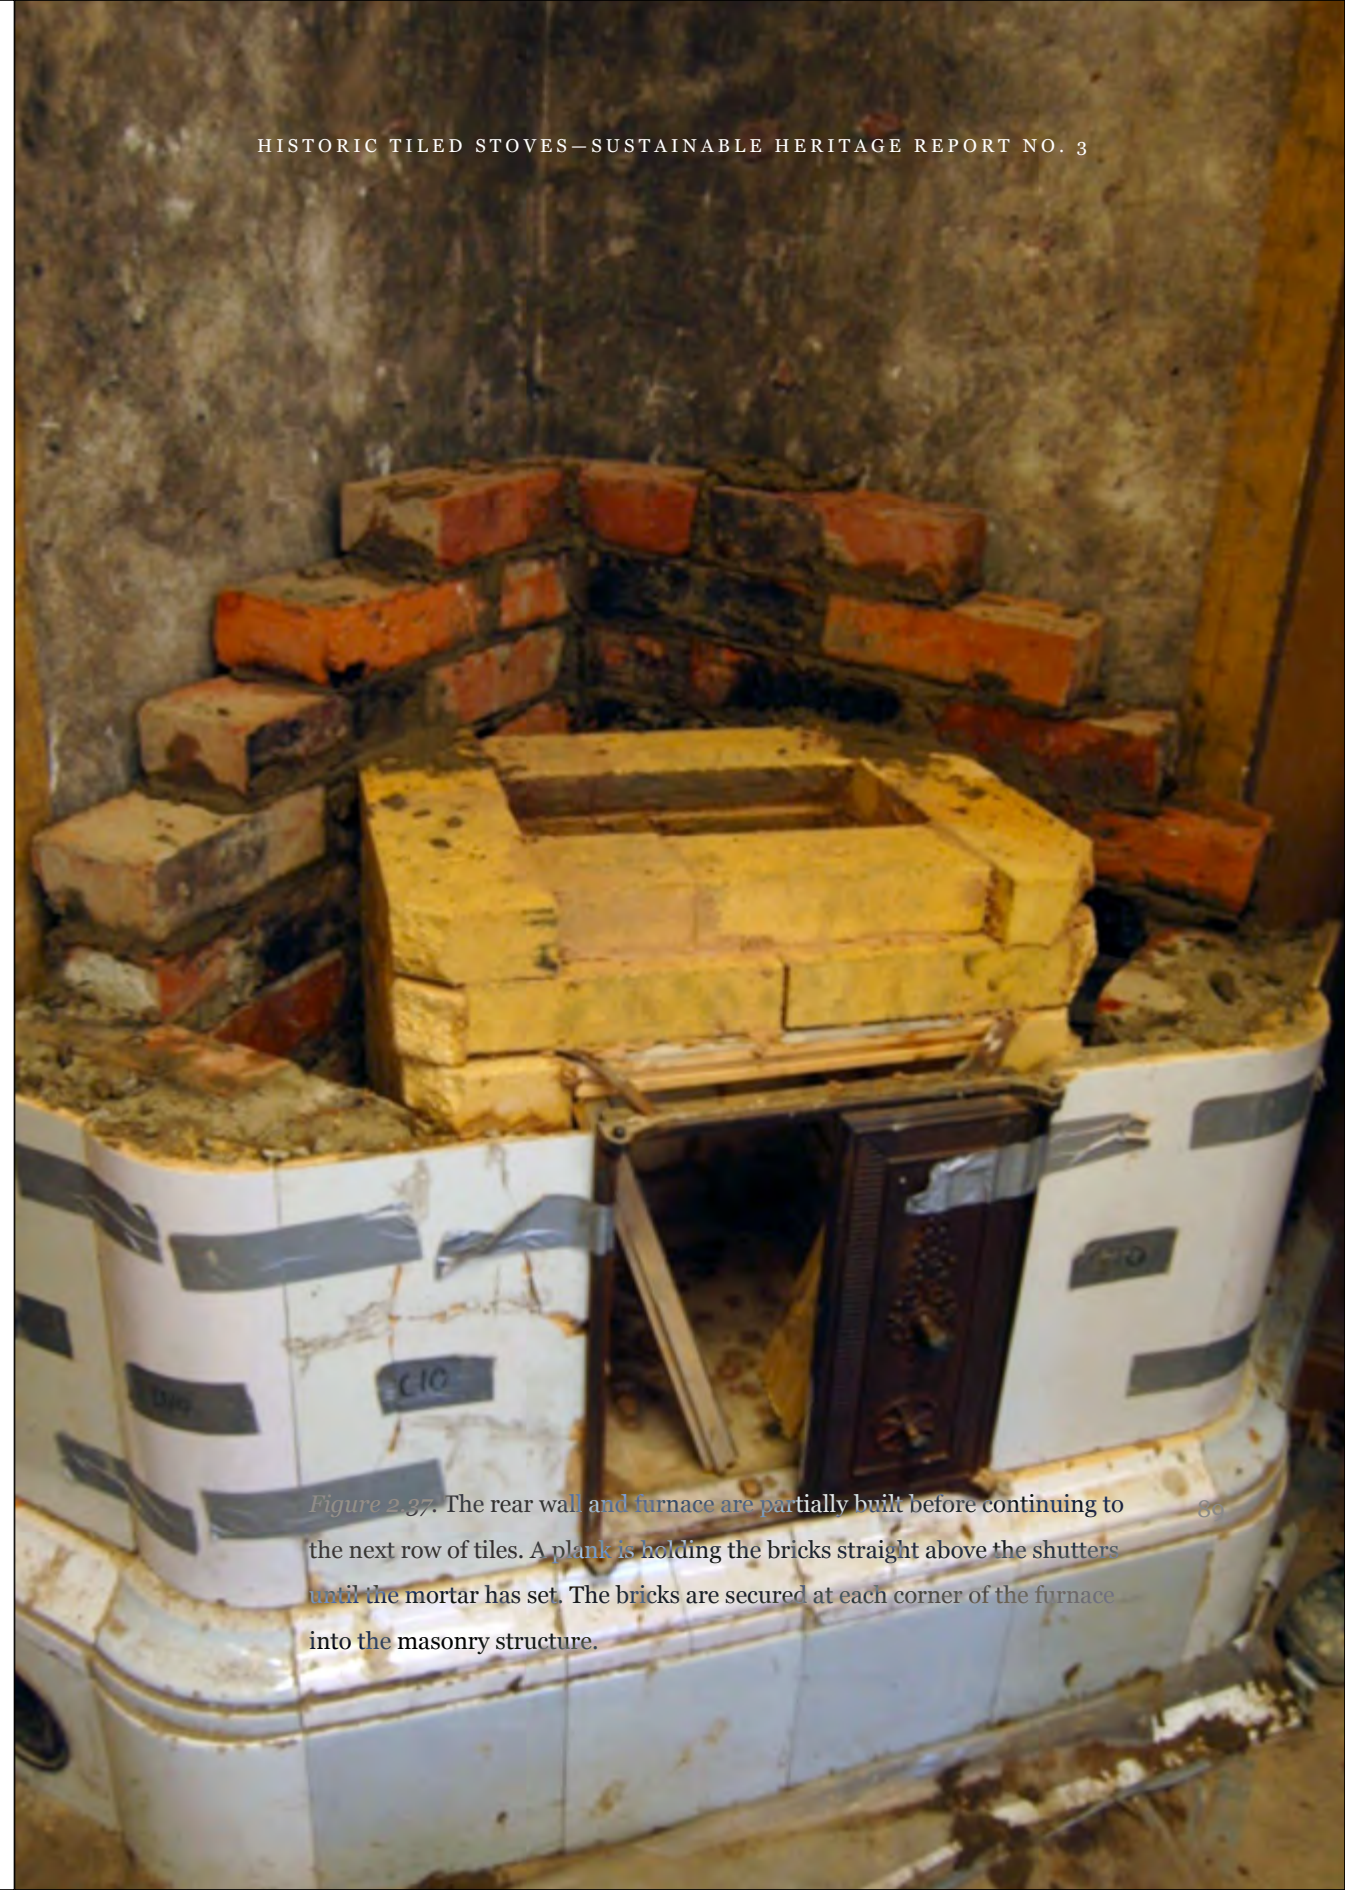
*Figure 2.37.* The rear wall and furnace are partially built before continuing to the next row of tiles. A plank is holding the bricks straight above the shutters until the mortar has set. The bricks are secured at each corner of the furnace into the masonry structure.

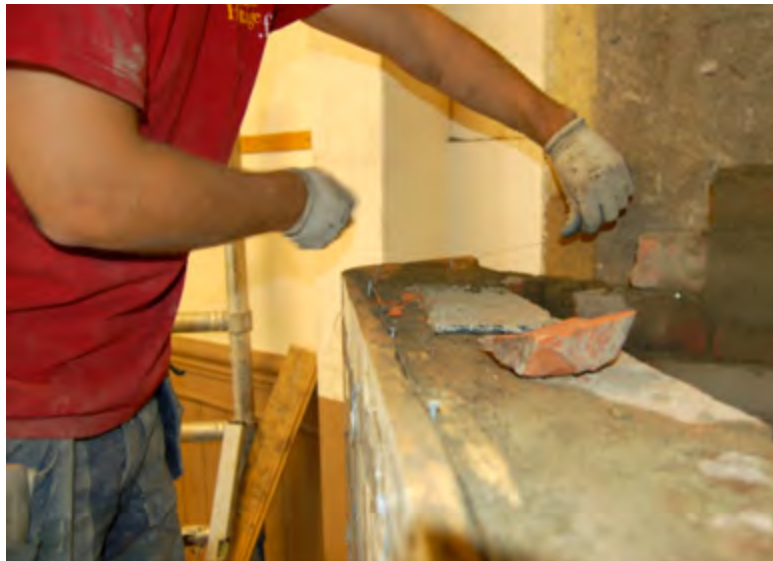
*Figure 2.38.* Nails are inserted into the existing holes in the flanges of each tile and tied together with a baling wire which is fastened in the joints of the rear brick course.

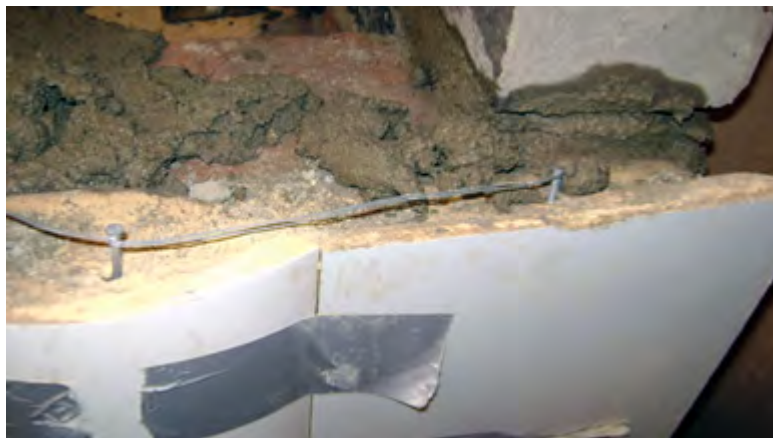
*Figure 2.39.* Nails and wire in detail.

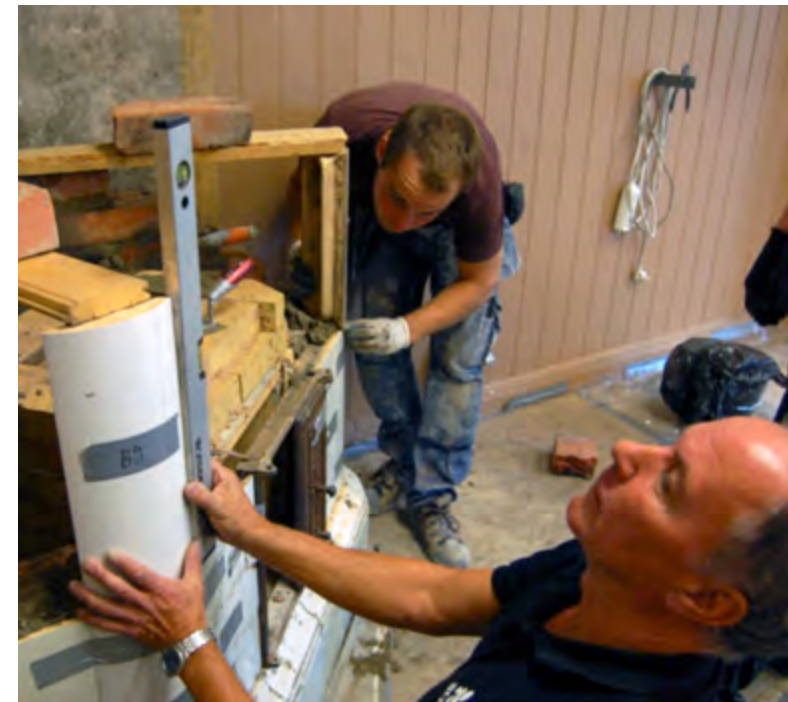
*Figure 2.40.* The corner tiles of tile row 9 are aligned with spirit levels. A small amount of mortar is placed beneath them before they are put in place. Master mason Krister Lindroos (*in the front*) assists with the difficult parts.

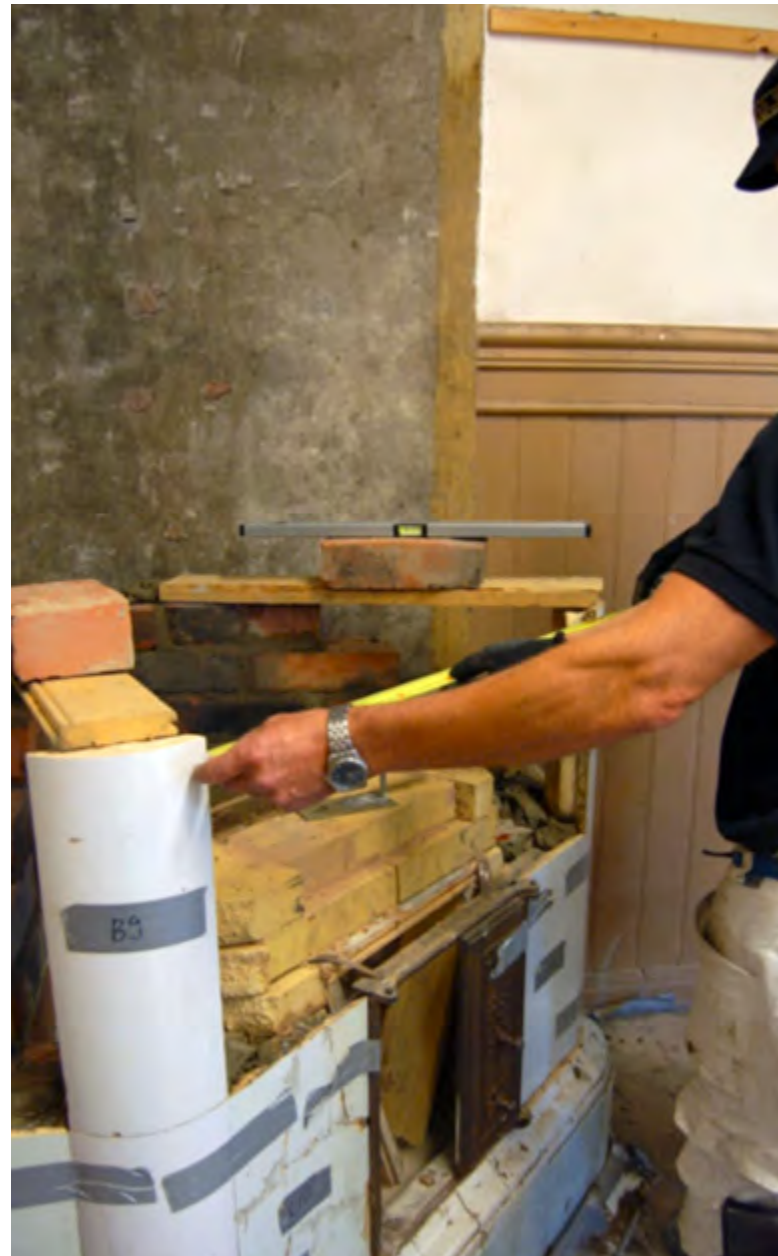
*Figure 2.41.* When both corner-tiles are in place the distance is double-checked to insure that the centre tiles will fit.

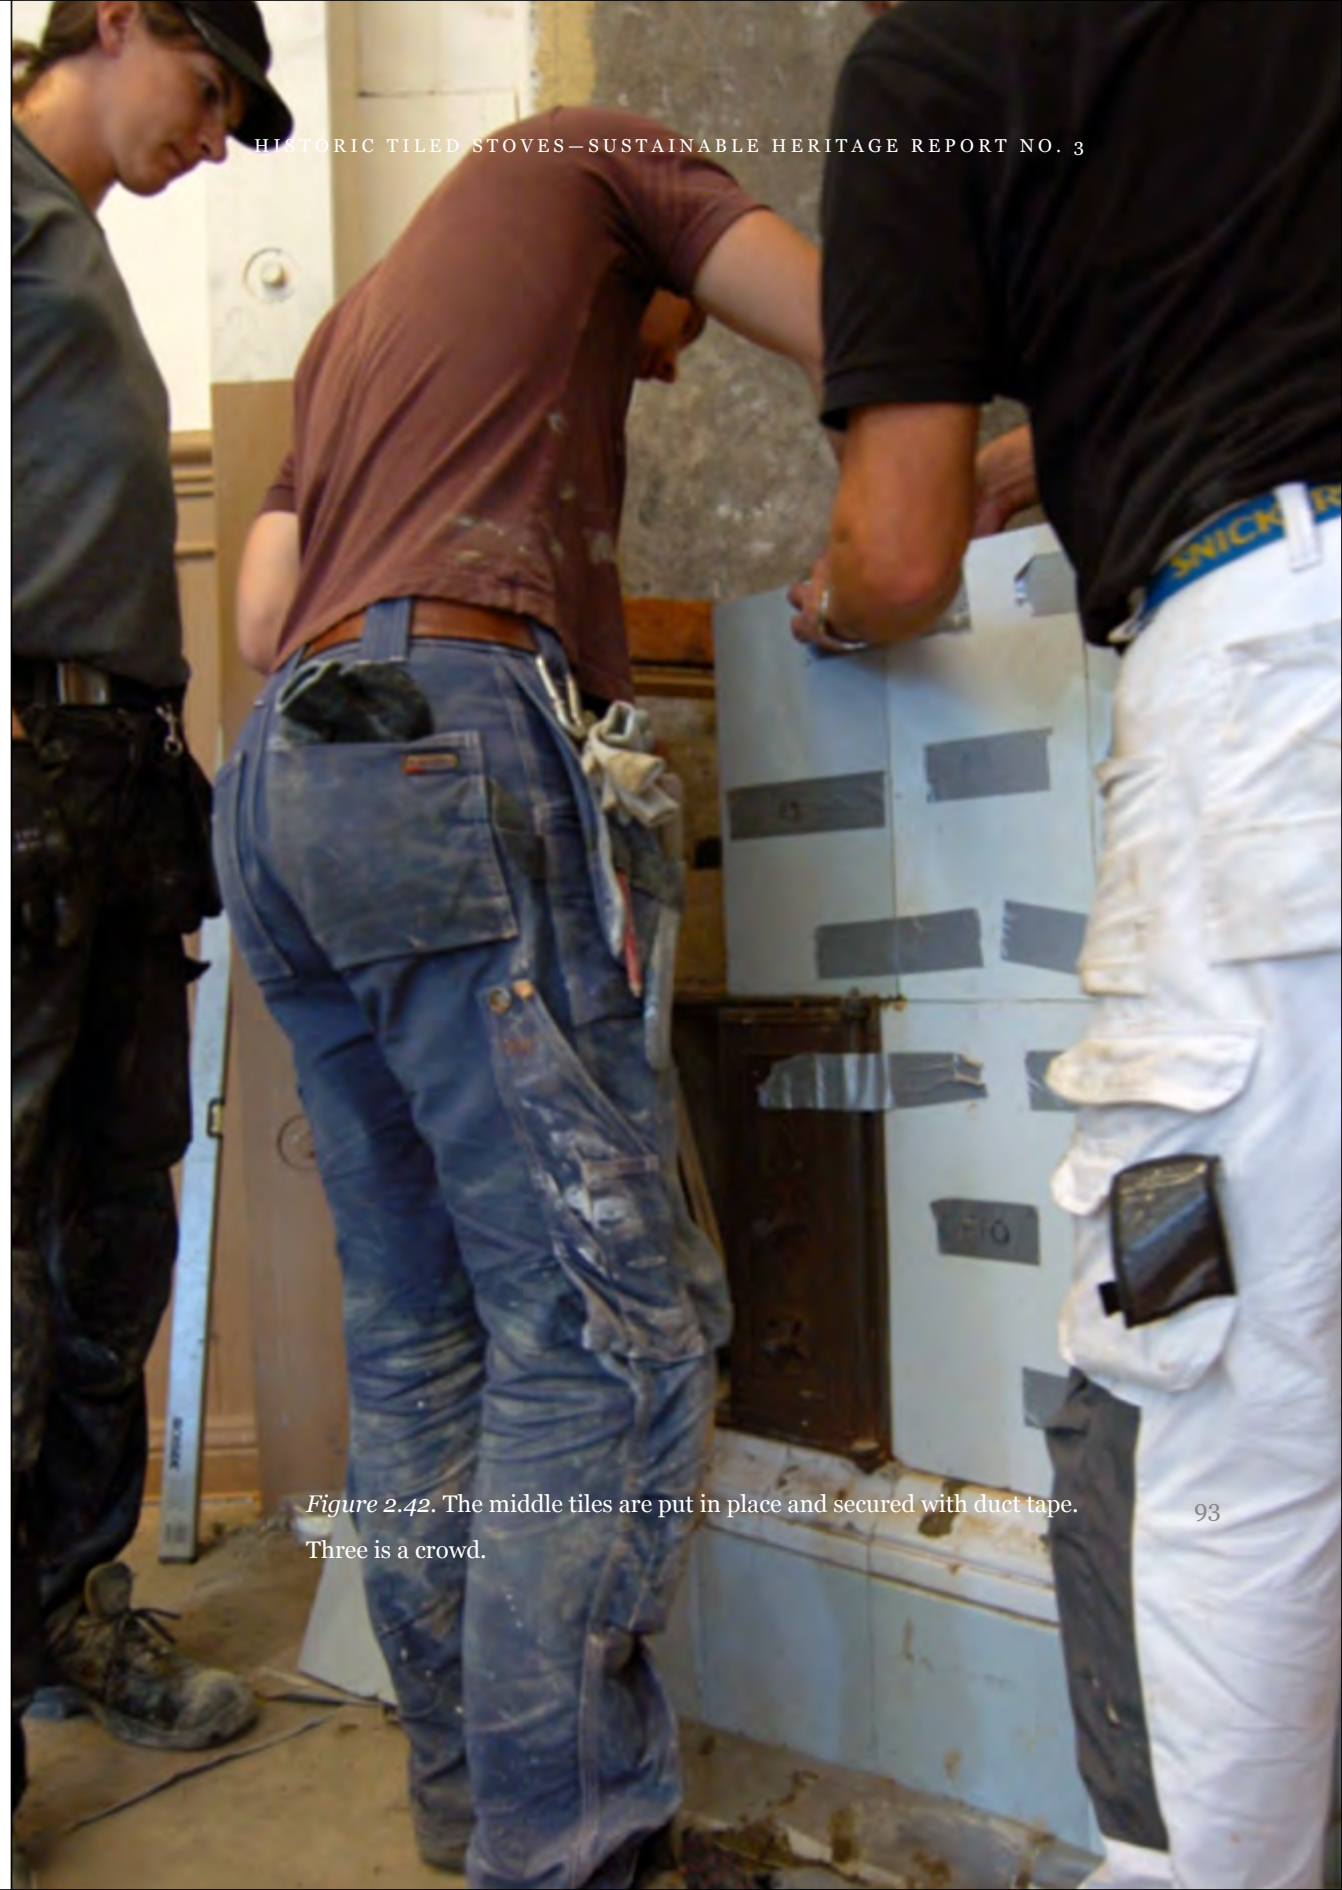
*Figure 2.42.* The middle tiles are put in place and secured with duct tape. Three is a crowd.

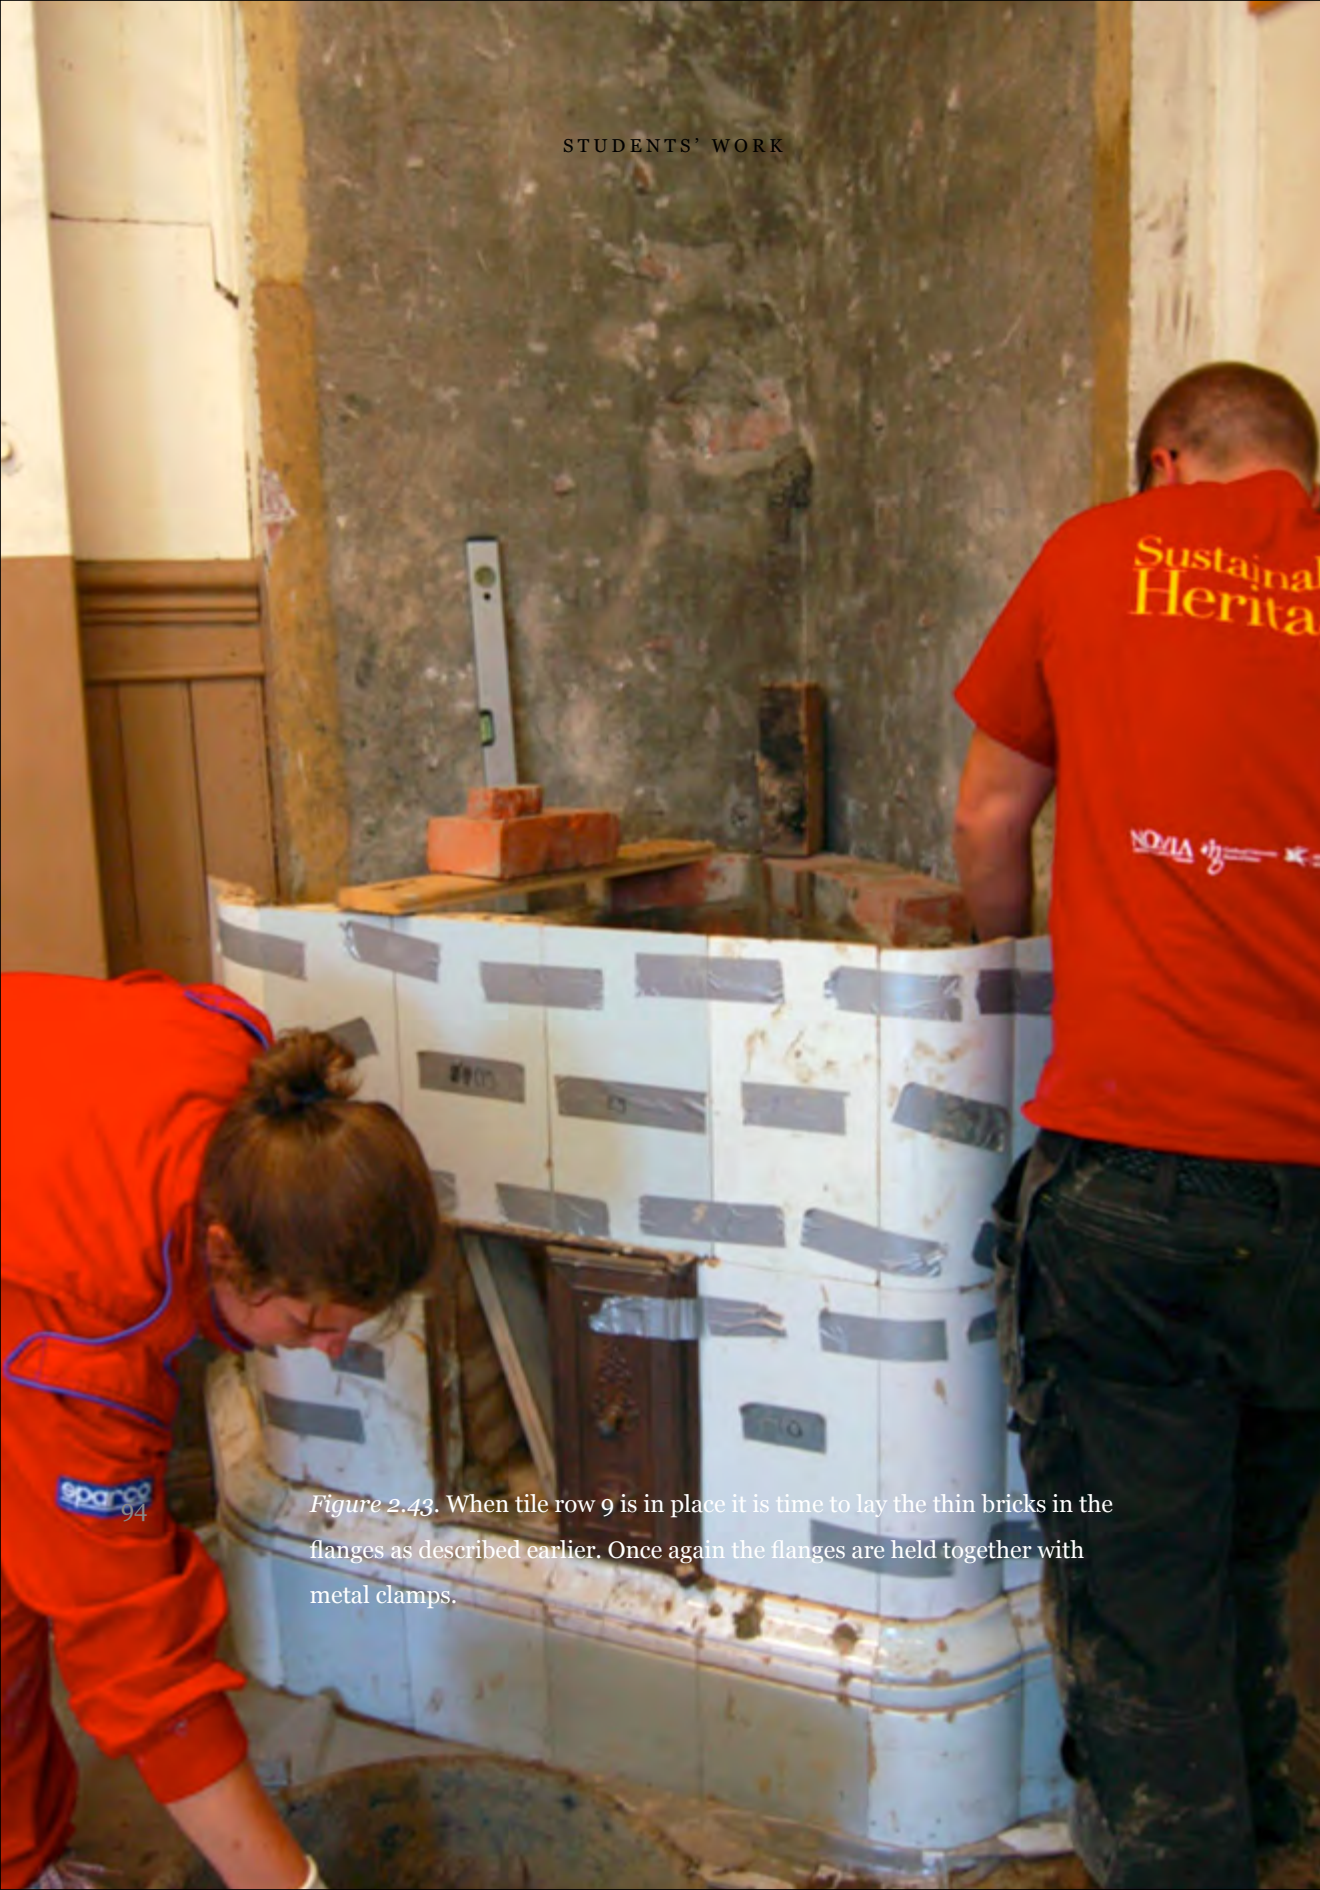
Figure 2.43. When tile row 9 is in place it is time to lay the thin bricks in the flanges as described earlier. Once again the flanges are held together with metal clamps.

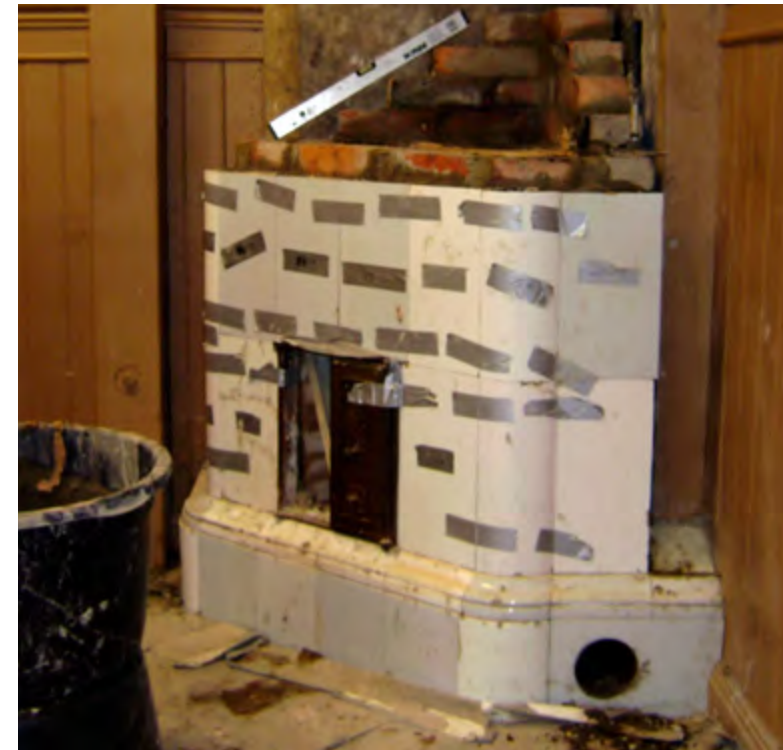
Figure 2.44. The rear brick wall and the front course is laid.

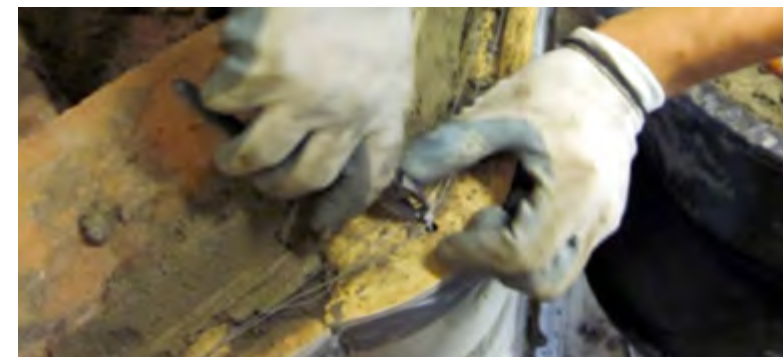
Figure 2.45. The baling wire is attached to the new nails.

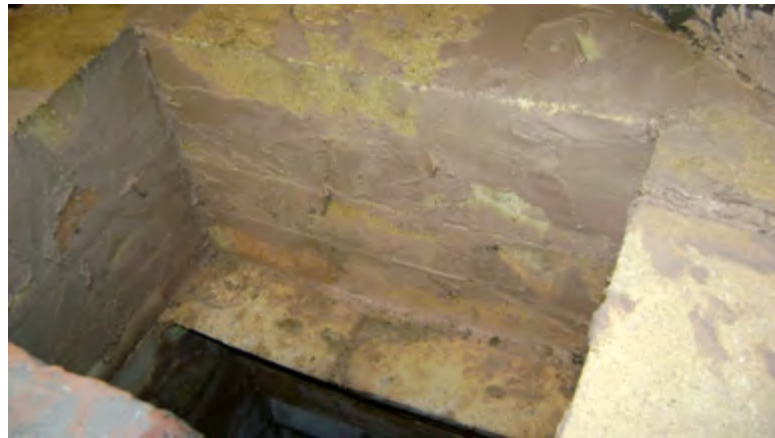
Figure 2.46. The bottle neck forms a shelf above the furnace.

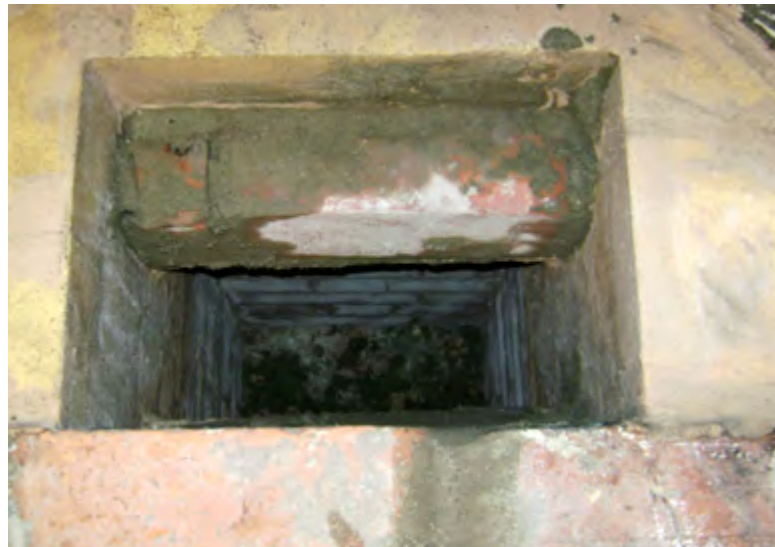
Figure 2.47. Behind tile row 8 the angle of the bottle neck of the middle flue has to be compensated in depth with approximately 50 mm of brick.

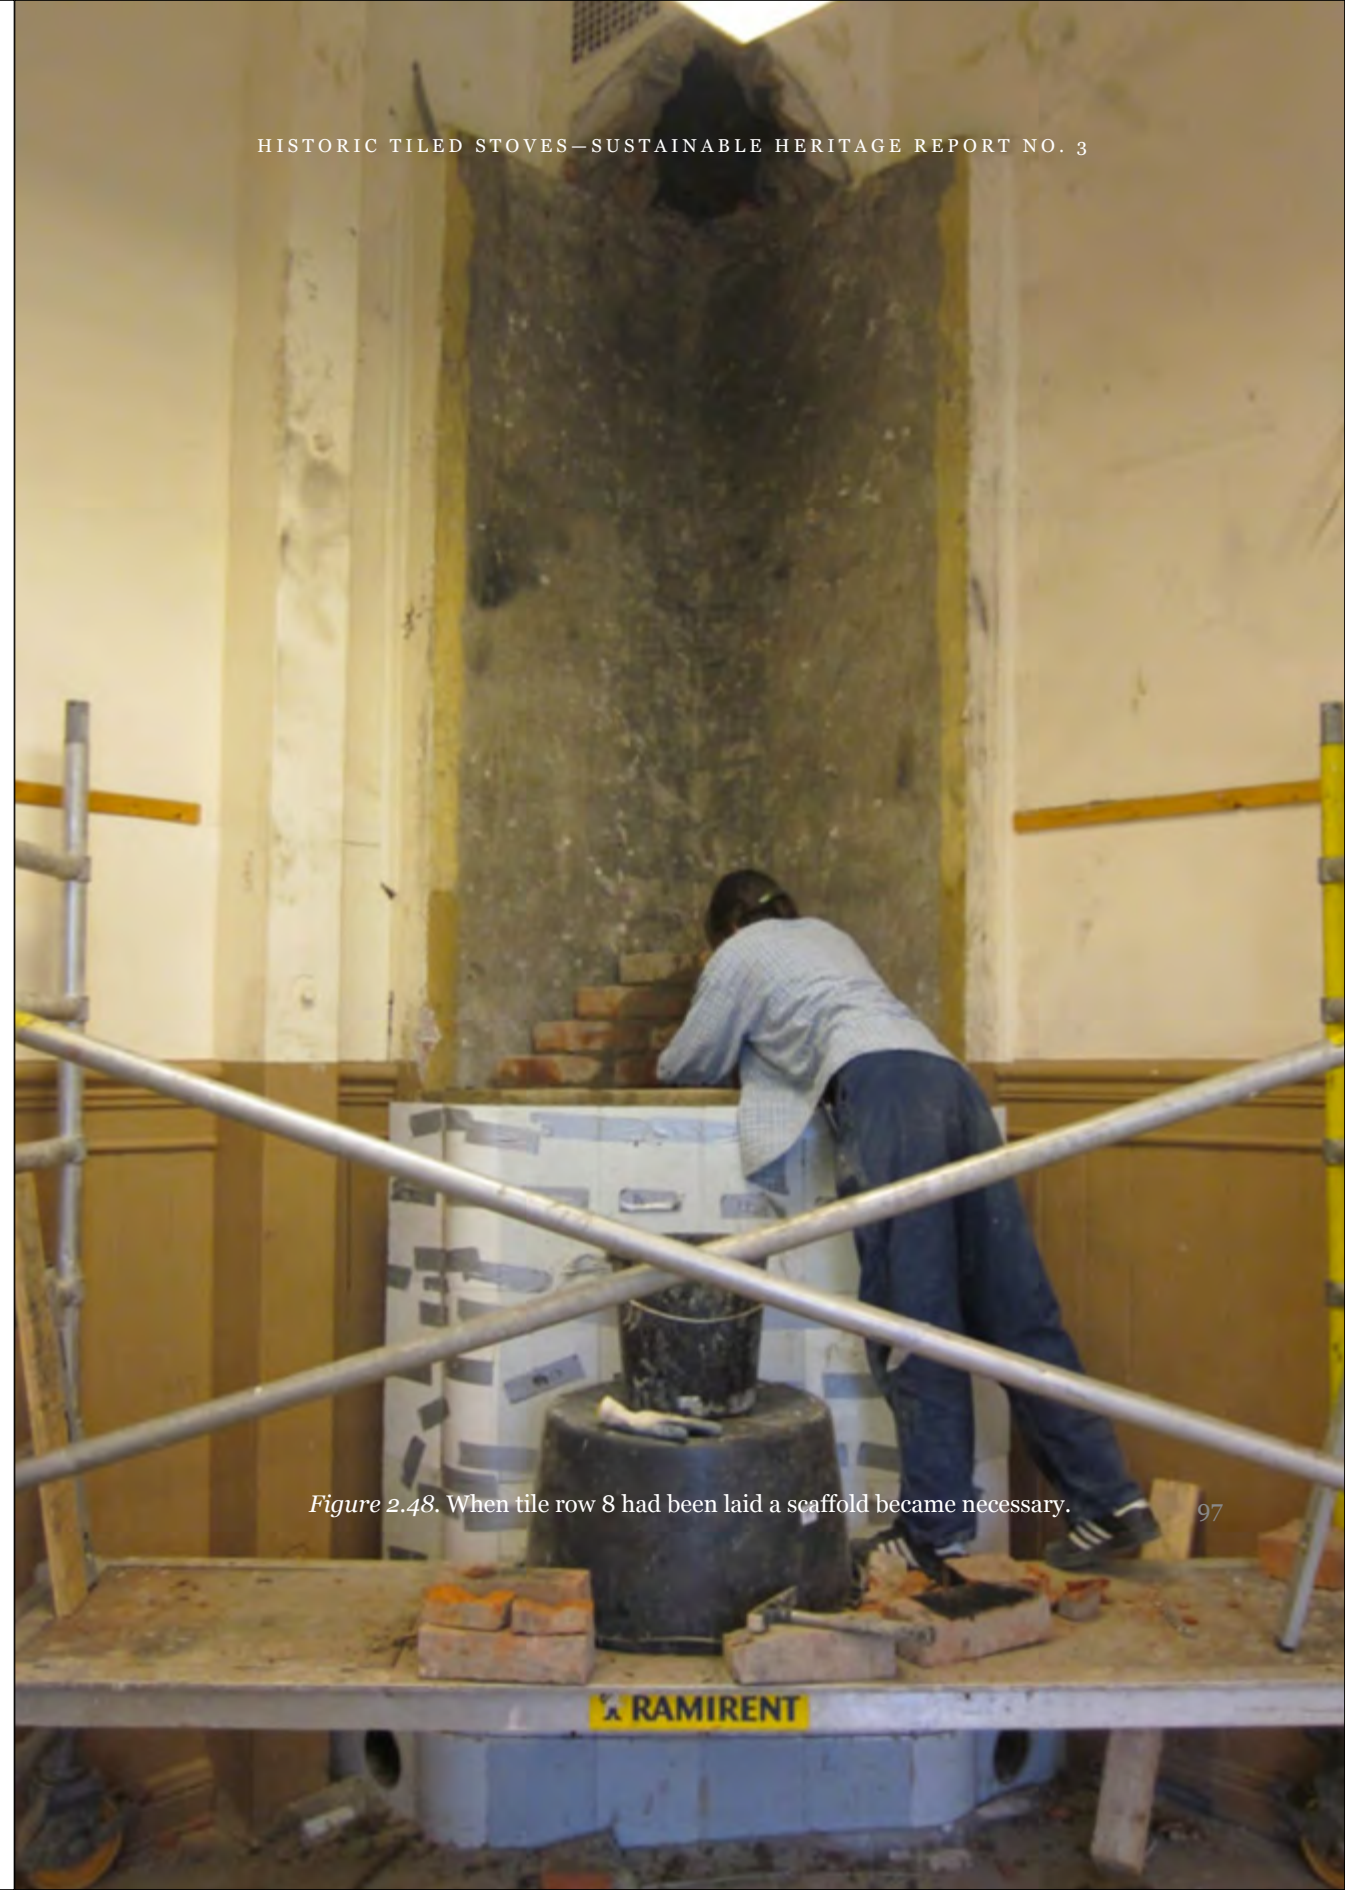
Figure 2.48. When tile row 8 had been laid a scaffold became necessary.

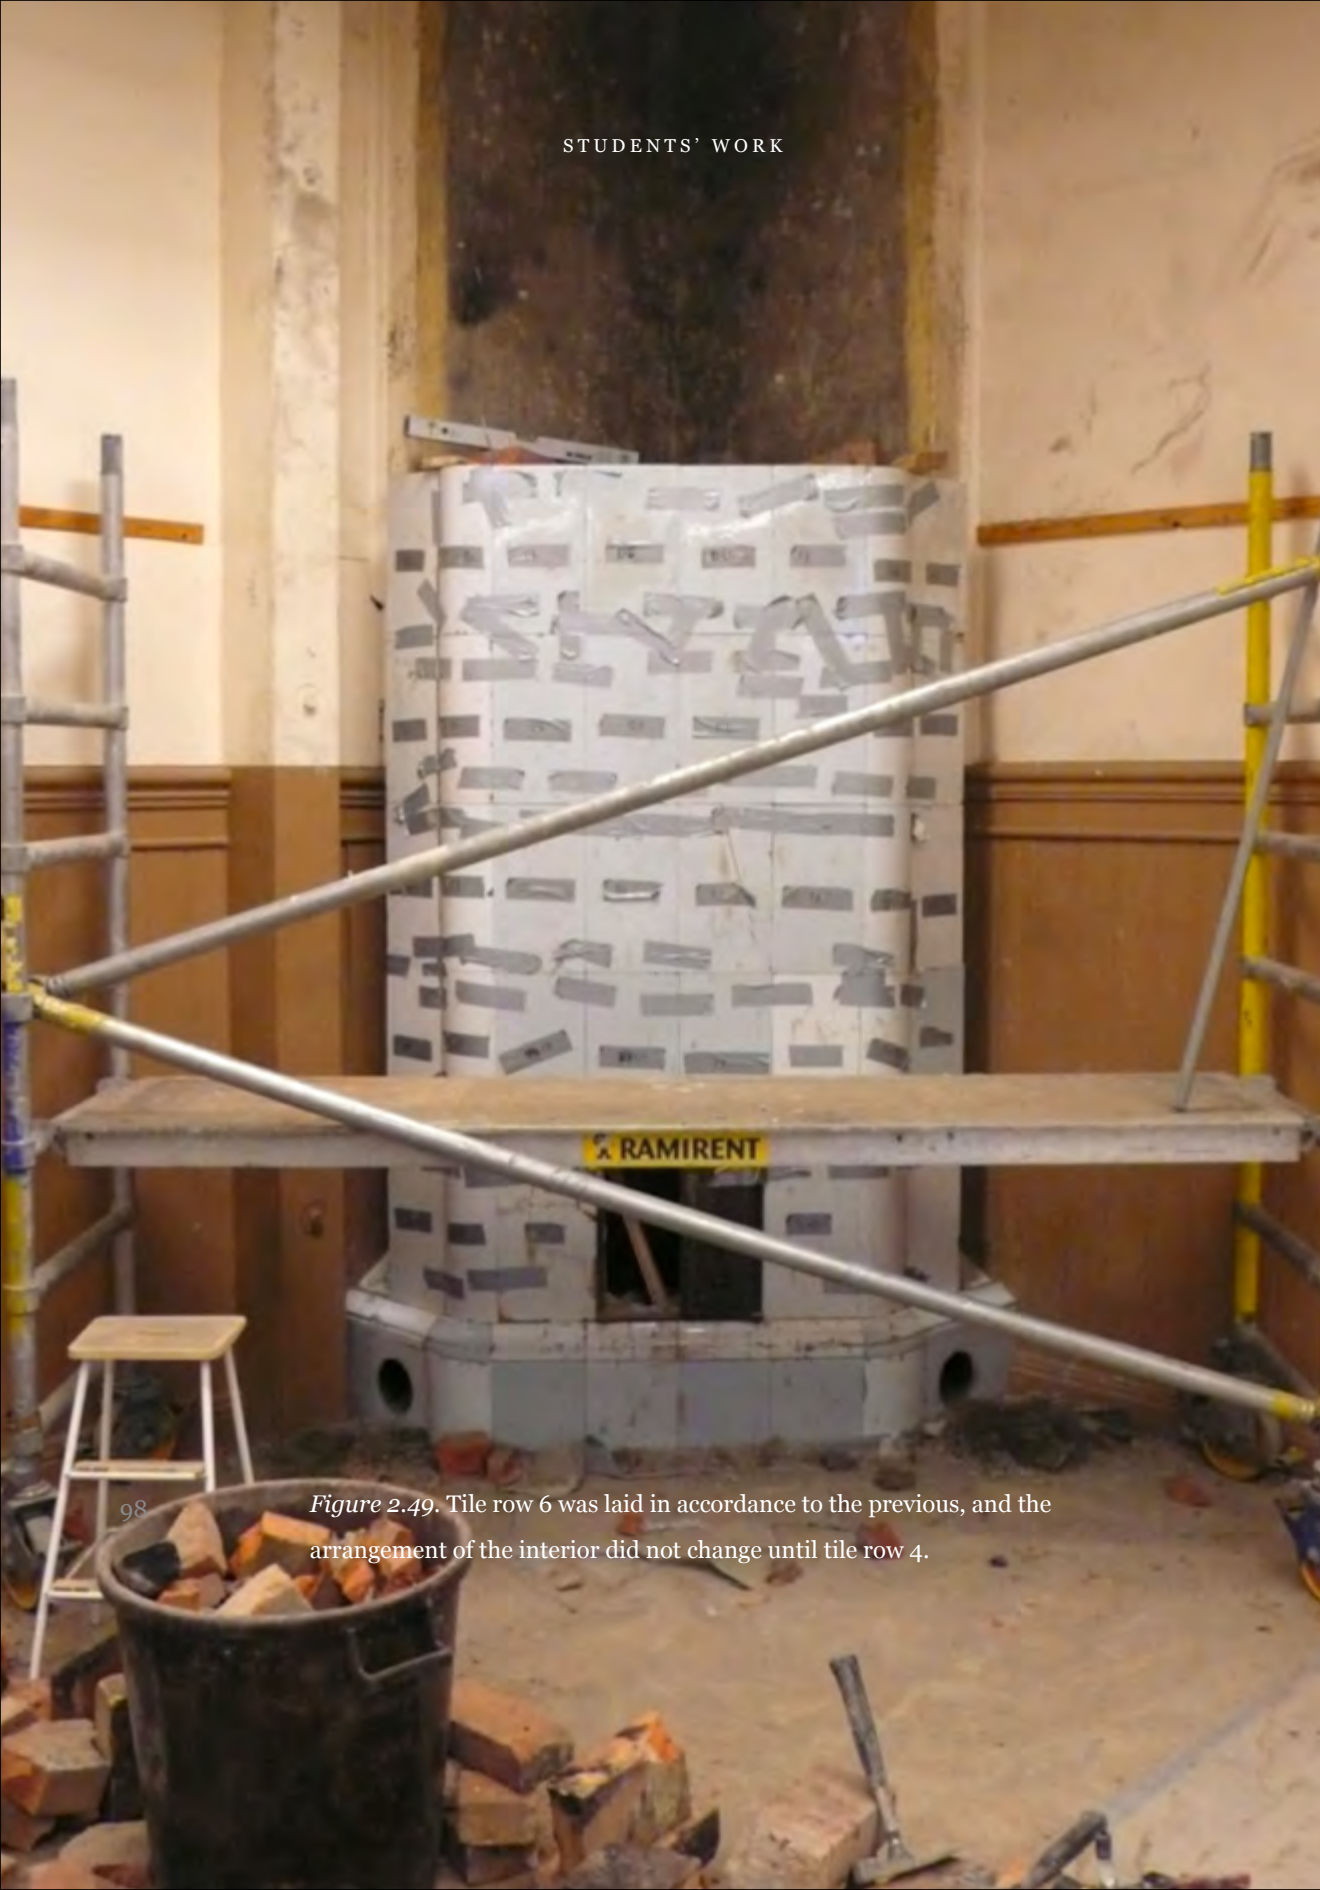
98 *Figure 2.49.* Tile row 6 was laid in accordance to the previous, and the arrangement of the interior did not change until tile row 4.

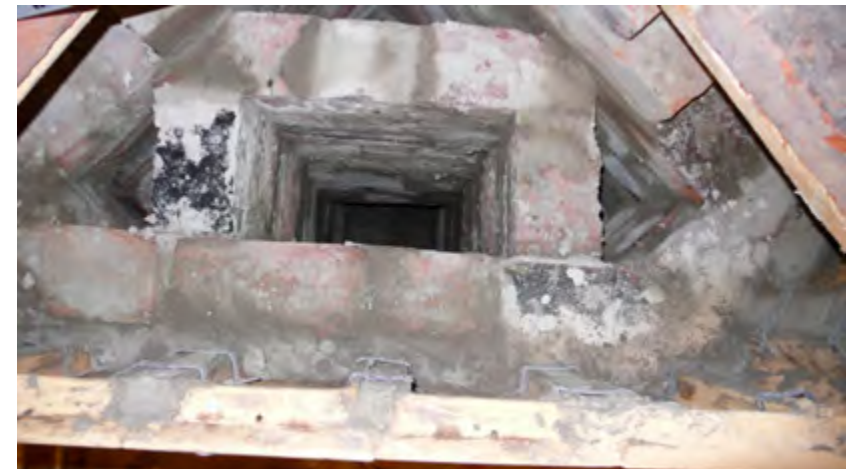
*Figure 2.50.* A view down the inside of the stove from the level of tile row 6.

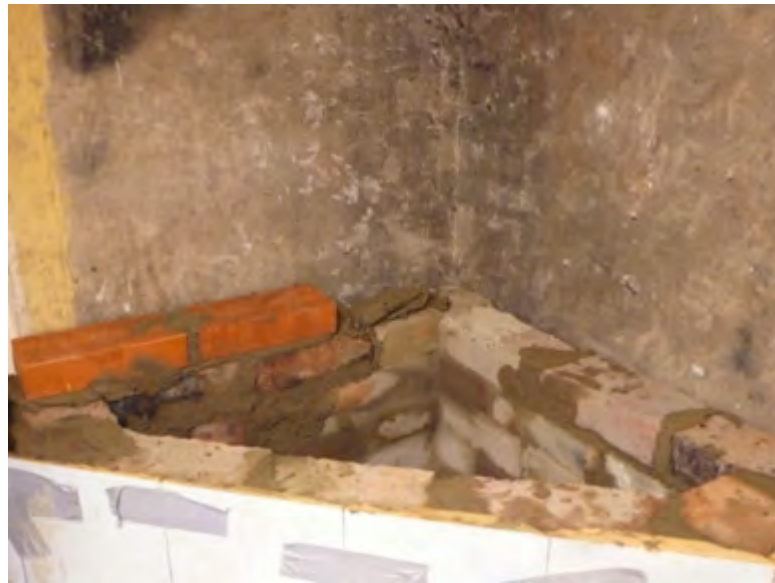
*Figure 2.51.* When we reached the top of tile row 7, we ran out of old bricks and started to use new PT-standard bricks.

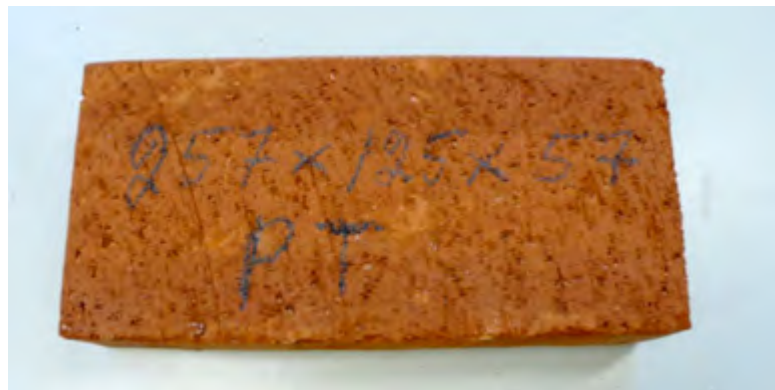
*Figure 2.52.* PT stands for 'peruskokoinen täystili', i.e. standard size solid brick of the dimensions 257 x 123 x 57 mm according to the producer (Wienerberger).

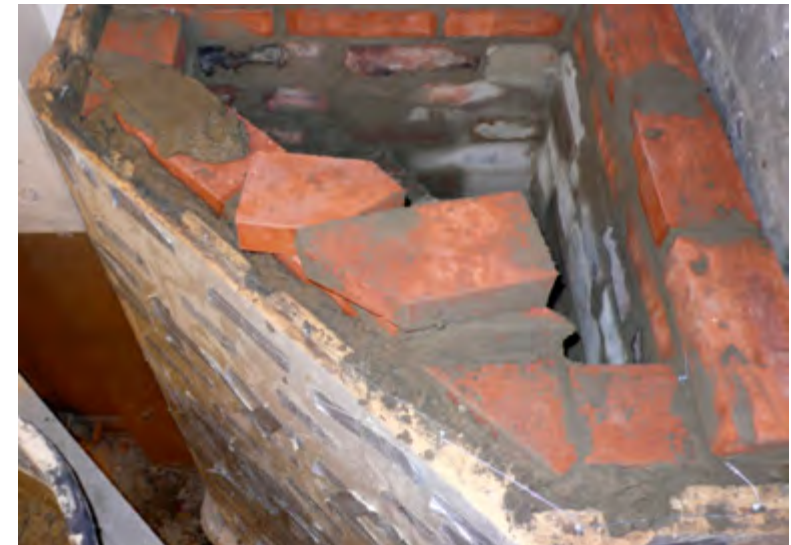
*Figure 2.53.* One and a half courses of the new bricks were laid. Before continuing the baling wire was attached as described before.

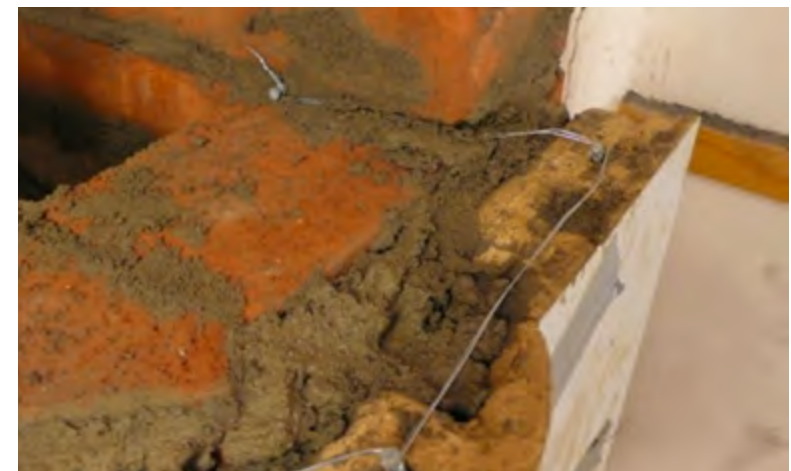
*Figure 2.54.* The wire is secured by a nail in the mortar joint of the side wall of the stove.

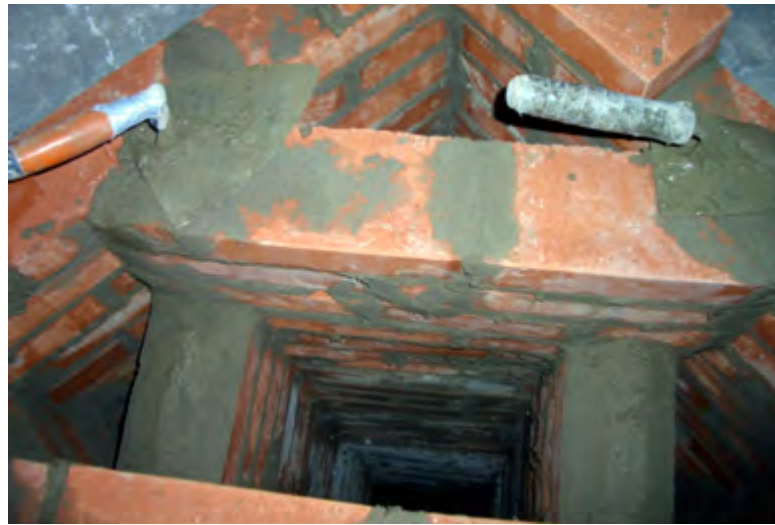
*Figure 2.55.* Looking down the system of flues just before the top was closed with solid brickwork.

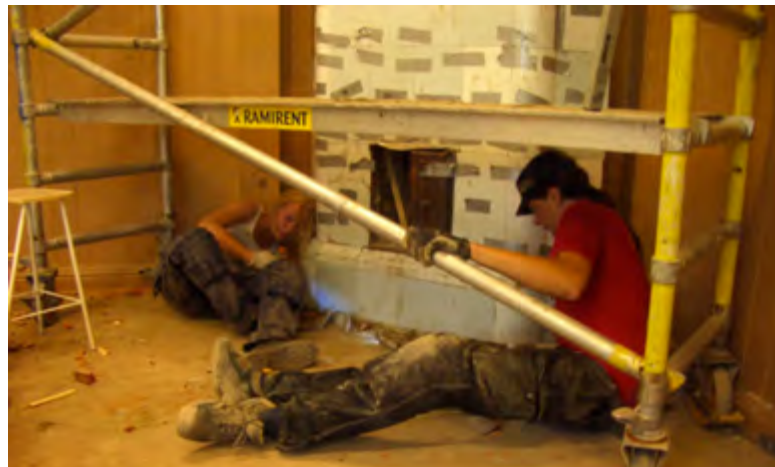
*Figure 2.56.* It is important to clean the bottom of the smoke flues from mortar droppings before the mortar sets!

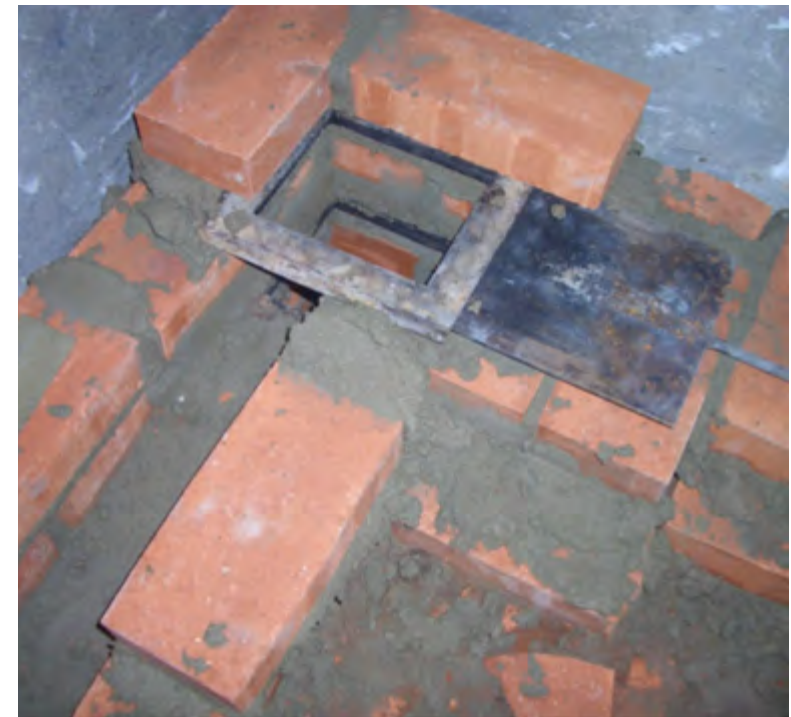
*Figure 2.57.* Tile row 3: the two dampers can be seen at the start of the chimney. To the left we have built the air duct for summer ventilation. (See also drawings.)

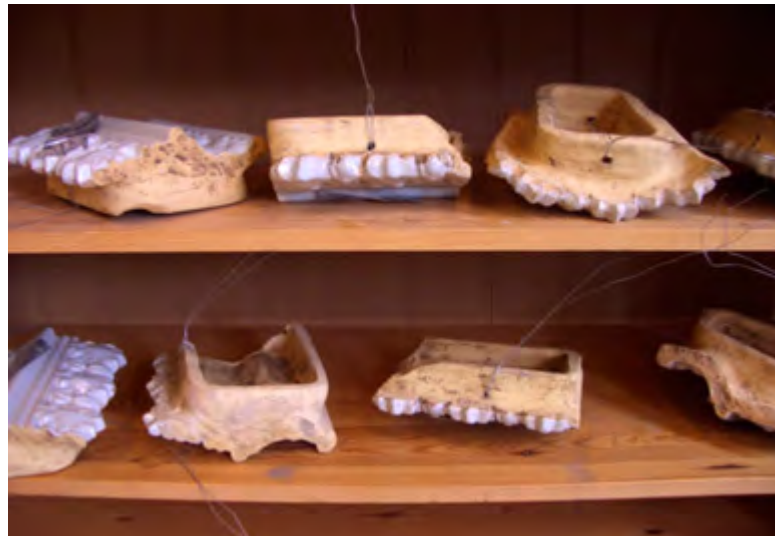
Figure 2.58. Crown tiles waiting to be installed.

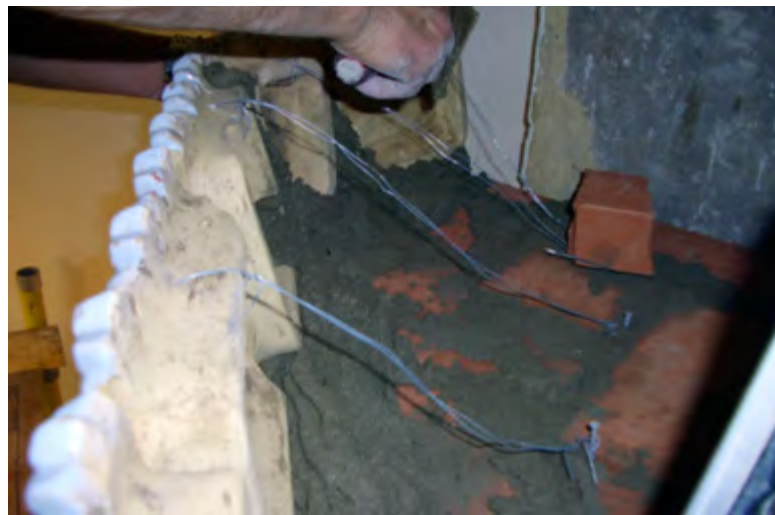
Figure 2.59. The masonry work for the stove is finished when these wires are finally covered with bricks and mortar.

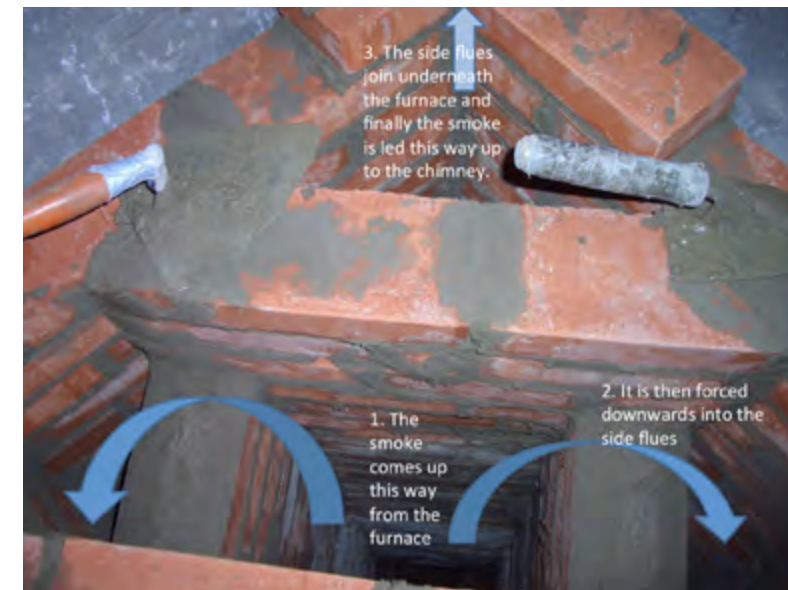
Figure 2.60. View down the flues at the level of tile row 4 (see also drawing). The next row of bricks will close the front flues.
