# Manual for Dismantling, Documenting and Rebuilding Historic Tiled Stoves

**—Sustainable Heritage Report No. 3**

Novia Publications and Productions,  
series S: Student Works, 2/2012

A joint project between Gotland University, Estonian Academy of Arts  
and Novia University of Applied Sciences.

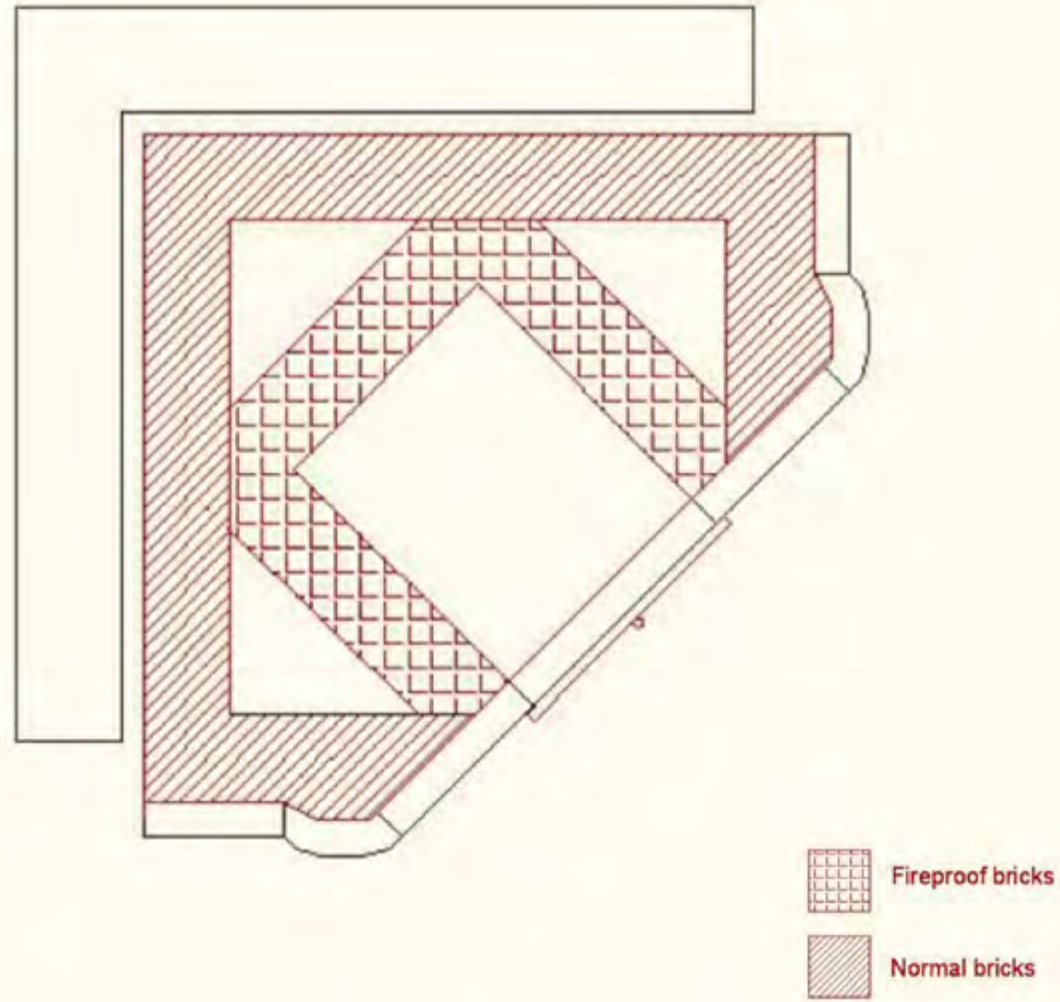
Figure 2.61. Tile row 10: square furnace in the middle; side flues meet underneath the furnace and lead to the flue in the back which leads to the chimney at the top.
